Effect of Flakeboard Manufacturing Variables on Composite Properties: Part 1. Effect of Resin Content, Wax Content, Pressing Conditions, and Edge Treatments on Paint Performance

**R. Sam Williams
Jerrold E. Winandy**

U.S. Forest Service, Forest Products Laboratory
Madison, Wisconsin

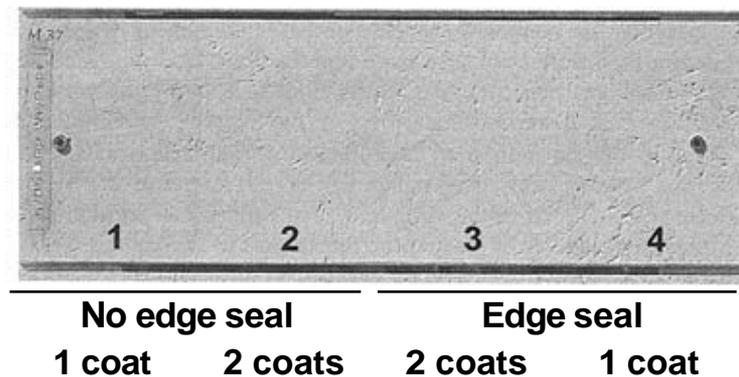
Figure 1. Single board showing four sections: 1. One coat of paint, no edge seal; 2. Two coats of paint, no edge seal; 3. Two coats of paint, edge seal; 4. One coat of paint, edge seal.

Half the length of the drip edge of all boards was painted with an edge-seal. Each 140- by 403-mm (5½- by 15 7/8-inch) board was marked (but not cut) into four 140- by 101-mm (approximately 5½- by 4-inch) paint-exposure zones designated as 1, 2, 3, and 4 when viewed from left to right along the 403-mm (15 7/8-inch) length of the board (**Figure 1**). Each of the two boards per flakeboard panel intended for finishing and subsequent outdoor exposure was edge-sealed with a commercial OSB edge seal on both side edges, the top edge and one-half of the bottom edge (Sections 3 and 4). The remaining two sections (1 and 2) were not edge-sealed along the bottom edge.

The middle half of each board (Sections 2 and 3) was finished with a latex primer and after 24 hours, the entire board (Sections S1-S4) was finished with a single top-coat of a high-quality latex paint. The back side of all boards was finished with a single coat of latex-based primer. After a week of drying, boards were stickered, bundled, and placed in the 30% RH/80°F (27°C) room for conditioning before installation at the two test sites (Madison, WI, and Gulfport, MS).

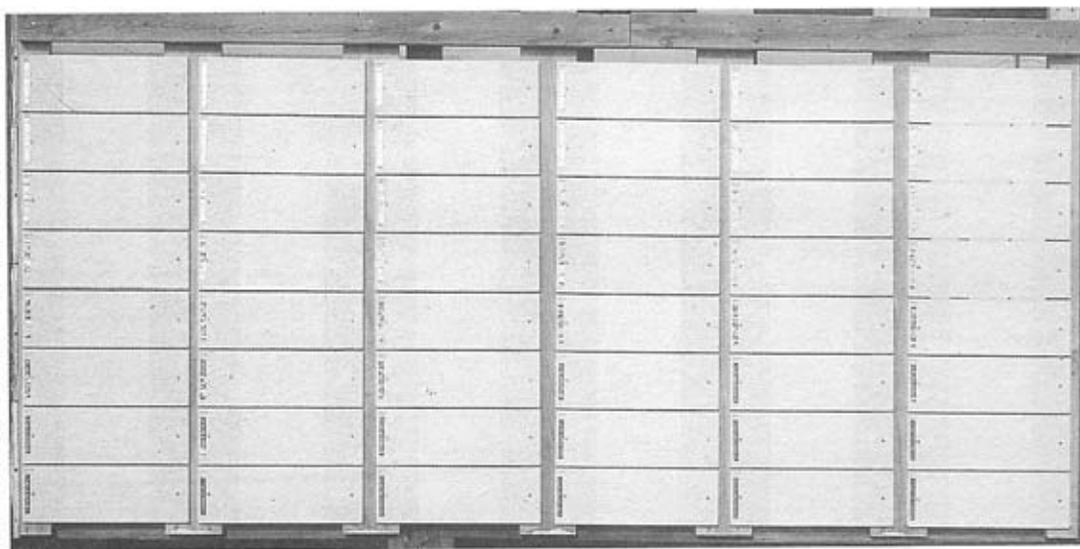
Figure 2. Painted boards mounted on test fence facing south, Madison, Wisconsin, soon after installation.

Painted specimens were placed on test racks vertically facing south at the FPL outdoor test sites located 5 km southwest of Madison, Wisconsin, (**Figure 2**) and 15 km north of Gulfport, Mississippi. The photograph was taken shortly after the boards were placed on the test fence.

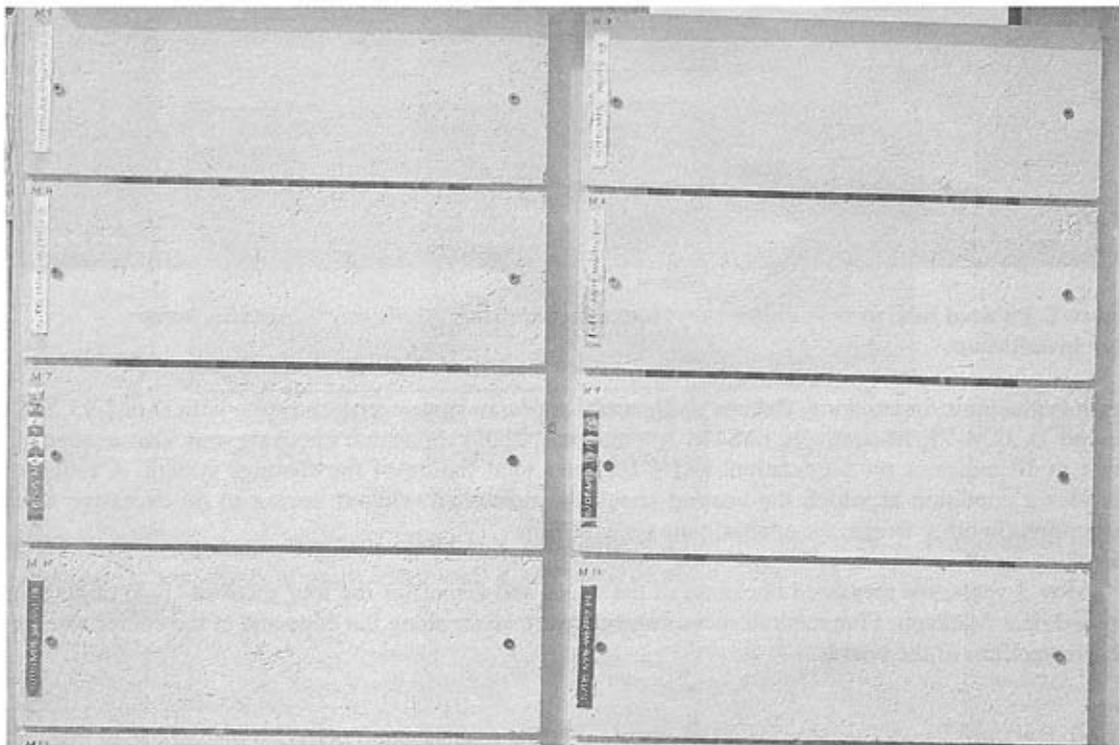
Figure 3. Close-up of several boards just after installation on the test fence near Madison, Wisconsin.

Figures 3 and 4 show the change in specimens exposed for 3 years near Madison, Wisconsin. The boards are typical of the other boards exposed at this site. Inspection of the painted flakeboard boards after 3 years exposure clearly shows a difference in performance of the one- and two-coat paint systems. Each of the boards has four sections (Sections 1-4 (labeled left to right), **Figure 1**). Ends of boards 1 and 4 have one coat (latex top-coat), and the center (Sections 2 and 3) has two coats of paint (latex primer and top-coat). The drip edge of the left half (Sections 1 and 2) has no edge sealer and the right half (Sections 3 and 4) has an edge sealer. Other than the obvious difference in performance of the one- and two-coat paint system, there appears to be little difference in performance between the edge sealed and non-edge sealed (**Figure 4**) specimens. The single coat of paint failed and there was considerable debonding of flakes. The dimensional change of surface flakes often telegraphed through the two-coat paint system.

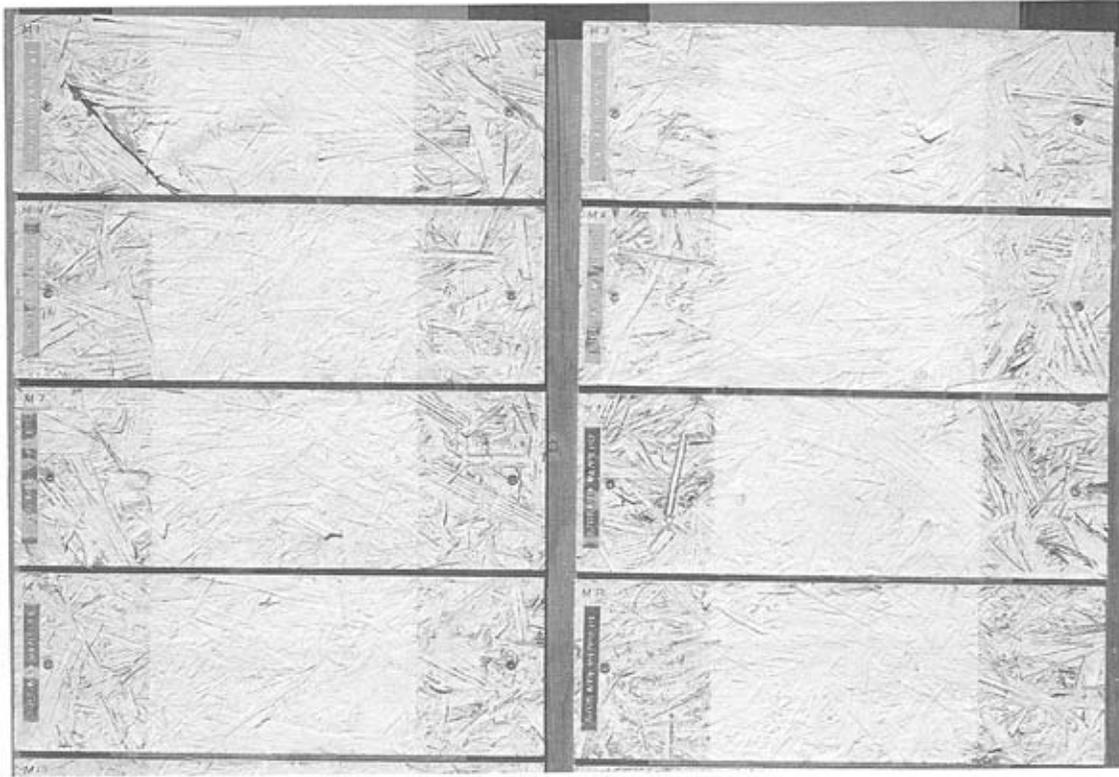
Figure 4. Close-up of the same boards as shown in Figure 3 after 3 years on the test fence near Madison, Wisconsin.

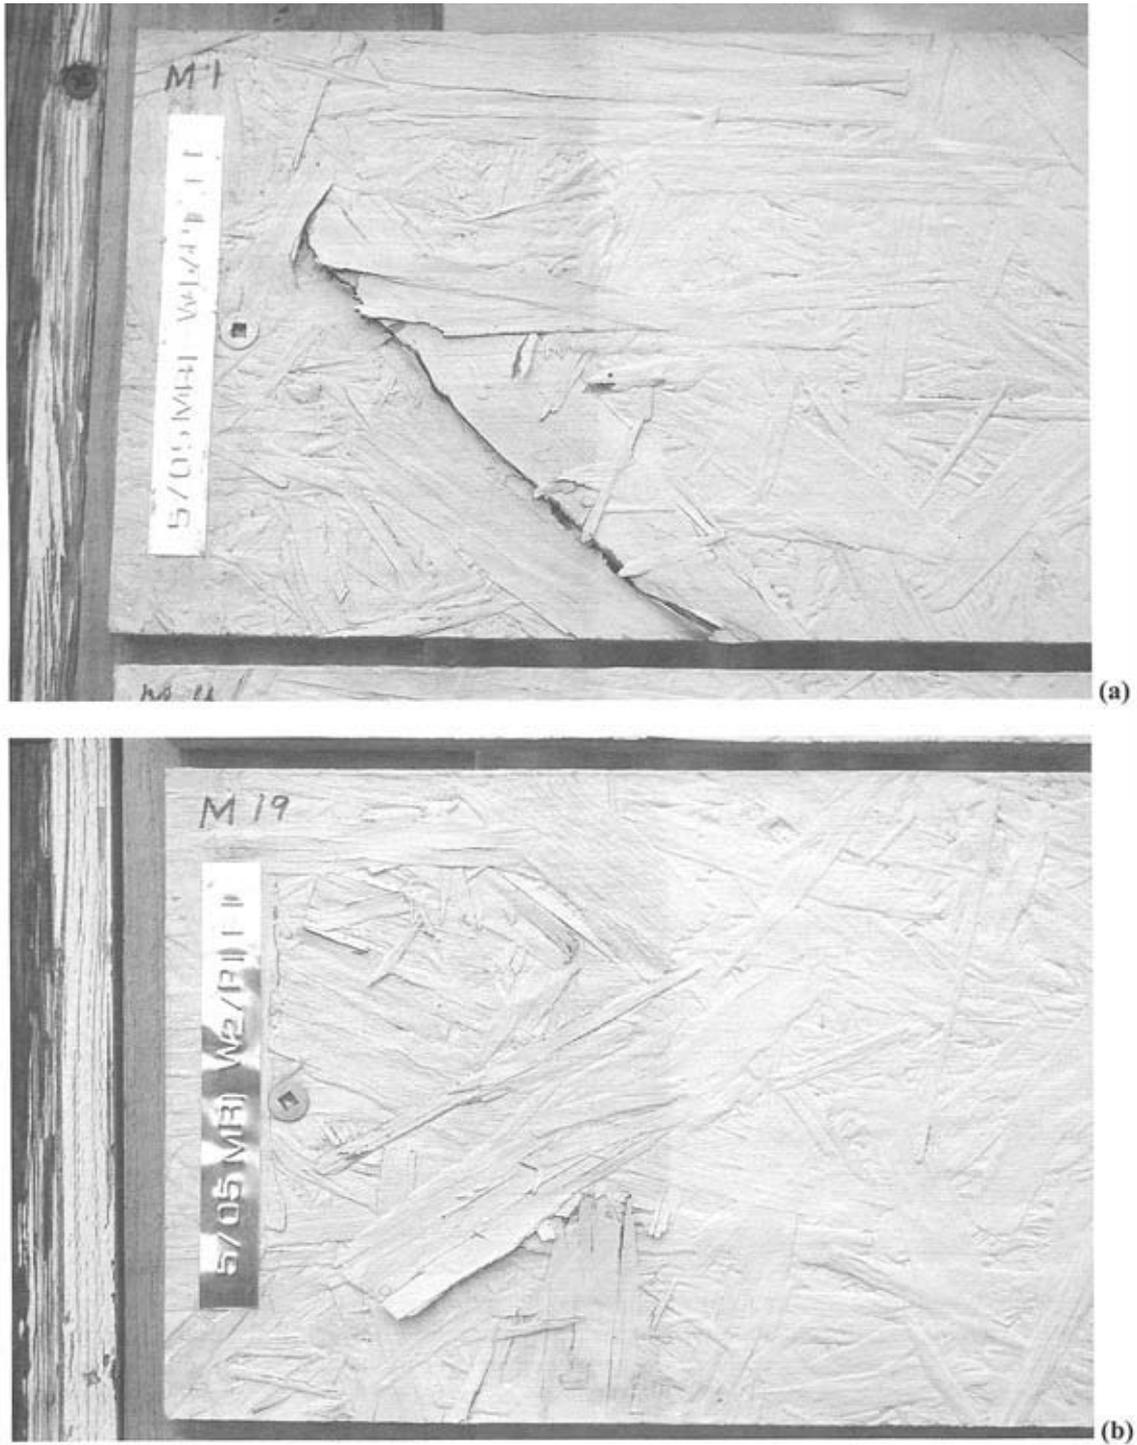
Figure 5. Close-up of boards on the test fence near Madison, Wisconsin, showing deterioration at the edges of large surface flakes.

We evaluated substrate condition (S) for checking, flake curling, and debonding and the paint for paint cracking (C), flaking (F), discoloration (D), and general appearance (G). Large flakes near the surface of the painted boards were generally problematic, as they tended to curl and debond (**Figure 5a and b**). The random orientation is quite apparent in this close-up. As mentioned previously, single-layer mat formation with random flake orientation presents the worst-case scenario for moisture-induced surface movement with few fines in the outer surfaces. Grozdits and Bibal (1983) reported that fines on the surface decreased surface degradation. In our study, this surface movement was more serious under a single coat of paint for the edge-sealed and non-edge-sealed sections of the boards than for the two-coat paint system. In some cases, debonding extended into the two-coat portion of the board (**Figure 5a**).

Figure 6a and b are typical of the change in the boards at the Gulfport test site. As with boards exposed near Madison, the boards having a single coat of paint had failed. In our subjective judgment, telegraphing of the two-coat paint system was slightly worse near Gulfport than near Madison. In general, boards having one coat of paint had severely cracked paint with the flakes debonding. This debonding was more pronounced with larger flakes (**Figure 5**).

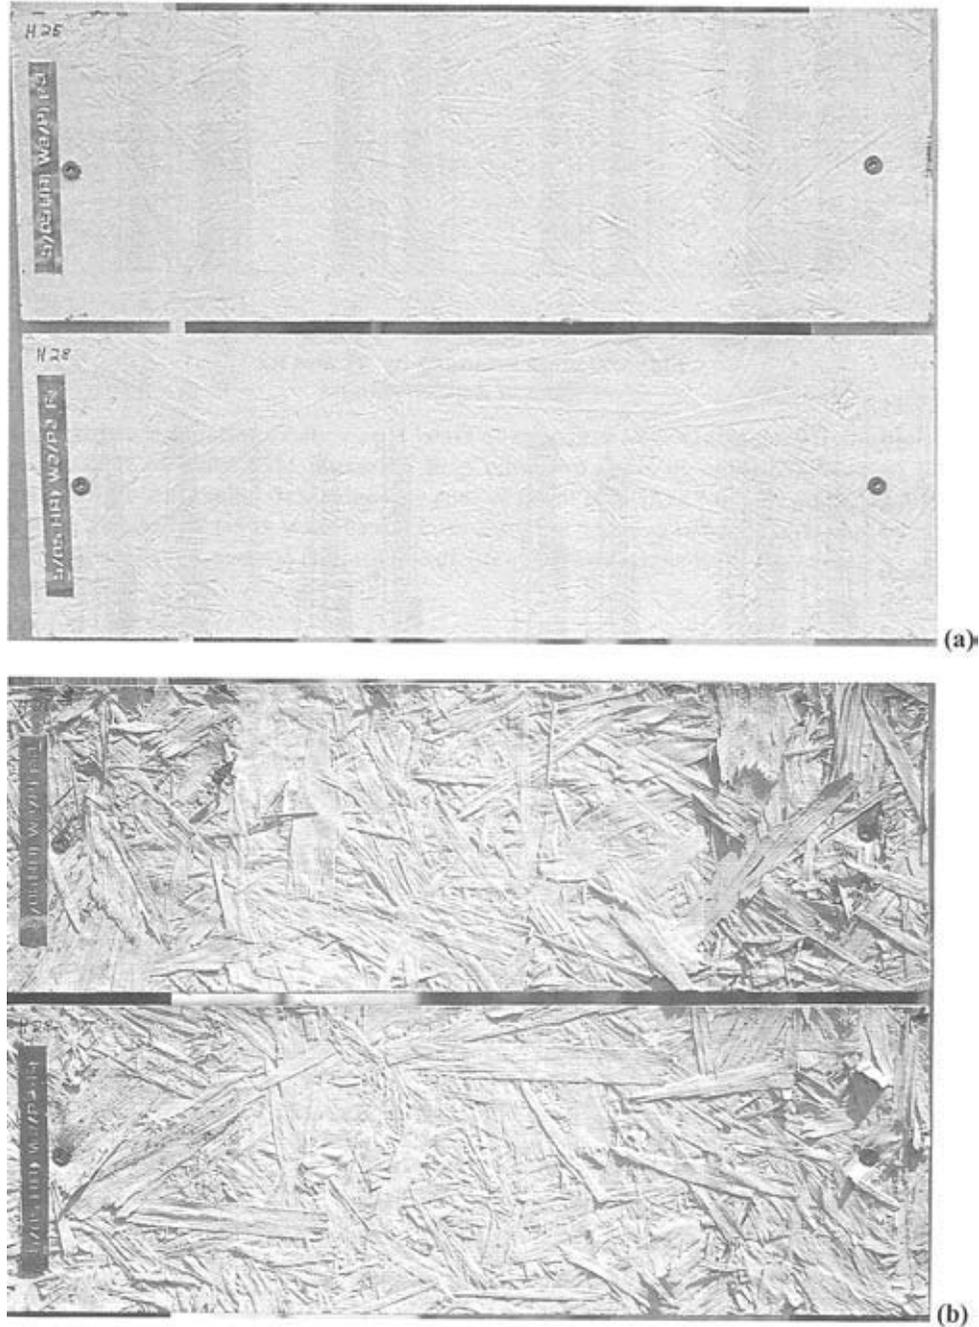
Figure 6. Close up of two boards just after installation (a) on the test fence near Gulfport, Mississippi, and following 3 years of exposure (b).

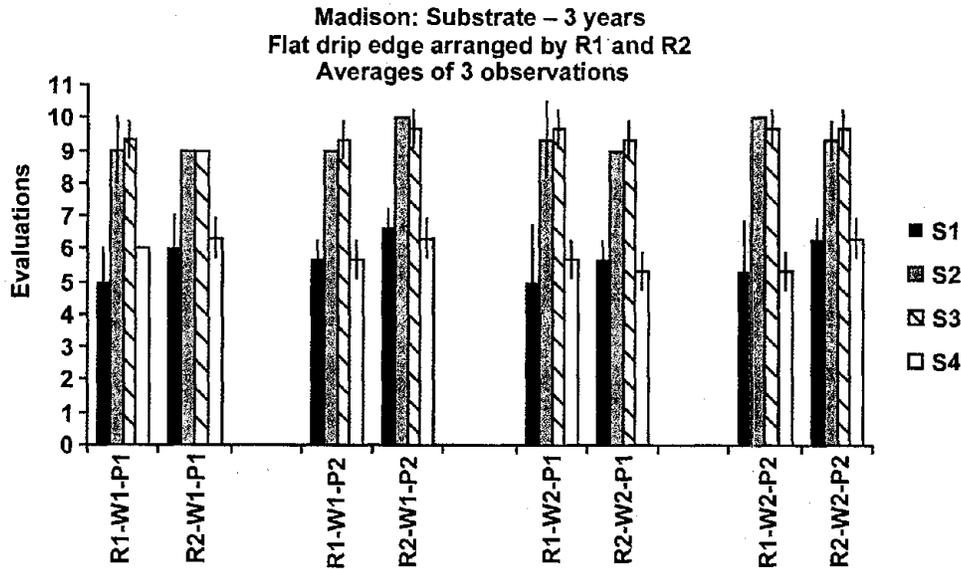
Figure 7. Substrate evaluations following 3 years of exposure near Madison., Wisconsin, for unsealed drip edge/one coat of paint (S1); unsealed drip edge/two coats of paint (S2); sealed drip edge/two coats of paint (S3); and sealed drip edge/one coat of paint (S4). R1 is 2.0% resin, R2 is 3.5% resin, W1 is 0.75% wax, and W2 is 1.5% wax. Error bars indicate ± one standard deviation from mean. Lack of a line indicating first standard deviation indicates all evaluations were the same.

We evaluated the data for the effect of edge-seal, bevel- or flat-drip edge, and manufacturing parameters (resin, wax, and press closure) for boards exposed near Madison and Gulfport. Location had the largest effect and amount of resin had the second largest effect on board performance (Figure 7). Figure 7 shows the condition of the substrate (S evaluation) for non-edge sealed (S1 and S2) and edge sealed (S3 and S4) for flat-drip edges for boards exposed near Madison. Bars are first standard deviation of averages of three observations. The most notable effect is for the one- and two-coat paint systems.

Two coats of paint and 3.5 percent resin in the boards improved paint performance, but the paint evaluation data revealed few other differences among experimental parameters (Figures 7 and 10). Statistical analysis provided a clearer picture of significant differences for the composite manufacturing parameters. The data were analyzed for edge-sealed compared with non-edge-sealed, bevel- compared with flat-edge, location, and manufacturing parameters (resin and wax content and press closure). There was no obvious effect for edge sealing or the type edge (bevel compared with flat). For statistical analysis, both the variability and the level of experimental redundancy affected the actual limits of significance. For this experiment, the limiting differences in means at the $p = 0.05$ and $p = 0.10$ levels of significance would be $0.58 \times SD$ and $0.49 \times SD$, respectively.

Significant substrate and finish-cracking effects for location, resin, wax, and press closure for the flat- and bevel-edge boards are shown in Table 1. The significant effects listed in Table 1 can be compared with the results in the various figures. For example, the difference between R1 and R2 can clearly be seen in Figures 7–10.

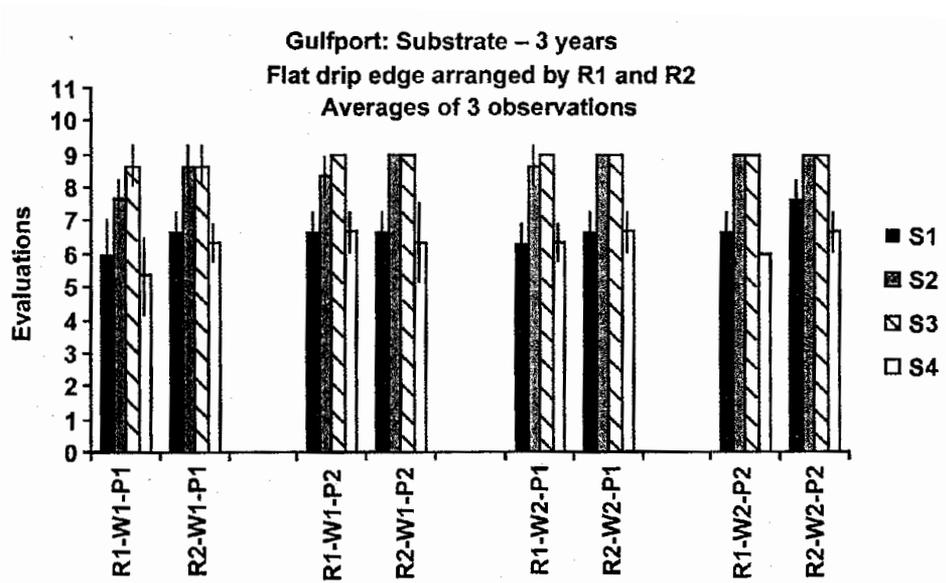
Figure 8. Substrate evaluations following 3 years of exposure near Gulfport, Mississippi, for unsealed drip edge/one coat of paint (S1); unsealed drip edge/two coats of paint (S2); sealed drip edge/two coats of paint (S3); and sealed drip edge/one coat of paint (S4 R1 is 2.0% resin, R2 is 3.5% resin, W1 is 0.75% wax, and W2 is 1.5% wax. Error bars indicate \pm one standard deviation from mean. Lack of a line indicating first standard deviation indicates all evaluations were the same.

The next effect is for resin content; higher resin content improved performance. Boards exposed near Gulfport were similar (Figure 8). The paint cracking evaluations for Madison and Gulfport show similar trends (Figures 9 and 10).

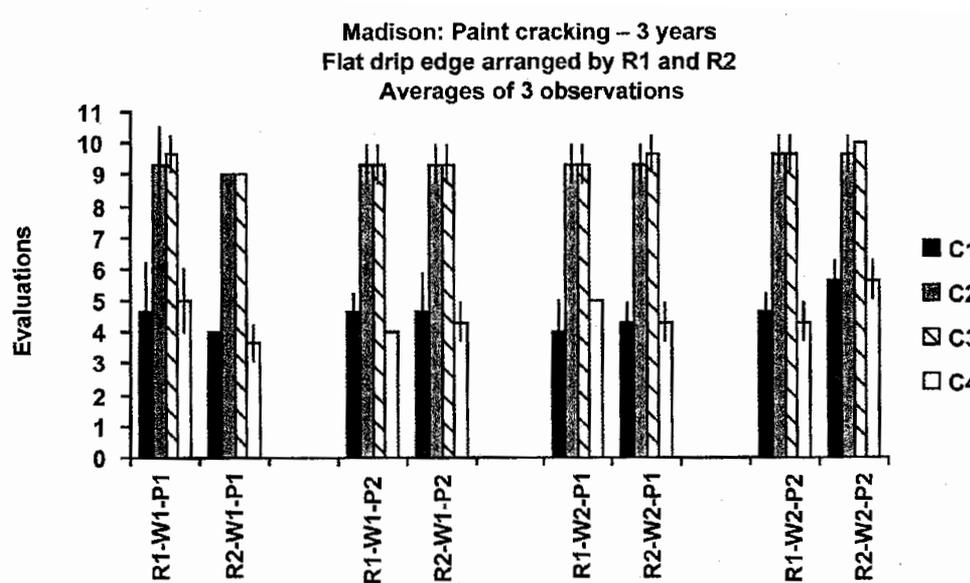
Figure 9. Paint cracking evaluations following 3 years of exposure near Madison, Wisconsin, for unsealed drip edge/one coat of paint (C1); unsealed drip edge/two coats of paint (C2); sealed drip edge/two coats of paint (C3); and sealed drip edge/one coat of paint (C4). R1 is 2.0% resin, R2 is 3.5% resin, W1 is 0.75% wax, and W2 is 1.5% wax. Error bars indicate \pm one standard deviation from mean. Lack of a line indicating first standard deviation indicates all evaluations were the same.

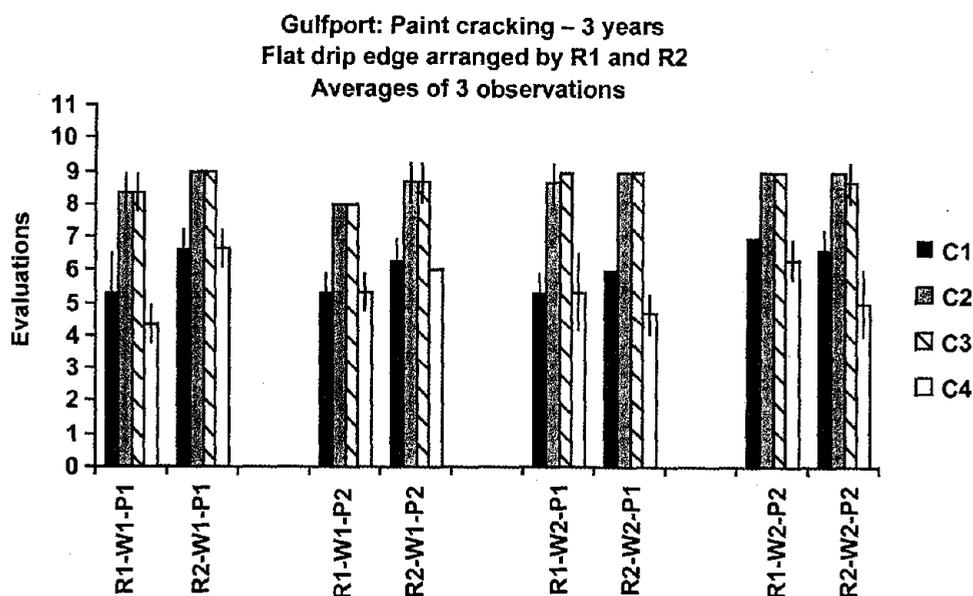
Figure 10. Paint cracking evaluations following 3 years of exposure near Gulfport, Mississippi, for unsealed drip edge/one coat of paint (C1); unsealed drip edge/two coats of paint (C2); sealed drip edge/two coats of paint (C3); and sealed drip edge/one coat of paint (C4). R1 is 2.0% resin, R2 is 3.5% resin, W1 is 0.75% wax, and W2 is 1.5% wax. Error bars indicate 5 one standard deviation from mean. Lack of a line indicating first standard deviation indicates all evaluations were the same.

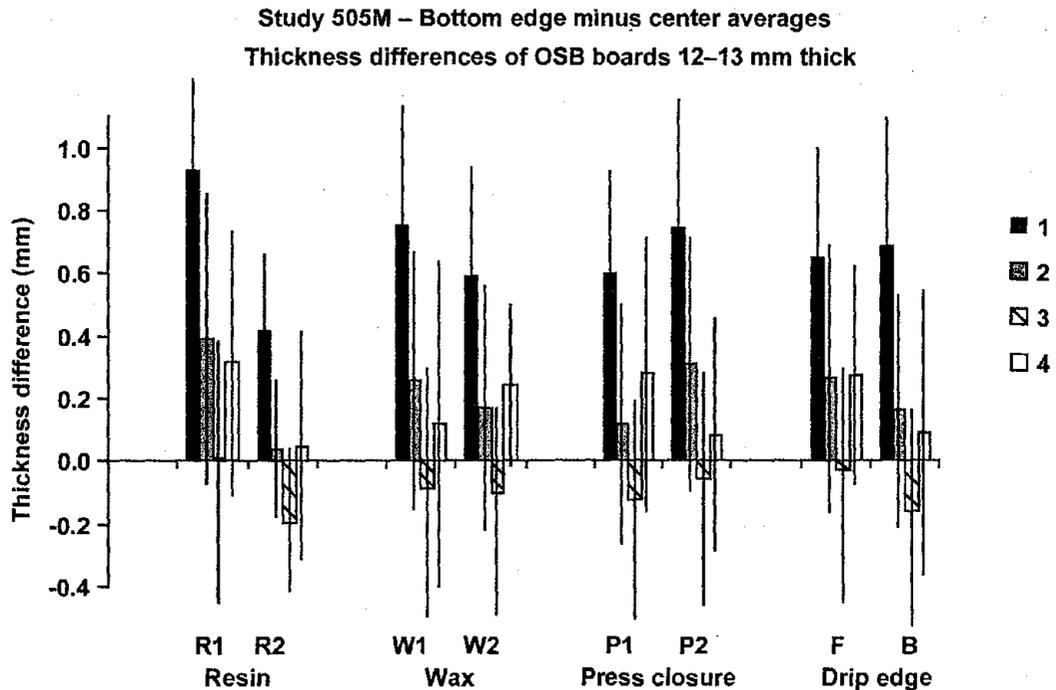
Figure 11. Thickness-swell difference between drip edge and center of board for: unsealed drip edge/one coat of paint (1); unsealed drip edge/ two coats of paint (2); sealed drip edge/two coats of paint (3); and sealed drip edge/one coat of paint (4). Lack of a line indicating first standard deviation indicates all evaluations were the same. R1 is 2.0% resin, R2 is 3.5% resin, W1 is 0.75% wax, and W2 is 1.5% wax. P1 is continuous press closure, P2 is two-stage press closure, F is flat edge, and B is bevel edge.

The original intent of the study was to assess paint performance. However, as the study progressed, it became apparent that substantial substrate degradation was occurring, particularly on the portions of the boards having one coat of paint. One method for quantifying the substrate degradation in a nondestructive manner is to measure thickness-swell. The results for the difference in thickness between the drip edge of the boards (measured approximately 3–5 mm from the drip edge) and the approximate center of boards showed substantial differences for the various experiment parameters (**Figure 11**). The most striking feature of this figure is the negative values for zones with two coats of paint over an edge-sealer. Edge seal decreased the thickness-swell for all paired comparisons (4<1, 3<2). The edges swelled less than the center of the board. In all cases, two coats of paint performed better than one coat (2<1, 3<4). The effects of resin content (R1/R2), wax content (W1/W2), press closure (P1/P2), and bevel- compared with flat-edge on thickness swell are similar to the results for the visually assessed paint performance (R2<R1, and W2<W1). We expected to observe a decrease in edge thickness-swell with an increase in resin and wax content, and our measurements confirmed this.

To analyze the unsealed compared with sealed effect, we considered the thickness difference between the edge and center for two sets of paired comparisons (1-4 and 2-3). For example, 1 and 4 are paired by being measured on the same strip from the same panel; both have one coat of paint (number 1 is not edge sealed whereas number 4 is edge sealed). In the other paired comparison (2 compared with 3), both have two coats of paint (number 2 is not edge sealed whereas number 3 is edge sealed). There are a total of eight [2 resins, 2 waxes, 2 presses], 3 replicates, 2 bevel-, flat-edge] = 48 measurements for 1 compared with 4 if we pool the bevel- and flat-edge measurements. The results for the pooled, bevel-, and flat-edge cases are presented in Table 2. The differences can clearly be seen in Figure 11.
