# Chapter 6

## FIRE DAMAGE OF WOOD STRUCTURES

*B. Kukay, R. White, and F. Woeste*

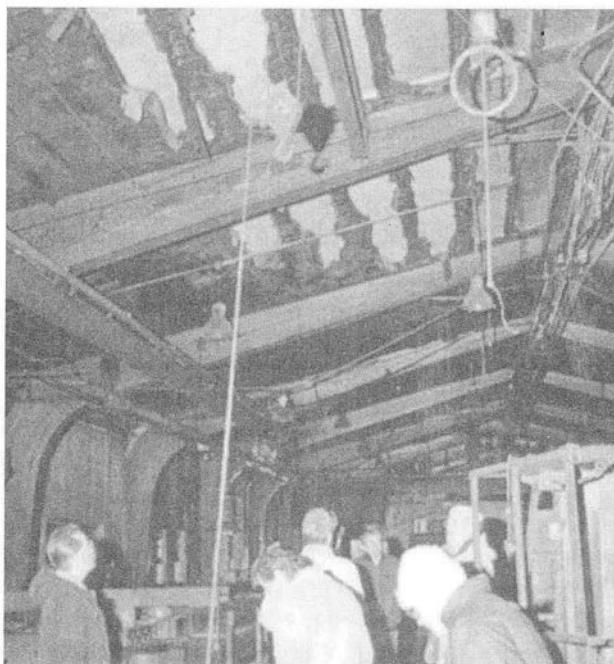
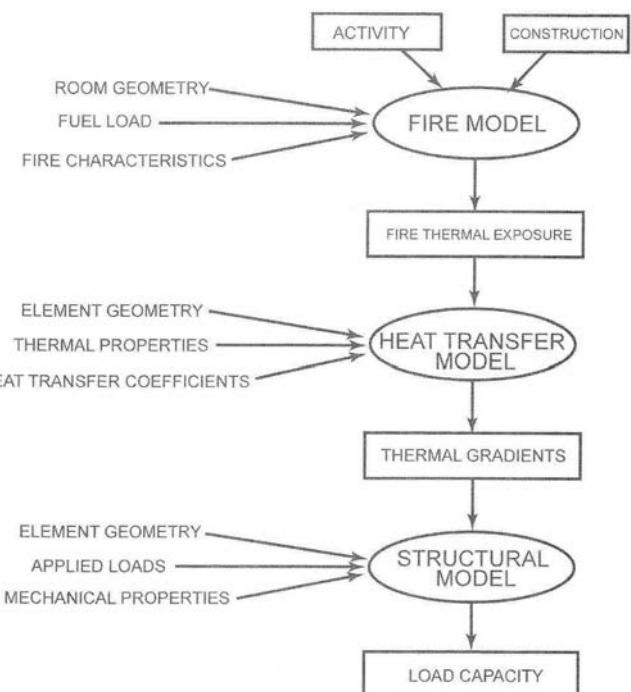
**Figure 6.1**  
A fire-damaged building at the US Forest Products Laboratory and a flowchart [1]  
for modeling fire-damaged wood members in a structural fire

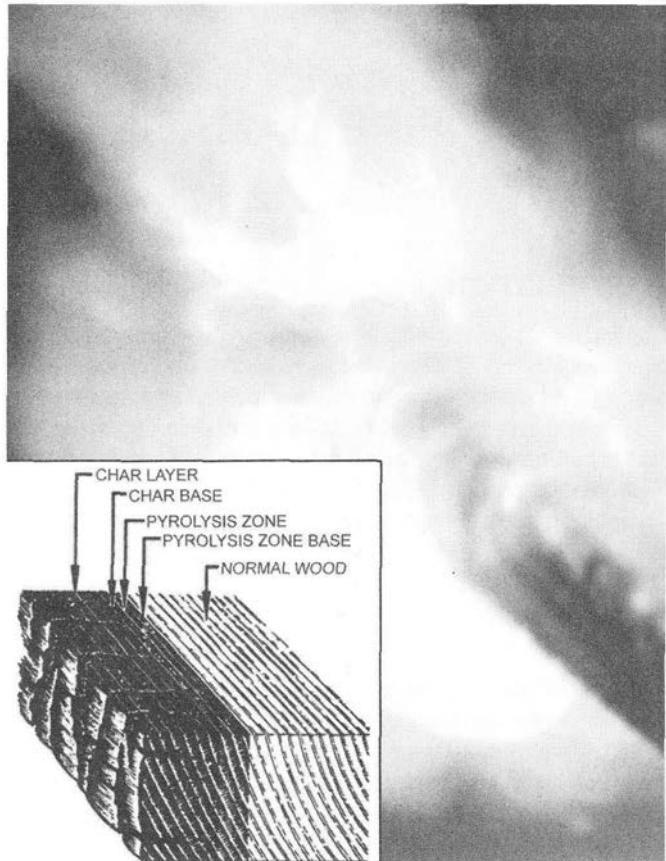
**Figure 6.2**  
**Degradation zones in a charred piece of wood [8]**

Sudden surface heating of a wood member in a fire results in surface charring and a steep temperature gradient. Thus, the stages of thermal wood degradation become zones of degradation in a structural wood member exposed to fire. In a broad sense, there is an outer char layer, a pyrolysis zone, a zone of elevated temperatures, and a cool interior (Figure 6.2). These zones of degradation reflect the temperature profile through the cross-section.

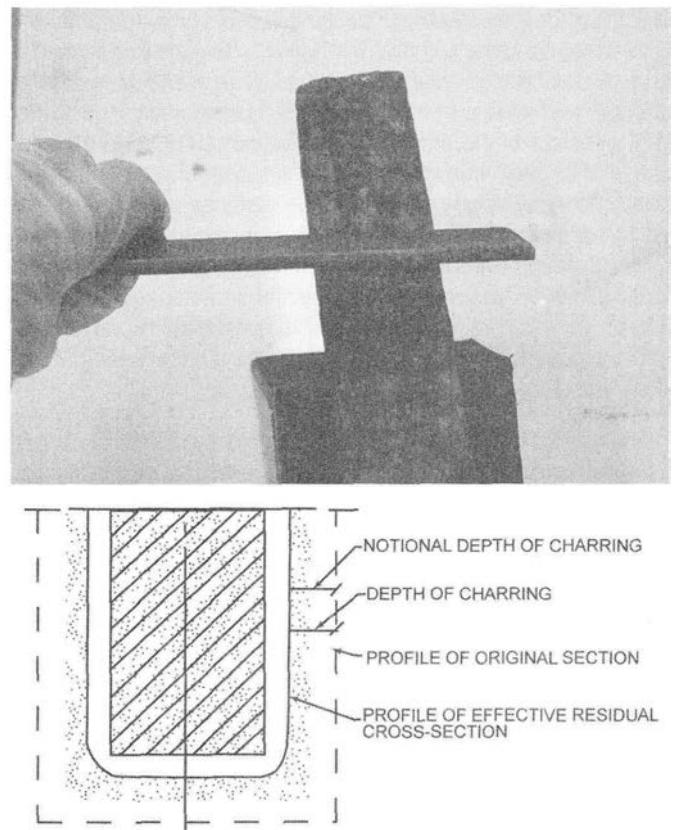
**Figure 6.3**  
Profile of a charred piece of wood [inset (22)]

The char layer can be easily scraped off a member that has been charred (Figure 6.3). Obviously, any charred portion of a fire-exposed wood member has no residual load capacity. The wood beneath the char layer has residual load capacity, but this residual capacity will be less than the load capacity prior to the fire. At a depth of only 8 mm (0.3 in.) beneath the char layer, the temperature is about 200°C. At 200°C, the residual strength properties still exceed 80 percent of the initial room temperature values. Members themselves that have only visual smoke damage or slight browning of the surface also have significant residual load capacity [22].

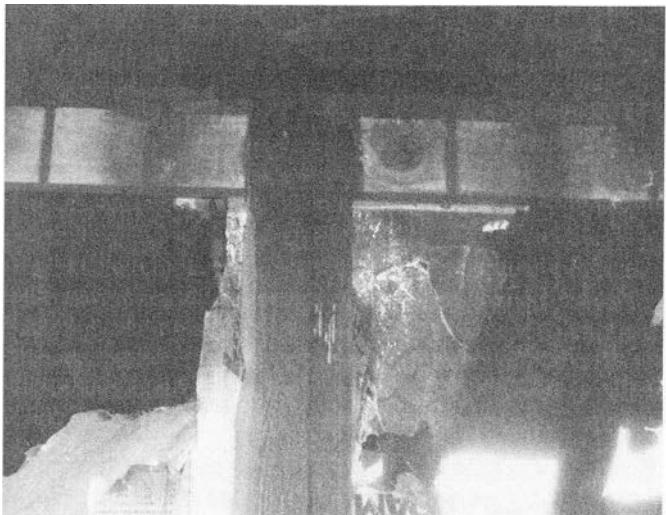
**Figure 6.4**  
Fire-damaged timber floor beam

After inspection of all affected timbers, the fire-damaged timber floor beams are about 8-inch by 12-inch (nominal) surfaced-four-sides (S4S) southern pine, and none of the timbers have grade marks. Varying degrees of degradation are present, and the most severely charred members are identified. At this point of the investigation, only the estimated char depth on the three exposed faces of the timbers needs to be determined. This step can be accomplished as the inspector carefully scrapes a small area of char on the three exposed sides to measure the char-free section dimensions. Sanding the area below the removed char isn't necessary at this stage of the investigation. For the beams examined, char depths are recorded as well as measurements on similar timbers with minor char that reveal that the timbers were probably manufactured as "unseasoned" 8-inch by 12-inch timbers at the time of construction, and the residual dimensions reflect about a ½-inch reduction for each of the three

exposed surfaces in comparison to smoke-damaged members (Figure 6.4).

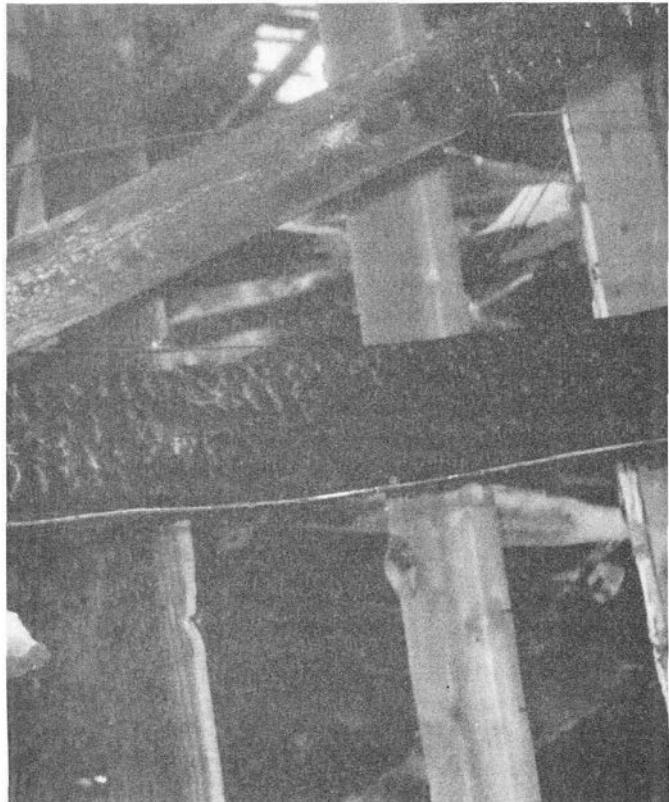
**Figure 6.5**

**Dimensional lumber, identifying degrees of degradation**

Assuming that the dimensional lumber and/or similar sized products are exposed to fire and allowed to self-extinguish, and assuming the fire is contained, lumber quality can be field verified from neighboring members (Figure 6.5). Although the ignition properties of dimensional lumber and composite materials are very similar to one another, Babrauskus [7] and Kukay and Todd

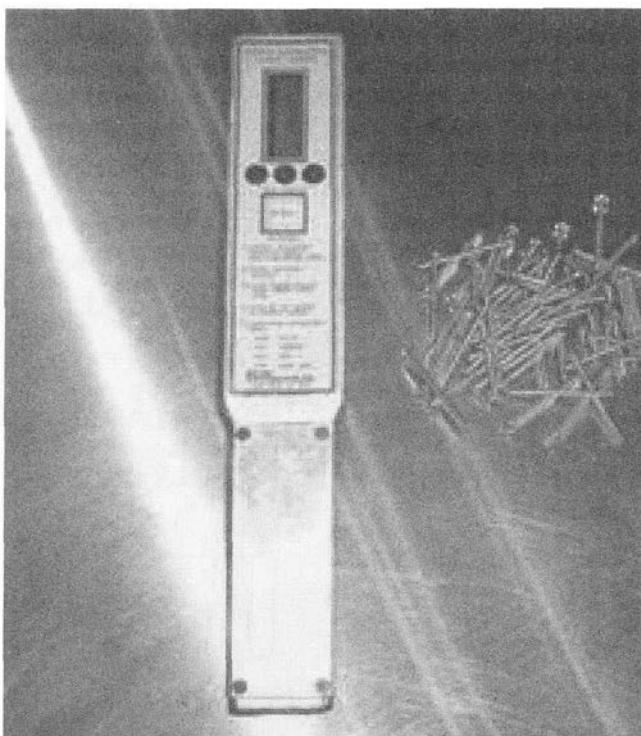
**Figure 6.6**  
**Screw-withdrawal test**

Current practice indicates the use of a digital screw extractor when the engineer is recording the maximum extraction load as a manual force is applied at a uniform rate of increase. From start to finish, each screw extraction is typically administered within 2 to 4 seconds. Digital screw extractors capable of recording the maximum extraction load to the nearest 10 pounds are sufficient. Related research specifies the extraction of  $\frac{5}{32}$ -inch by 2-inch-long machine screws from  $\frac{5}{32}$ -inch pilot holes. The machine screws are inserted to consistent depths of 1.5 inches and are measured from the un-charred surface. Because screw-withdrawal resistance is a function of insertion depth, instances may arise where it is necessary for the inspector to place a perforated 0.25-inch thick metal plate between charred members. To limit variability among screw withdrawal tests, only machine screws that are manufactured from similar lots and batches should be used throughout a post-fire investigation. A digital screw extractor is depicted in Figure 6.6.

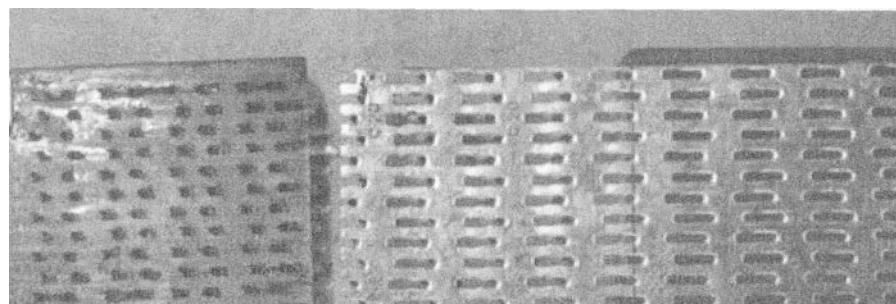
a) charred wood failure beneath plate

**Figures 6.7a and 6.7b**  
**Test specimens of metal plate connections**  
*(Courtesy of US Forest Products Laboratory)*

It is the degradation of the wood beneath a metal plate connection that results in its failure (Figure 6.7a). In situations when the heating is strictly via radiation, the metal plate may actually initially protect the wood beneath the metal plate from charring as much as the adjacent wood (Figure 6.7b). The test specimens in Figures 6.7a and 6.7b are from a project to develop a fire-endurance model for metal-plate-connected wood trusses [40, 41]. If there is damage to the plate area, the plate is discolored, or there is charring under the plate, it is recommended that the connection be considered ineffective [42].

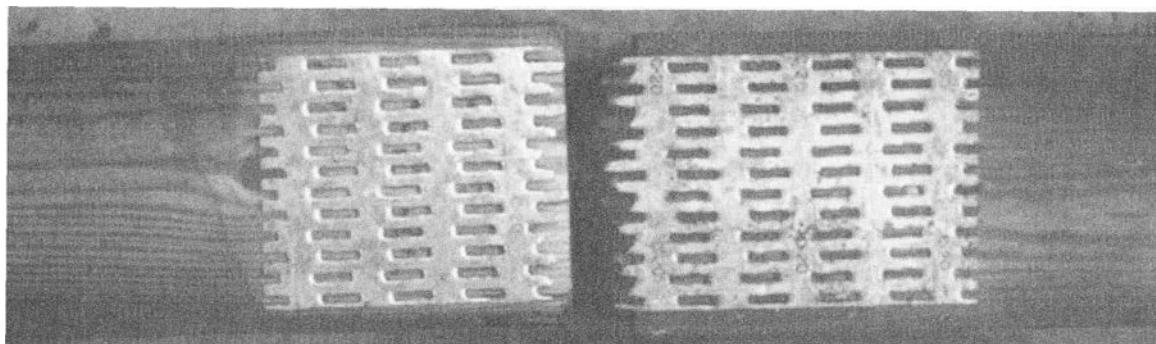
b) failure of metal plate with un-charred wood beneath plate
