Fastener Corrosion: Testing, Research, and Design Considerations

In: WCTE 2006-9th World Conference on timber engineering; 2006 August 6-10; Portland, OR. Corvallis, OR.: Oregon State University: 8 p. On CD

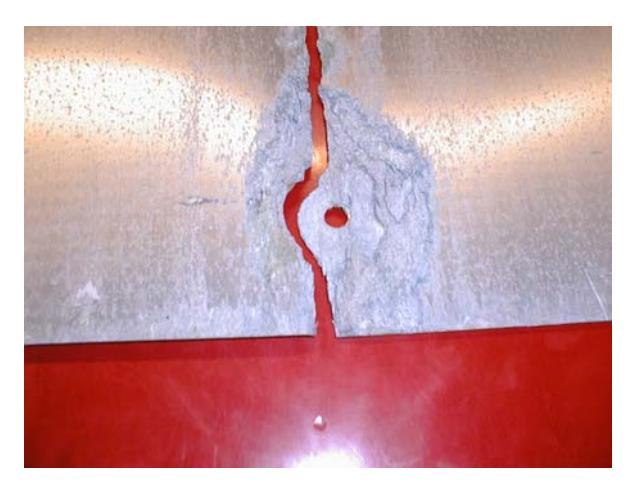
Figure1: Failure of an aluminum traffic sign that was attached to ACQ-treated wood with a stainless steel fastener. Photo courtesy of WISDOT.

Recently in the state of Wisconsin, aluminum road signs were to be attached to ACQ-treated posts. Hearing concerns about new preservatives and corrosion of fasteners, engineers specified stainless steel lags screws for attaching the signs to the posts. After a short time, several signs failed at points of attachment, a failure never previously observed. Figure 1 shows one of the aluminum sign that suffered extensive corrosion damage near the point of attachment, which ultimately led to failure.

This is an example of galvanic corrosion, which occurs when dissimilar metals are placed in electrical contact and the less noble metal corrodes at the expense of the more noble metal. Although galvanic corrosion is often used to protect structures and ships via a sacrificial anode, if not accounted for in design practices, it can lead to failures in service. Even if the metals are protected by paint or another barrier, galvanic corrosion can occur through defects in the barrier.

The anodic (less noble) metal should never be coated, because defects in the coating exacerbate the effect of galvanic corrosion by localizing it to a small surface area (Elliott, 2003).
