U. S. FOREST SERVICE
RESEARCH PAPER
- FPL 29 -
JUNE 1965

*Performance of Container Fasteners Subjected
to Static and Dynamic Withdrawal*

R. S. Kurtenacker, Engineer

FOREST PRODUCTS LABORATORY¹ FOREST SERVICE
U. S. DEPARTMENT OF AGRICULTURE

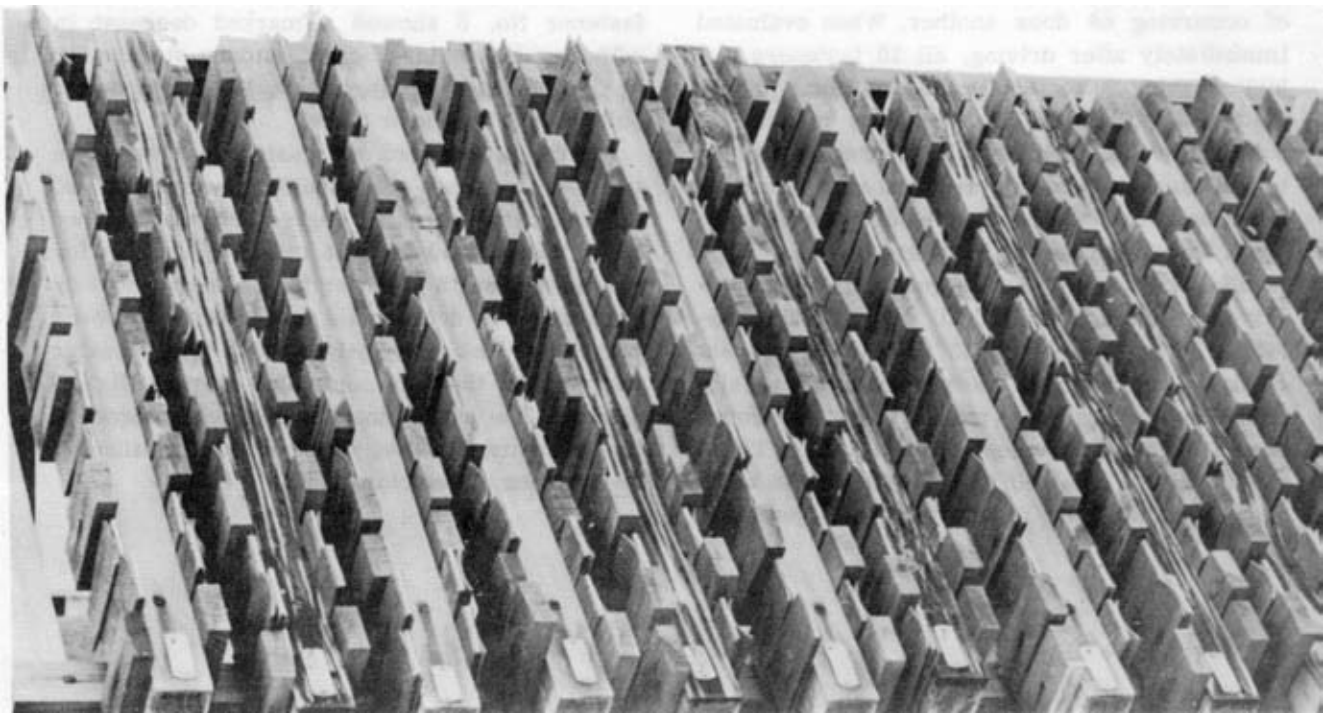
ZM 123 780

Figure 9.--Test specimens after 1-year's exposure at the U.S. Forest Products Lab. exposure site west of Madison, Wis. Note the weathered appearance and the deterioration of the plywood cover pieces.
