## Research–Demonstration House Development and Evaluation in North Carolina

### Phase II: Performance of Water Management Details for Windows and Doors

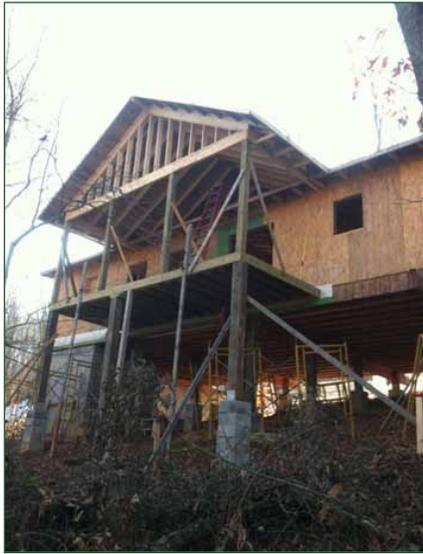
**Figure 2. House foundation was designed to minimize erosion and to include engineered wood products and locally harvested white oak posts.**  
*Photo by John Mark Roberts.*
