# Biodeterioration of Wood

Carol A. Clausen, Supervisory Research Microbiologist

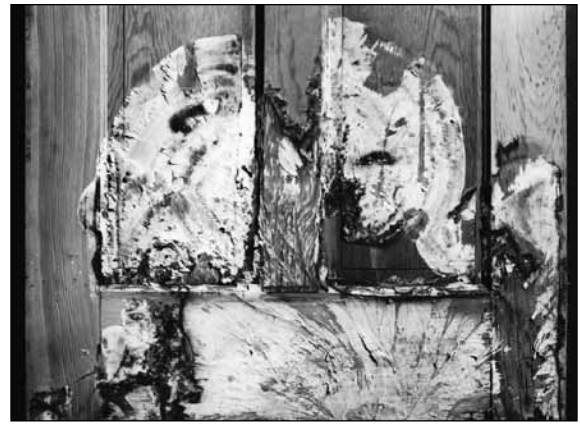
**Figure 14-4. Mycelial fans on a wood door.**

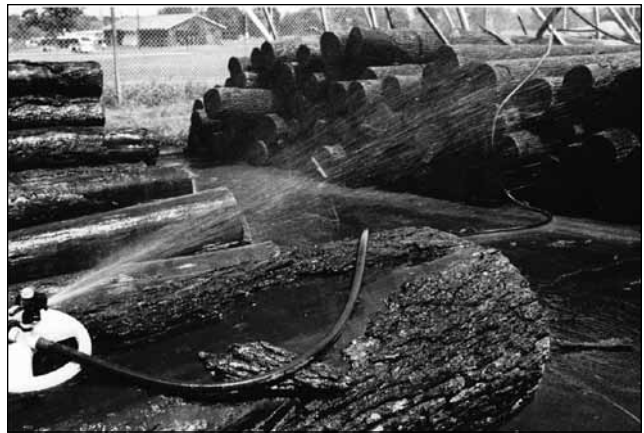
Figure 14–6. Spraying logs with water protects them against fungal stain and decay.

For logs, rapid conversion into lumber or storage in water or under a water spray (Fig. 14–6) is the surest way to avoid fungal damage. Preservative sprays promptly applied to the wood will protect most timber species during storage for 2 to 3 months, except in severe decay hazard climates, such as in Mississippi (Fig. 14–1). For longer storage, an end coating is needed to prevent seasoning checks, through which infection can enter the log.

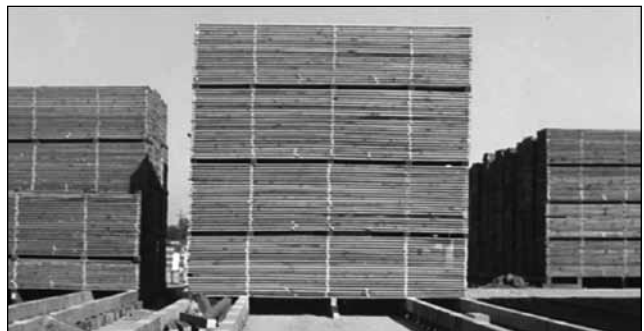
Figure 14–7. A sanitary, well-drained air-drying yard.

Air-drying yards should be kept as sanitary and as open as possible to air circulation (Fig. 14–7). Recommended practices include locating yards and sheds on well-drained ground; removing debris (which serves as a source of infection) and weeds (which reduce air circulation); and employing piling methods that permit rapid drying of the lumber and protect against wetting. Storage sheds should be constructed and maintained to prevent significant wetting of the stock. Ample roof overhang on open sheds is desirable. In areas where termites or water-conducting fungi may be troublesome, stock to be held for long periods should be set on foundations high enough so that the wood can be inspected from beneath.

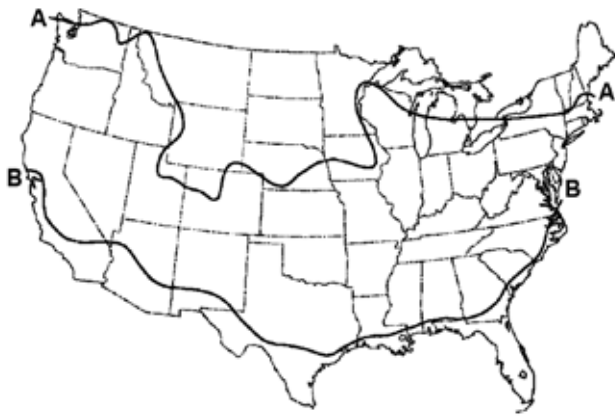
Figure 14–9. A, the northern limit of recorded damage done by subterranean termites in the United States; B, the northern limit of damage done by dry-wood termites.

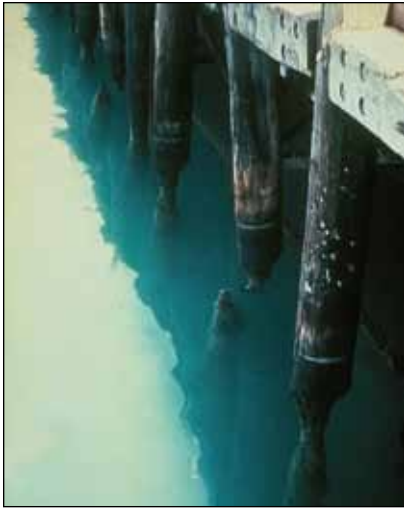
**Figure 14-11. *Limnoria* damage to piling.**
