Outdoor Wood Weathering and Protection

William C. Feist

U.S. Department of Agriculture, Forest Service, Forest Products
Laboratory, Madison, WI 53705-2398

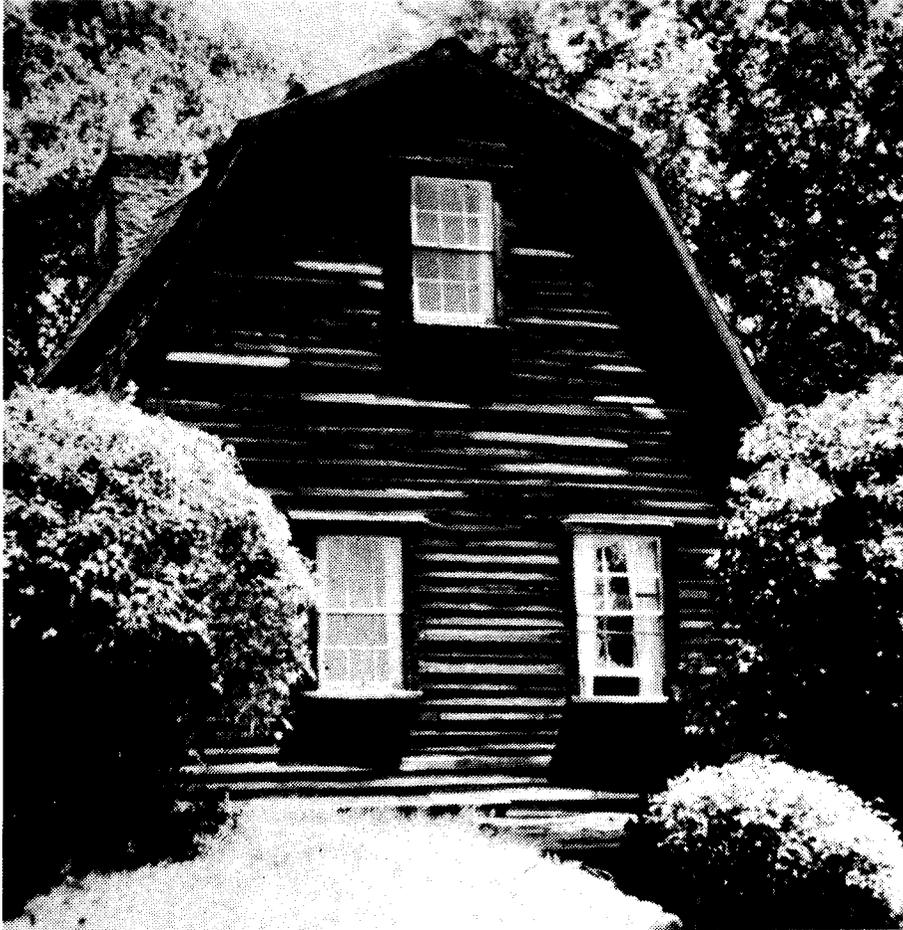
Figure 1. Old Fairbanks house at Dedham, MA, built in 1637. Most of the white pine clapboard siding was replaced in 1903, and it has withstood 85 years without paint..

WOOD IS A NATURALLY DURABLE MATERIAL that has long been recognized for its versatile and attractive engineering and structural properties. Wood has immense archaeological importance. Contrary to the misconception that old wood is not sound, wood in a favorable environment can last for centuries (1,2). The tomb of the Egyptian pharaoh Tutankhamen, who ruled in the 14th century B. C., contained wood objects that were in perfect condition when recovered in the 20th century. Some Japanese temples constructed with wood date back 13 centuries. In Lucerne, Switzerland, a covered bridge built in 1440 is still in service, and in the United States, some 950 covered bridges built during the 19th century still remain. Many wood dwellings in the United States are centuries old (Figures 1 and 2).

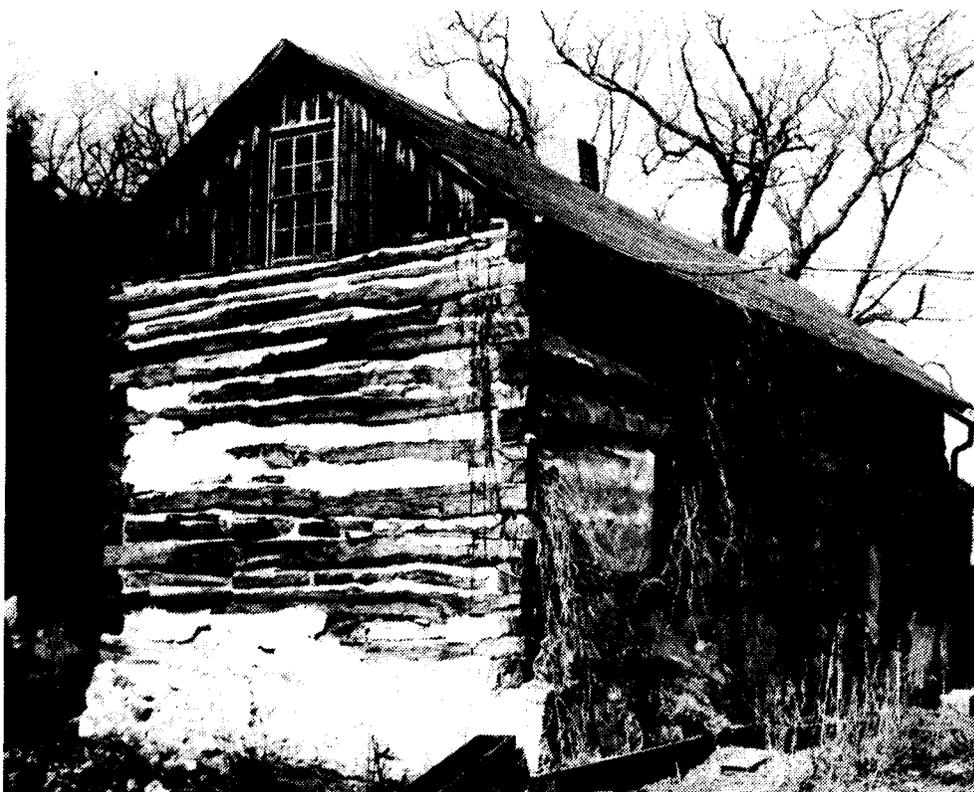
Figure 2. White oak log cabin near Middleton, WI, constructed around 1845 and never painted or finished.

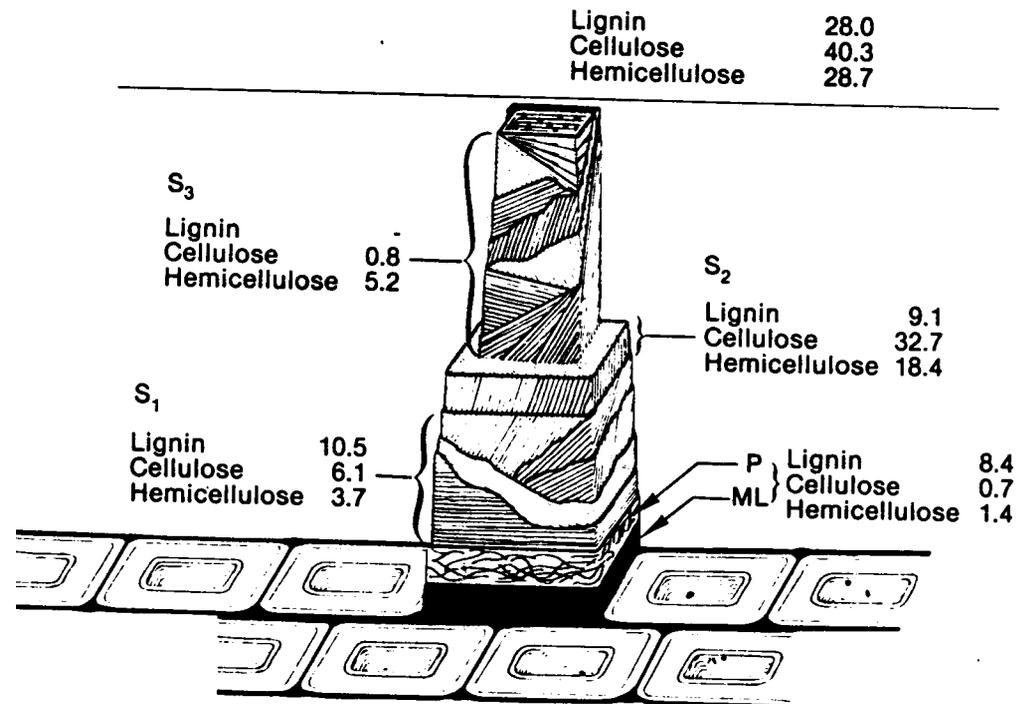
Figure 3. Chemical components in a typical softwood cell wall. Values are given as percentages.

The degradation of wood by any biological or physical agent modifies some of the organic components of wood (2). These components are primarily polysaccharides (cellulose, hemicelluloses) and polyphenolics (lignin) (Figure 3). Extractives are also present in relatively small quantities, and their concentration determines color, odor, and other nonmechanical properties of a wood species. A change in the organic components may be caused by an enzyme, a chemical, or electromagnetic radiation, but invariably the net result is a change in molecular structure through some chemical reaction. Stalker (5) conveniently divided the environmental agents that bring about wood degradation into categories; all agents other than fungi, insects, or animals are categorized as physical forms of energy. The relative effects of various energy forms on wood, indoors and outdoors, are compared in Table I. The most serious threat to wood indoors comes from thermal energy, and outdoors, from weathering—the combination of chemical, mechanical, and light energies.

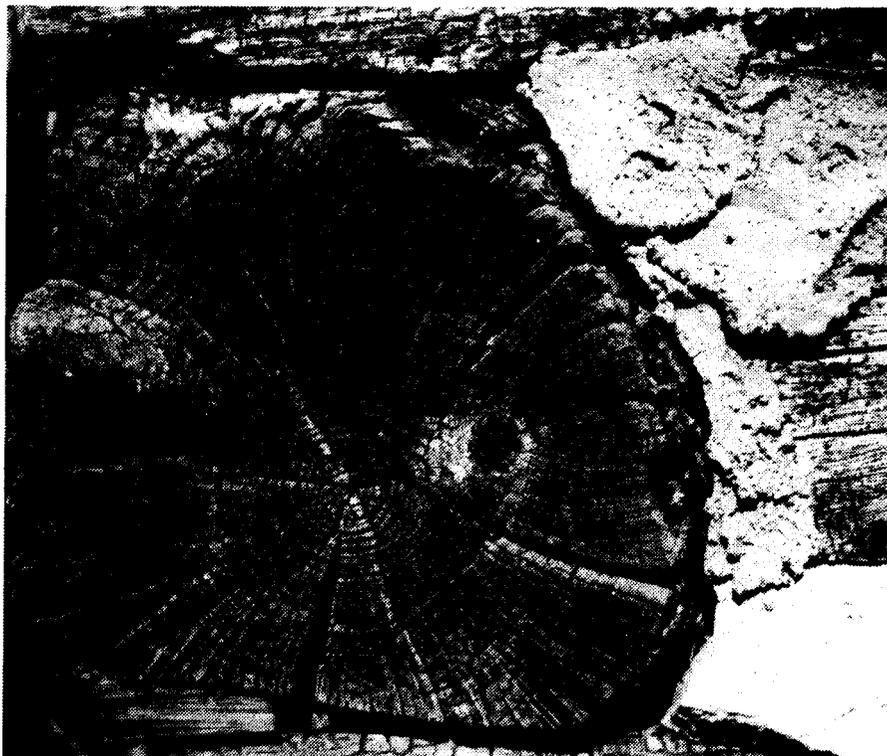
Figure 4. Close-up view of 140-Year-old weathered white oak logs of house shown in Figure 2.

In outdoor weathering of smooth wood, original surfaces become rough as the grain raises. The wood checks, and the checks grow into large cracks (Figure 4). Other changes may occur. The grain loosens; boards cup, warp, and pull away from fasteners; the roughened surface changes color, gathers dirt and mildew, and becomes unsightly; the wood loses its surface coherence and becomes friable; and splinters and fragments break off the surface. All these effects, which are brought about by a combination of light, water, and heat, are encompassed in weathering.

Physical Changes. Weathering of wood surface caused by the combined action of light and water results in surface darkening and leads to formation of macroscopic-to-microscopic intercellular and intracellular cracks or checks. Cell wall bonds near the wood surface lose their strength. As weathering continues, rainwater washes out degraded portions of the wood and further erosion takes place (Figures 4 and 7). Thus, a cyclical sequence

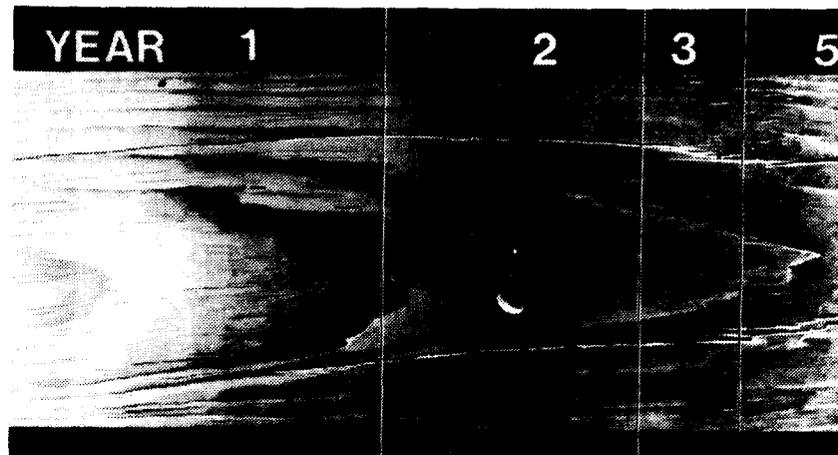
Figure 5. Atrist's rendition of surface color changes during the outdoor weathering process of a typical softwood. Wood initially darkens (yellows or browns) and eventually lightens (grays).

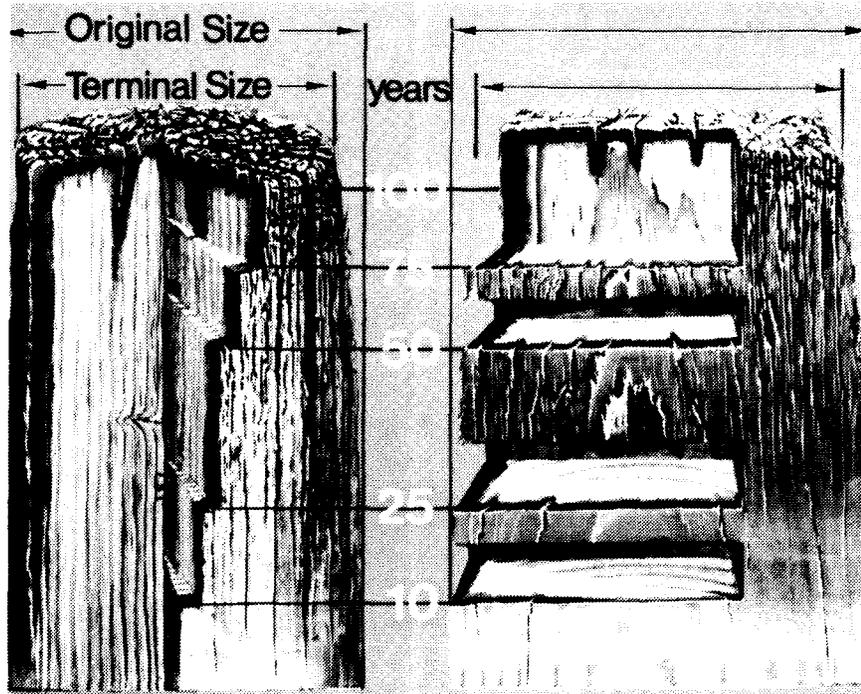
Figure 6. Artist's rendition of the weathering process of round and square timbers. Cutaway shows how wood just below the surface is relatively unchanged.

of events occurs during the natural weathering process (Figure 8). Erosion and checking differ in intensity because of different types of wood tissue on the surface, and the wood surface becomes increasingly uneven (Figure 6).

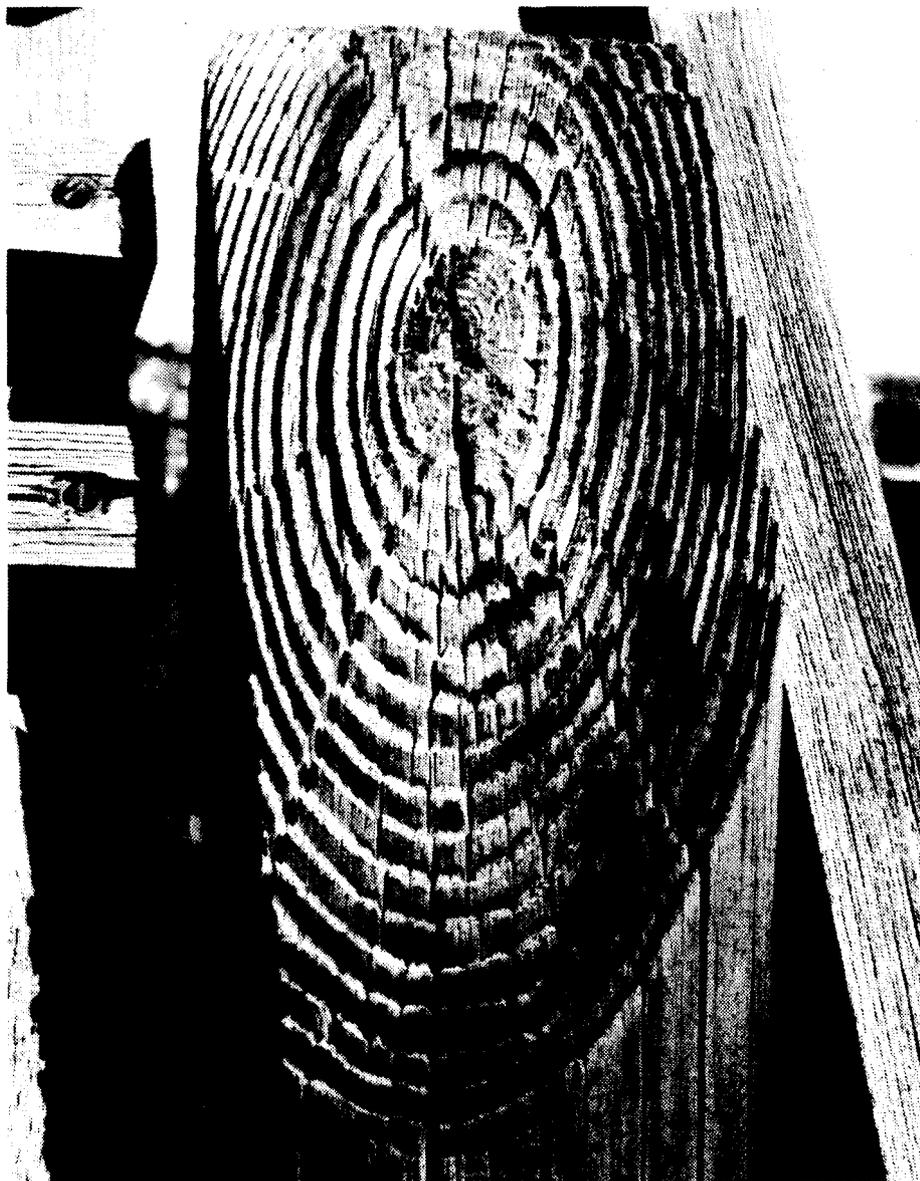
Figure 7. Weathered surface of softwood after 15 years of exposure in Madison, WI.

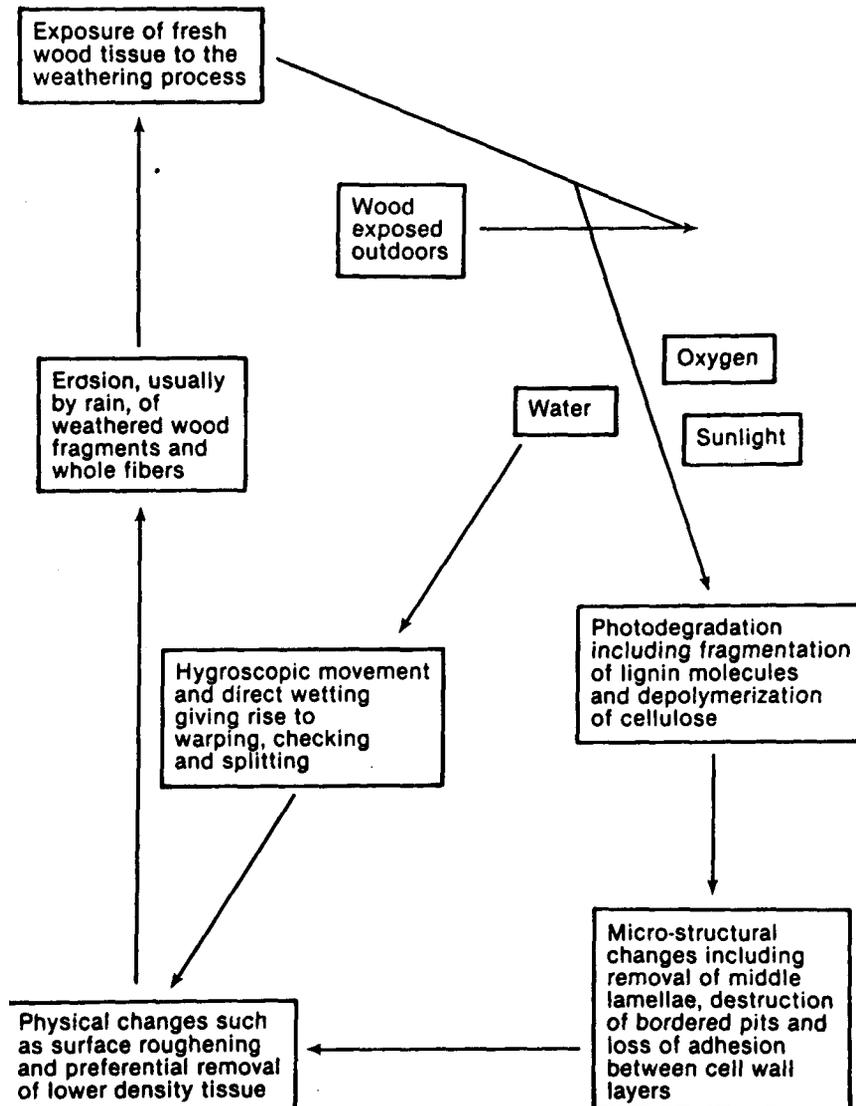
Figure 8. Cyclical sequence of events during natural weathering (Reproduced with permission from ref 88. Copyright 1986).

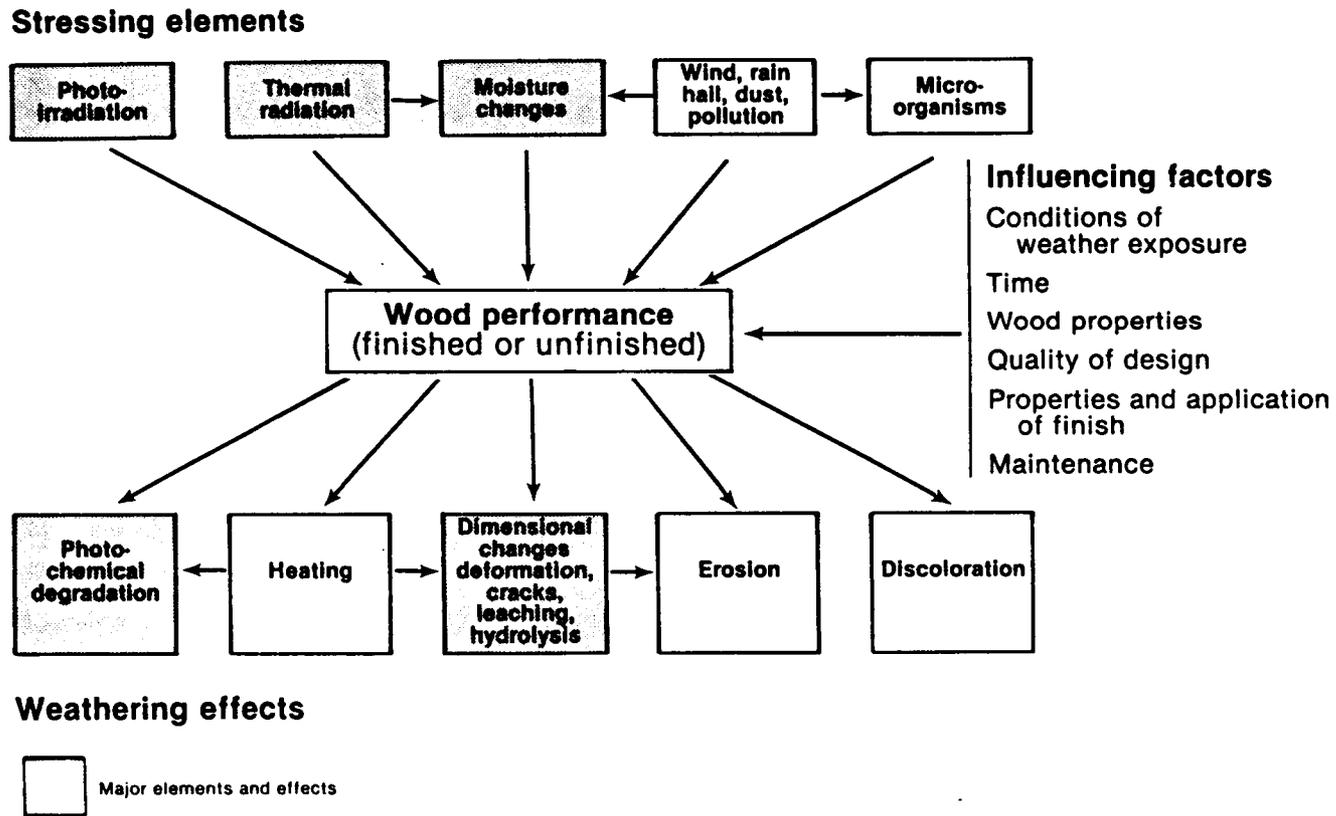
Figure 9. Stressing factors, influencing factors, and weathering effects that contribute to wood-finish performance.

Paint and other coatings (finishes) for wood used indoors can protect the wood for many decades and can obviate refinishing (4, 90, 91). Indoor finishes are relatively unaffected by wood properties. Outdoors, some wood finishes may last only 1–2 years because of degradation from UV light and water. The durability of outdoor finishes primarily depends on the wood itself. Wood properties that are important in finishing are moisture content, density and texture, resin and oil content, width and orientation of growth rings, and defects such as knots, reaction wood, and diseased wood (92). Other contributing factors are the nature and quality of the finish used, application techniques, pretreatment, time between refinishing, extent to which the surfaces are sheltered from the weather, and climatic and local weather conditions (93–99). The stressing factors, which influence factors and weathering effects that contribute to wood-finish performance, are summarized in Figure 9.
