Corrosion Avoidance with New Wood Preservatives

By Samuel L. Zelinka and Douglas R. Rammer

Reprinted with permission by Wood Design Focus (Vol. 16, No. 2), Summer 2006

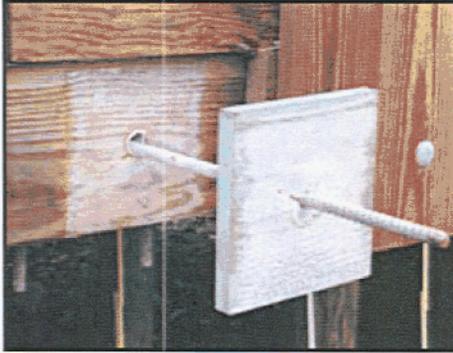
Corrosion of galvanized bridge hardware in contact with alkaline copper quaternary (ACQ) after 3 years of service.

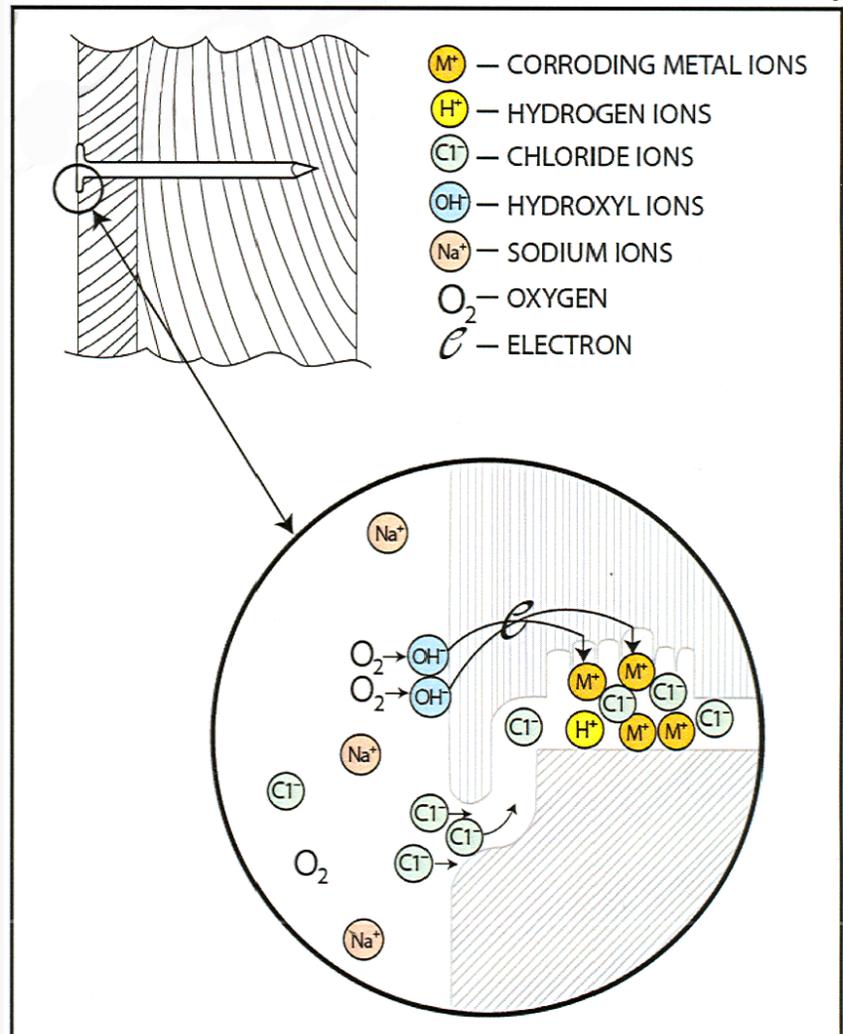
Mechanism of crevice corrosion of fasteners in wood, originally proposed by A.J.Baker of the USDA Forest Products Laboratory (FPL) in 1978.

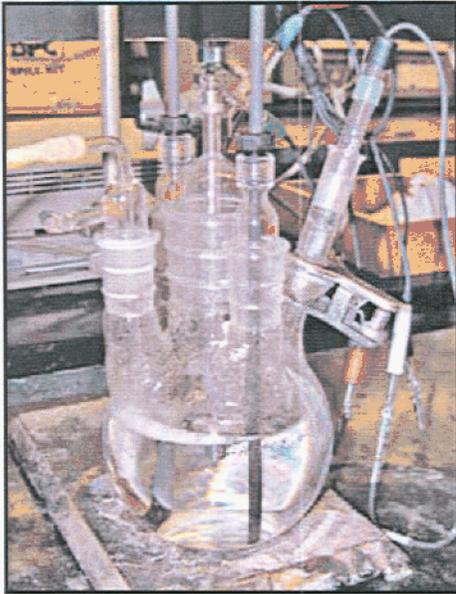
Typical electrochemical test set up for rapidly measuring corrosion rate. These methods are being developed at FPL for use on preservative treated wood.

Samuel L. Zelinka is a Materials Engineer with the USDA Forest Products Laboratory in Madison, WI. Sam is currently working on developing electrochemical methods to evaluate the corrosion rate of fasteners in treated wood. He can be reached via e-mail at szelinka@fs.fed.us.
