Effect of Cladding Systems on Moisture Performance of Wood-Framed Walls in a Mixed-Humid Climate

S. Craig Drumheller, Charles G. Carl: Effect of Cladding Systems on Moisture Performance of Wood-Framed Walls in a Mixed-Humid Climate, Thermal Performance of the Exterior Envelopes of Whole Buildings XI International Conference, December 5-9, 2010, Clearwater Beach, Florida

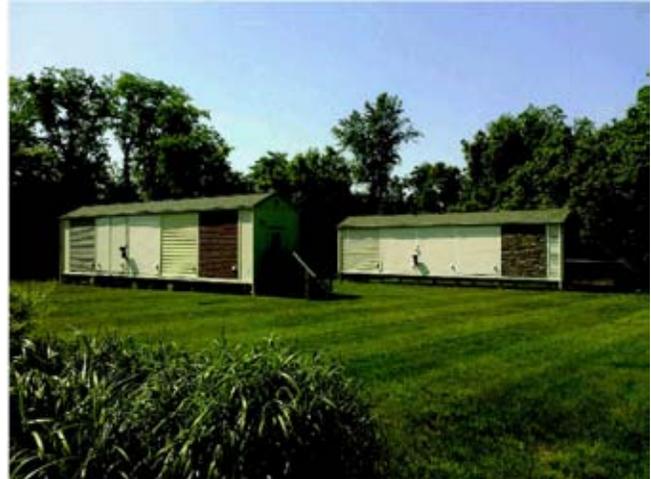
Figure 2 Test buildings 1 (right) and 2 (left).

Both test structures had a nominal footprint of 8 ft by 48 ft (Figure 2). Each building allowed for five pairs of 8 ft wide by 9 ft high wall test panels to be installed as exterior wall sections, with one panel of each pair having cardinal orientation southern exposure and the other panel of the pair having northern exposure. Test structure 1 was constructed on site and was commissioned in January 2008. The second building was prefabricated and delivered to the site; walls were then added on site, with data collection for the walls beginning in November 2008.

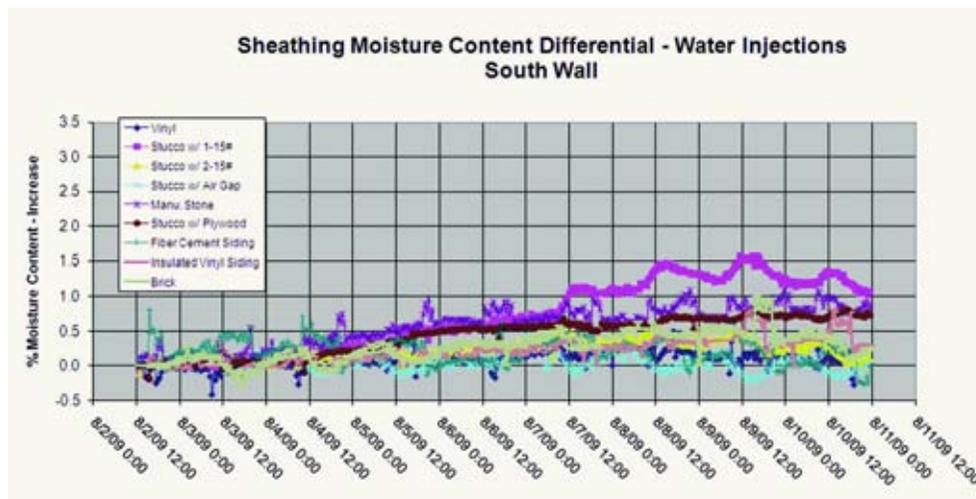
Figure 8 Sheathing moisture content increase with water injections: south. Note: stucco wall with plywood readings were determined to be unreliable, and thus were not reported on this graph.

The wall pair with manufactured stone cladding showed an increase in sheathing moisture content in response to water injection testing, but to a lesser degree than the wall pair with stucco cladding and a single layer of WRB (Figures 8 and 9).

The response of the stucco-clad walls with plywood sheathing was similar to that of the walls with manufactured stone cladding (Figures 8 and 9). The responses of these walls to water injection testing were greater than those of otherwise similar walls with OSB sheathing. This behavior concurs with the relative sheathing moisture content levels in plywood-
