# Wood Structural Panel & Foam Insulation Systems:

Hygrothermal Behavior & Lateral Load  
Resistance — Experimental Studies

**JOINT RESEARCH REPORT**

**September 30, 2014**

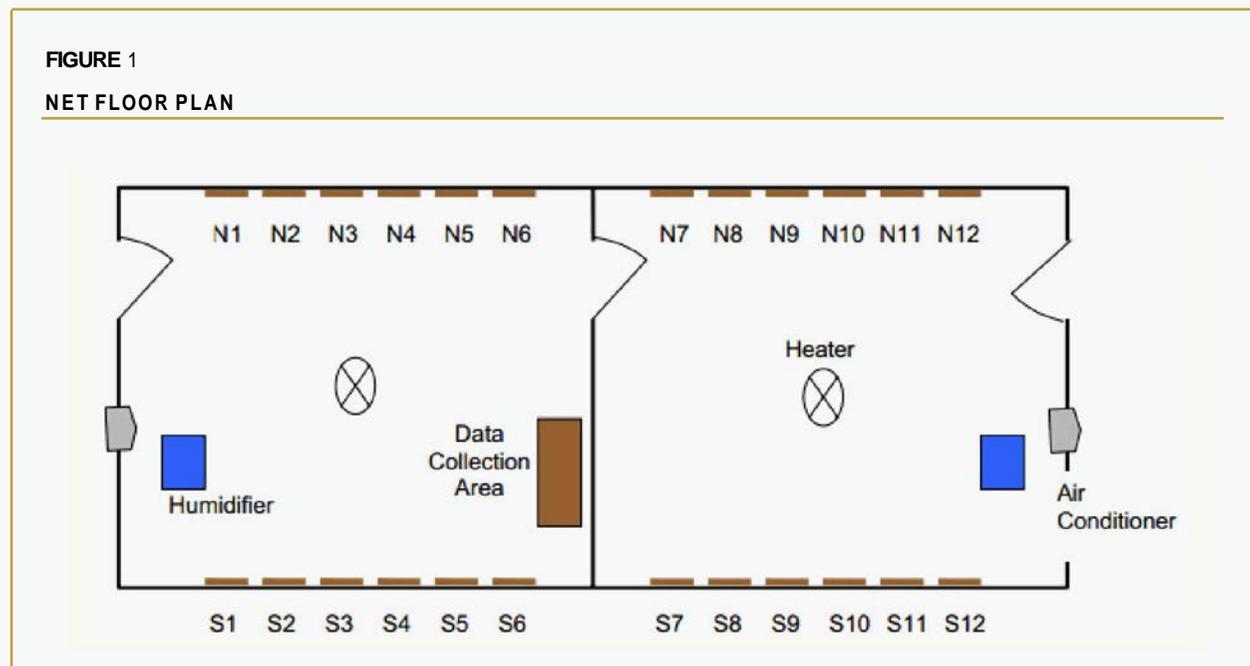
A plan view of the NET is shown in Figure 1. Figure 2 shows the south-facing walls of the NET. Note the walls are segmented and can be independently configured to fit specific test purposes.

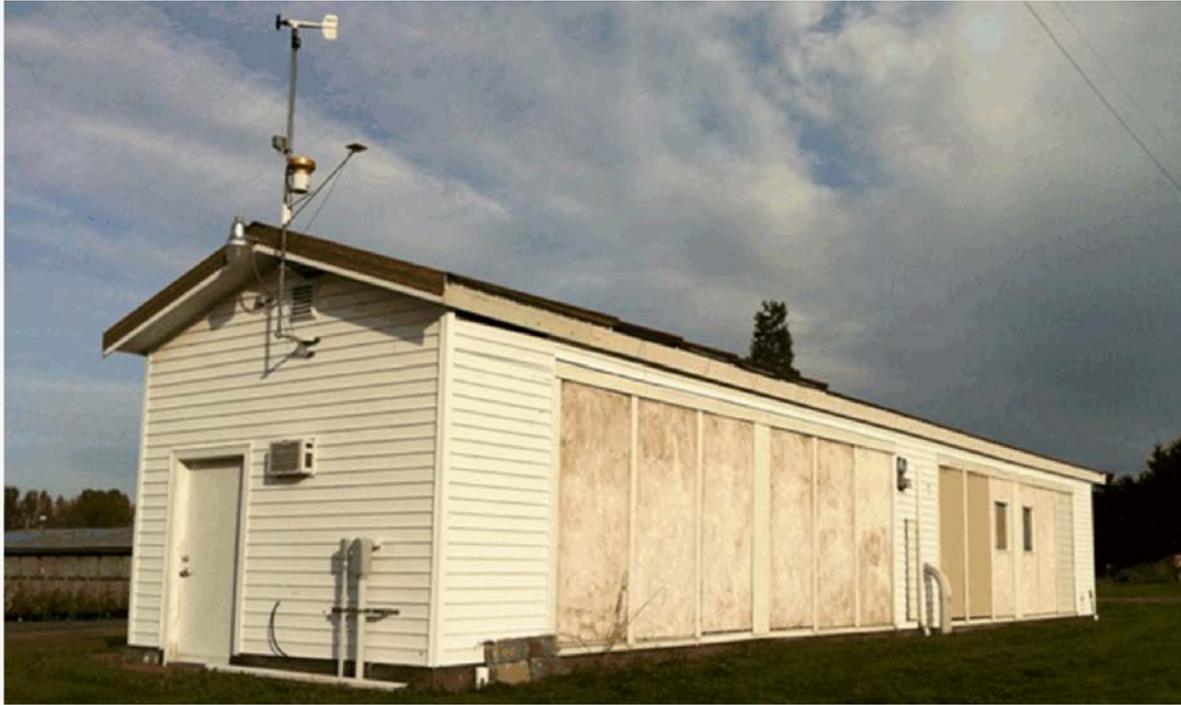
FIGURE 2

## SOUTH-FACING SIDE OF THE WSU NET FACILITY IN PUYALLUP, WASHINGTON

The primary weather instruments were located on top of the building at the southwest corner of the NET (see Figure 2). Additional pyranometer locations are noted below. Weather instruments were measured every five minutes and averaged every hour.

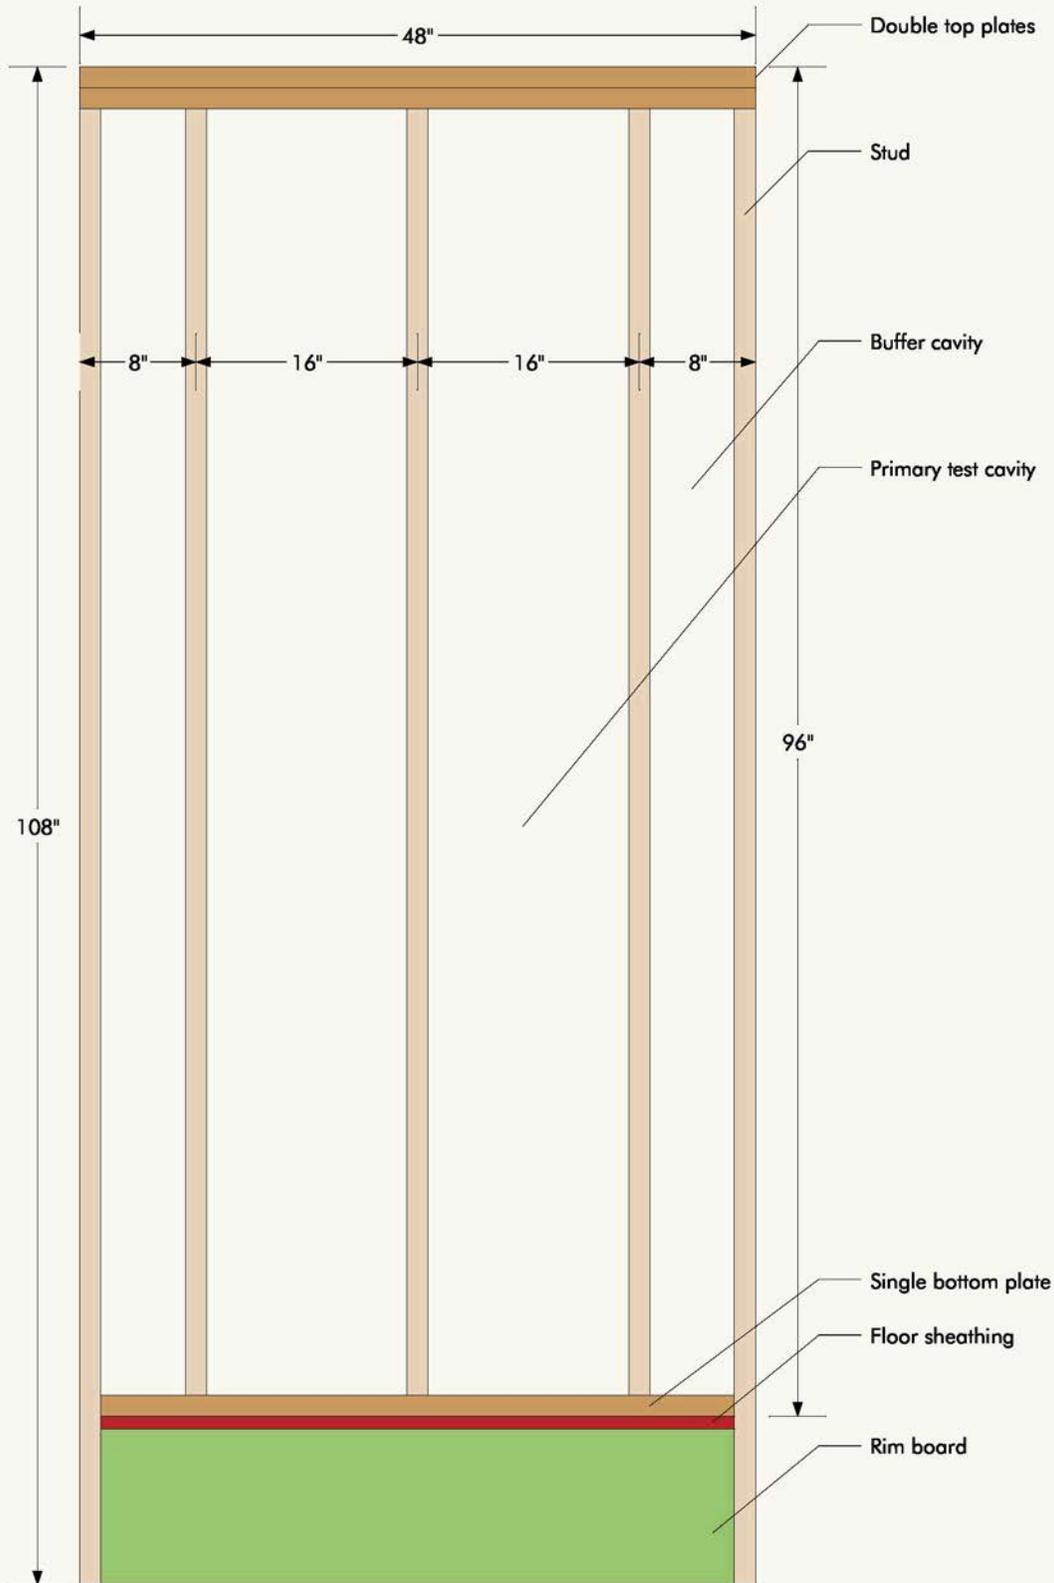
FIGURE 3  
WALL FRAME FOR EACH TEST WALL

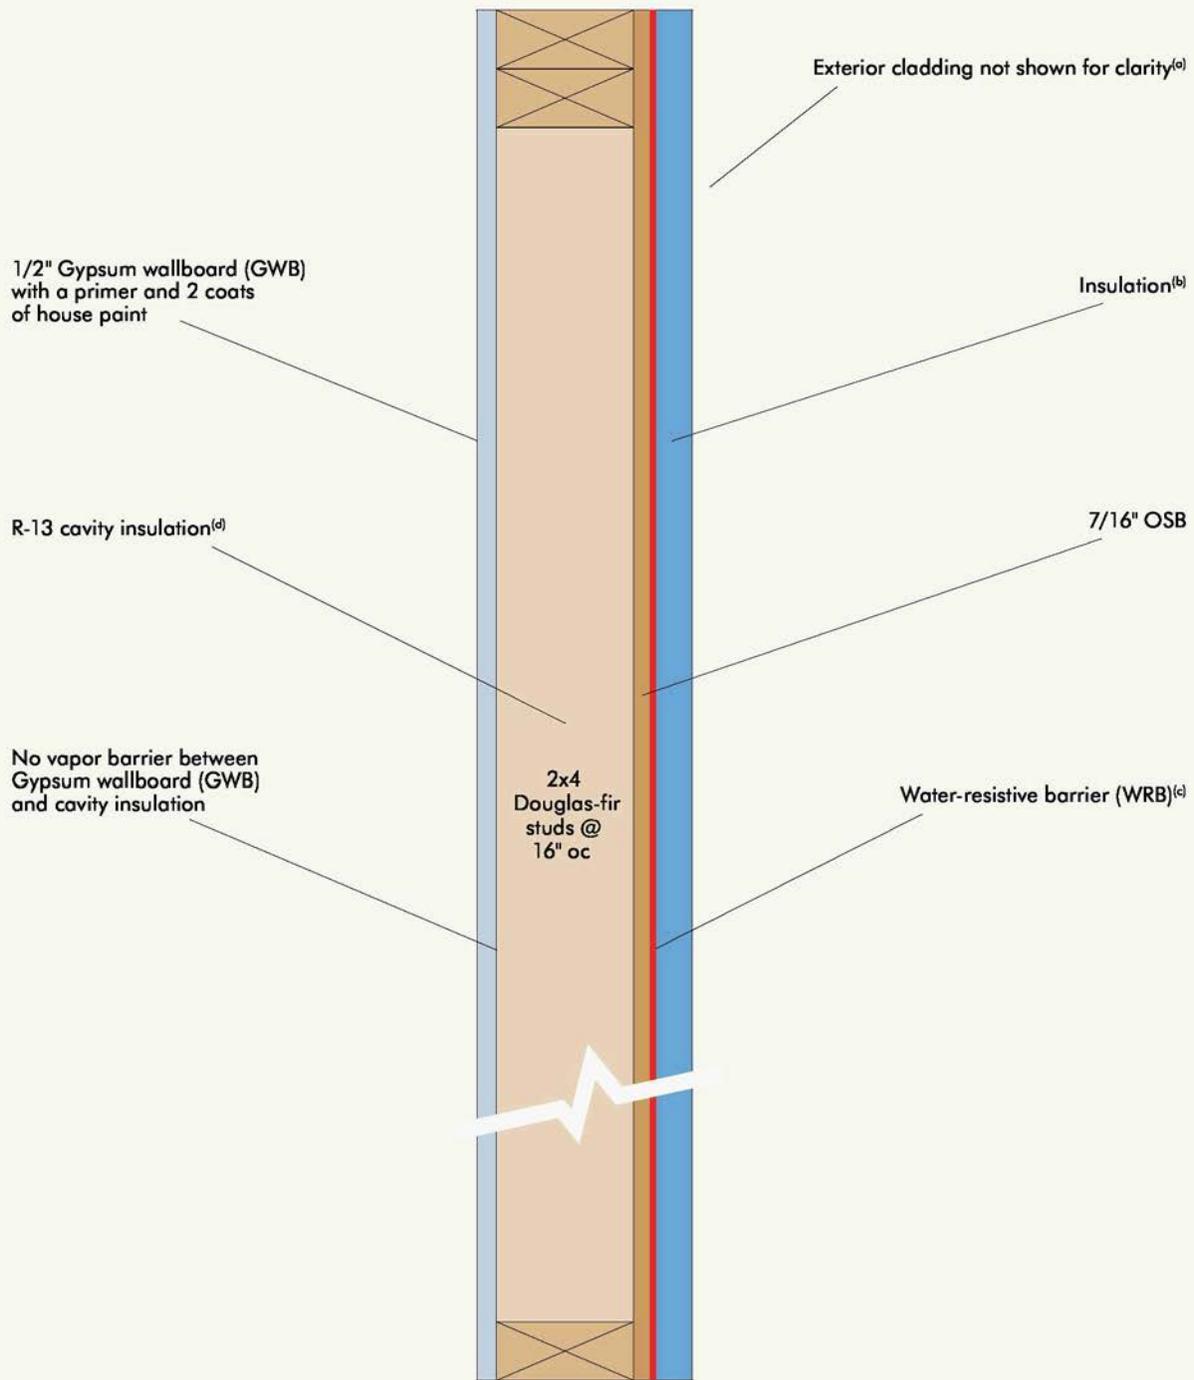
**FIGURE 4**  
**SCHEMATIC CONFIGURATION OF TEST WALLS**

- (a) Vinyl siding (white color) without furring strips installed based on the manufacturer's recommendations.
- (b) Insulation used: 1" XPS (R-5) square edge (with joint taping) or 1-1/4" mineral wool insulation (MWI) (R-5) (Roxul ComfortBoard IS-8 pcf).
- (c) Water-resistive barrier (WRB) required for mineral wool insulation (MWI) (Roxul). WRB not required for extruded polystyrene (XPS).
- (d) Unfaced fiberglass batt.

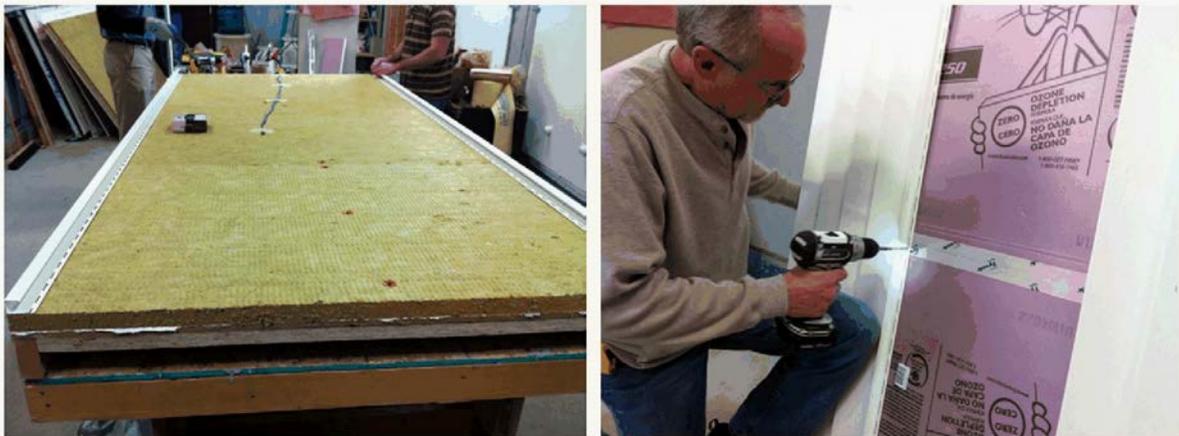
FIGURE 5

TEST WALLS WITH 1-1/4-INCH MWI (Left) AND 1-INCH XPS (Right)

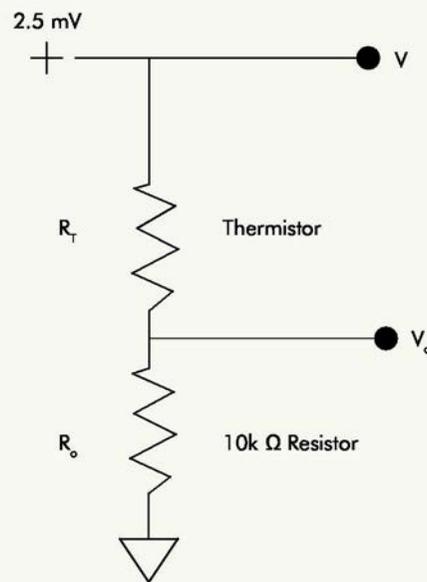
FIGURE 6

## THREE-WIRE HALF BRIDGE FOR TEMPERATURE MEASUREMENT

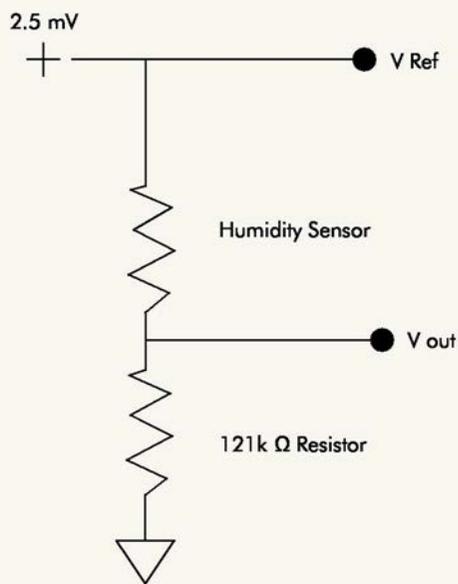
FIGURE 7

**THREE-WIRE HALF BRIDGE FOR RH MEASUREMENT**

Relative Humidity was measured using a Hycal IH-3610-1 (Honeywell H1H) using a similar circuit to the temperature sensing circuit (Figure 7). It uses a precision 121k  $\Omega$  resistor.

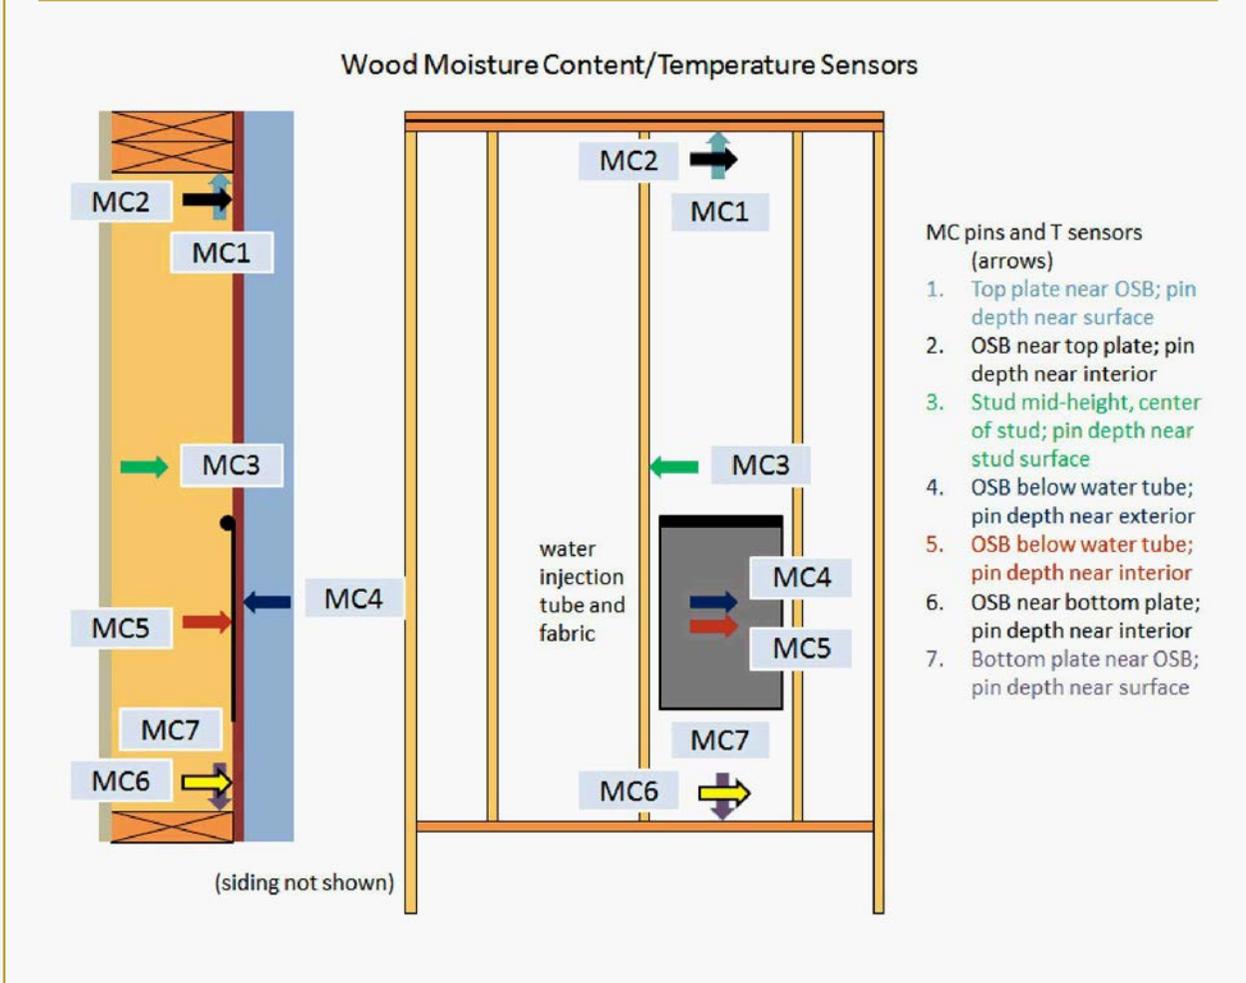
**FIGURE 8**  
**PLACEMENT OF MOISTURE CONTENT/TEMPERATURE SENSORS IN TEST WALLS**

Wood moisture content was measured in the framing at the following locations: top plate near the exterior sheathing (MC1), bottom plate near the exterior sheathing (MC7), and the center stud at mid-height (MC3). Moisture content was measured in the OSB sheathing at the following locations: near the top plate (MC2); below the water injection tube (MC4 and MC5); and near the bottom plate (MC6).

The sensor locations are illustrated in Figures 8 and 9.

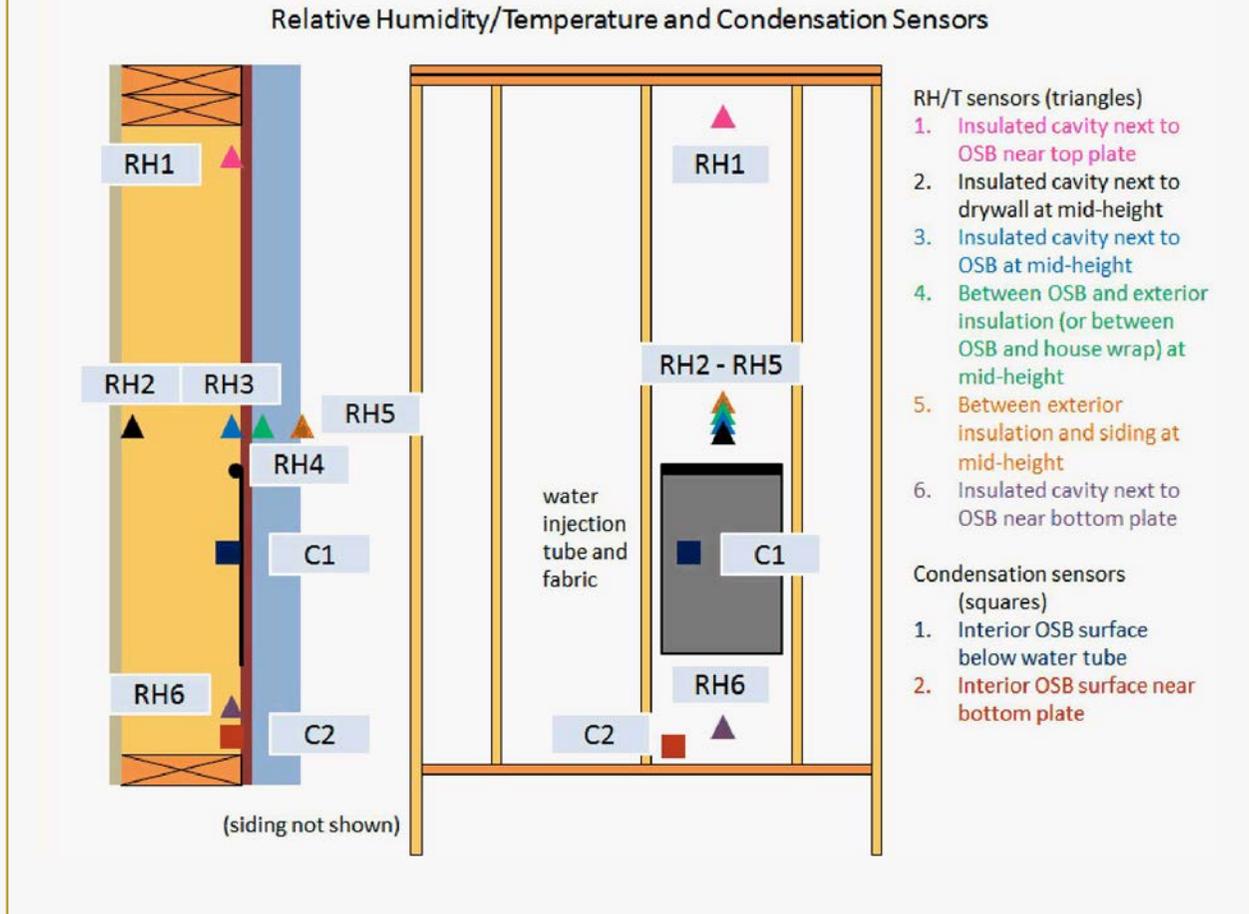
FIGURE 9

PLACEMENT OF RELATIVE HUMIDITY/TEMPERATURE AND CONDENSATION SENSORS IN TEST WALLS

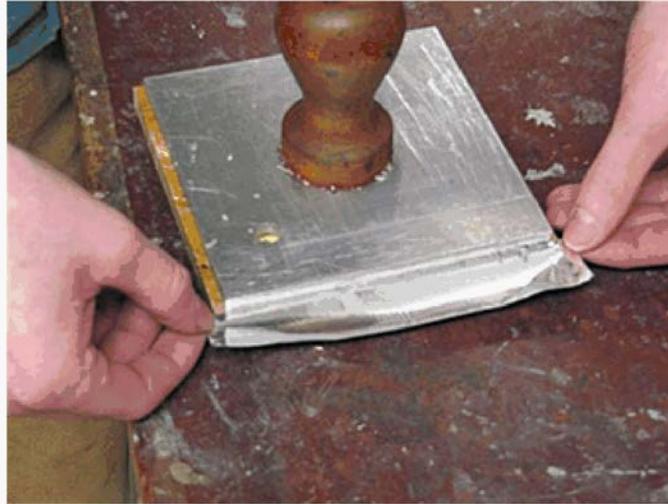
FIGURE 10

**TEST SPECIMEN EDGE SEALED WITH FOIL TAPE FOR TESTING**

All specimens were tested after equilibrating to environmental conditions of  $73 \pm 2^\circ\text{F}$  and  $50 \pm 2\%$  relative humidity in accordance with ASTM E96. The edges of the specimens were masked with a foil tape prior to testing, as shown in Figure 10.

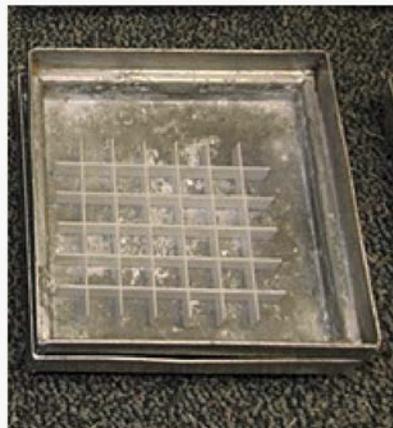
FIGURE 11

**ALUMINUM DISH WITH PLASTIC GRID**

For the water (wet-cup) method, 100 grams of distilled water was put in the bottom of each aluminum dish. A plastic grid was placed in the bottom of each dish to reduce water surges, as shown in Figure 11. On the other hand, the desiccant (dry-cup) specimens were prepared with 150 grams of desiccant leveled out in the bottom of each aluminum dish. Paraffin wax was used to seal the gaps between the dish edge and the sides of the specimens, as shown in Figure 12 (the wet-cup method shown).

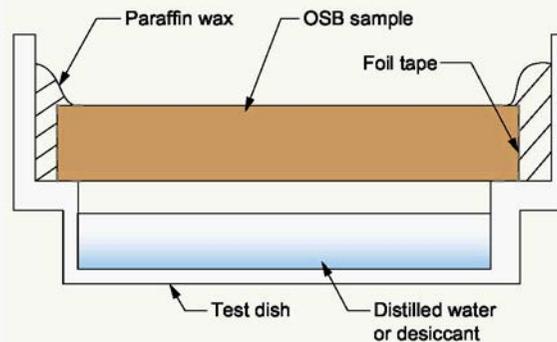
FIGURE 12

## SPECIMEN PREPARATION FOR MEASURING WATER VAPOR PERMEANCE (WET CUP SHOWN)

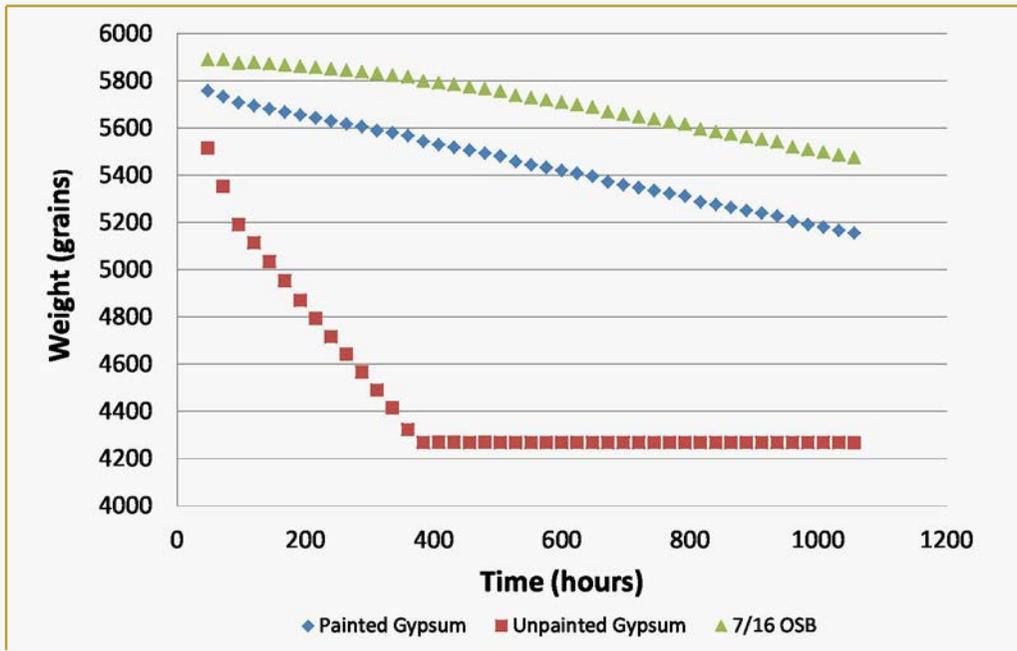
FIGURE 13

MEAN SPECIMEN WEIGHT FROM 2 DAYS TO 44 DAYS FOR WET CUP TEST GROUPS

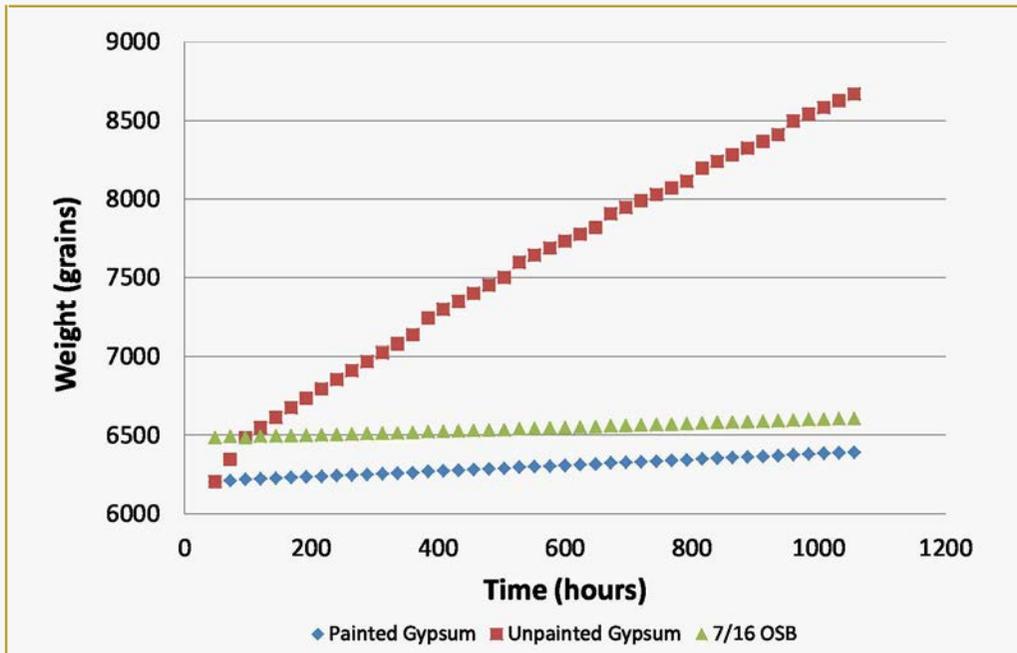
FIGURE 14

MEAN SPECIMEN WEIGHT FROM 2 DAYS TO 44 DAYS FOR DRY CUP TEST GROUPS

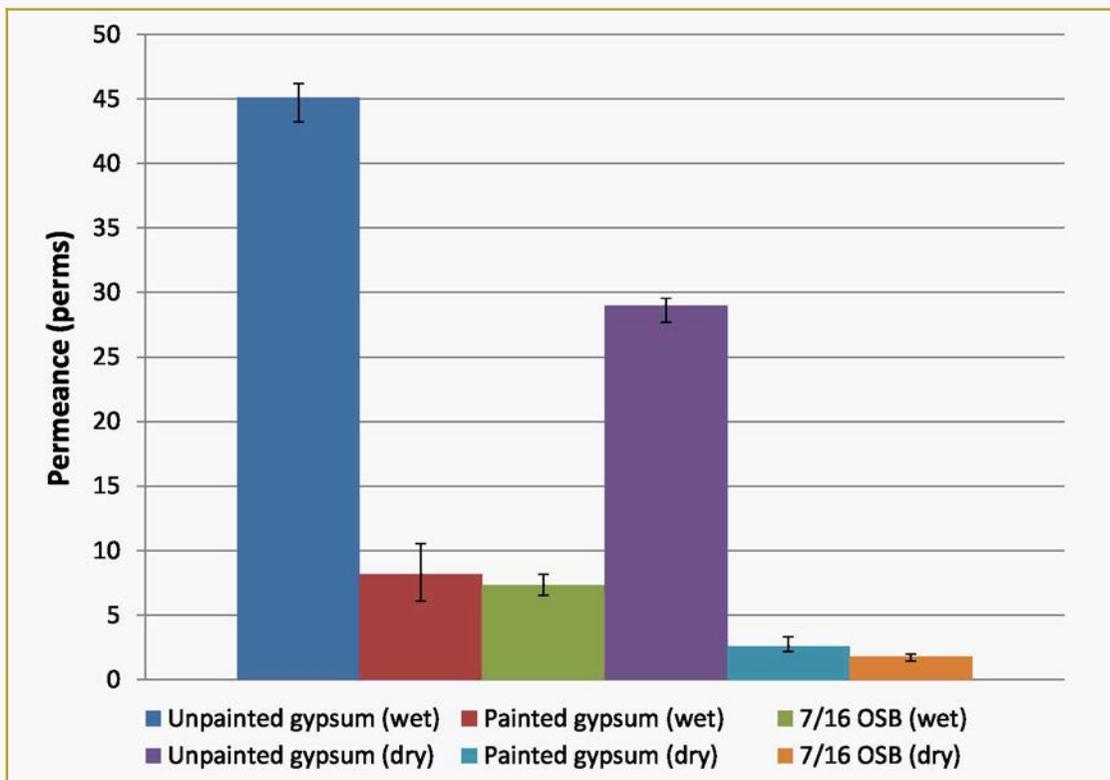
**FIGURE 15**

The permeance values of the OSB specimens determined in this study, as shown in Figure 15, were similar to the typical OSB permeance, as presented in *APA Technical Note, Water Vapor Permeance of Wood Structural Panels and Wood Wall Construction, Form J450* [1]. It should be noted that the top of the vertical bar in Figure 15 represents the mean value for each test group and the vertical line represents the range of permeance values.

**MEAN PERMEANCE BETWEEN TEST GROUPS**

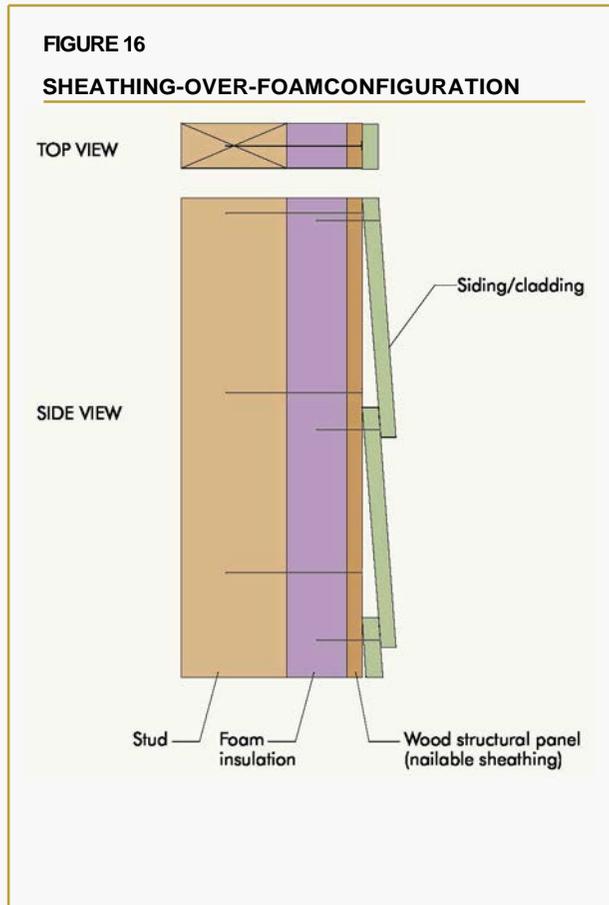
As previously discussed, the foam-over-sheathing configuration is a better choice for structural performance. However, there are very limited wall racking data for the sheathing-over-foam configuration. Therefore, this portion of the project was intended to investigate a structurally viable method for sheathing-over-foam applications, as shown in Figure 16.

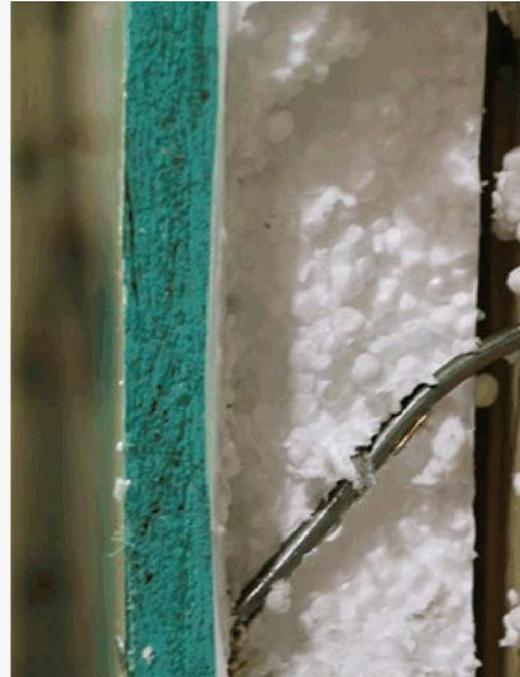
**FIGURE 17**

The data showed that the sheathing-over-foam wall had a significantly lower load capacity (approximately 63 percent of the control walls) and was significantly more flexible. In this type of wall construction, since the nails are cantilevering through the foam plastic insulation, it is more flexible than traditional wall construction. Figure 17 shows the typical failure mode of sheathing-over-foam walls. Based on these initial data, the objective of the test series program was to investigate the feasibility of attaching WSP sheathing over 1-inch expanded polystyrene as an acceptable configuration to meet the minimum performance of wall bracing in accordance with the IRC.

**NAIL YIELDING FOR A SHEATHING-OVER-FOAM WALL**

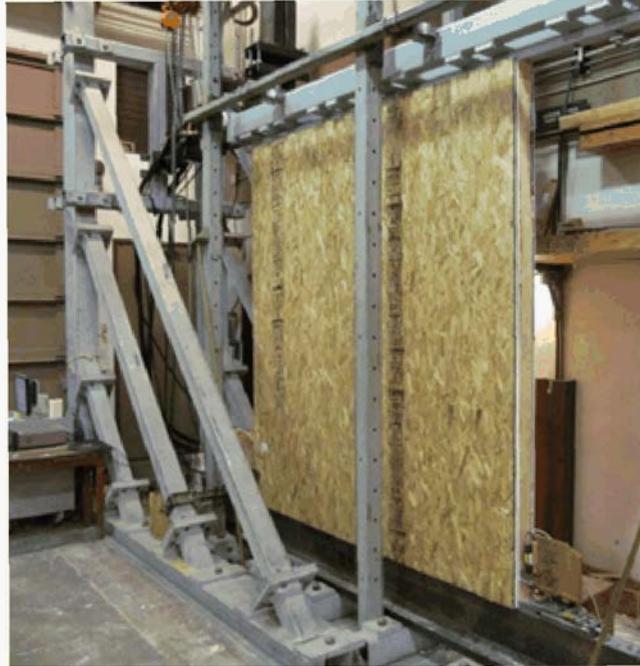
FIGURE 18

TEST FRAME WITH TEST WALL IN PLACE

All tested walls were 8 feet x 8 feet, consisting of two 4-foot x 8-foot OSB and 1-inch-thick expanded polystyrene panels. Stud framing was assembled in accordance with ASTM E72. The OSB and foam panels were attached vertically to the framing, while the 1/2-inch gypsum wallboards were attached horizontally with unblocked horizontal wall joints on the opposite face of the wall. Testing was conducted on the APA wall racking test frame, as shown in Figure 18.

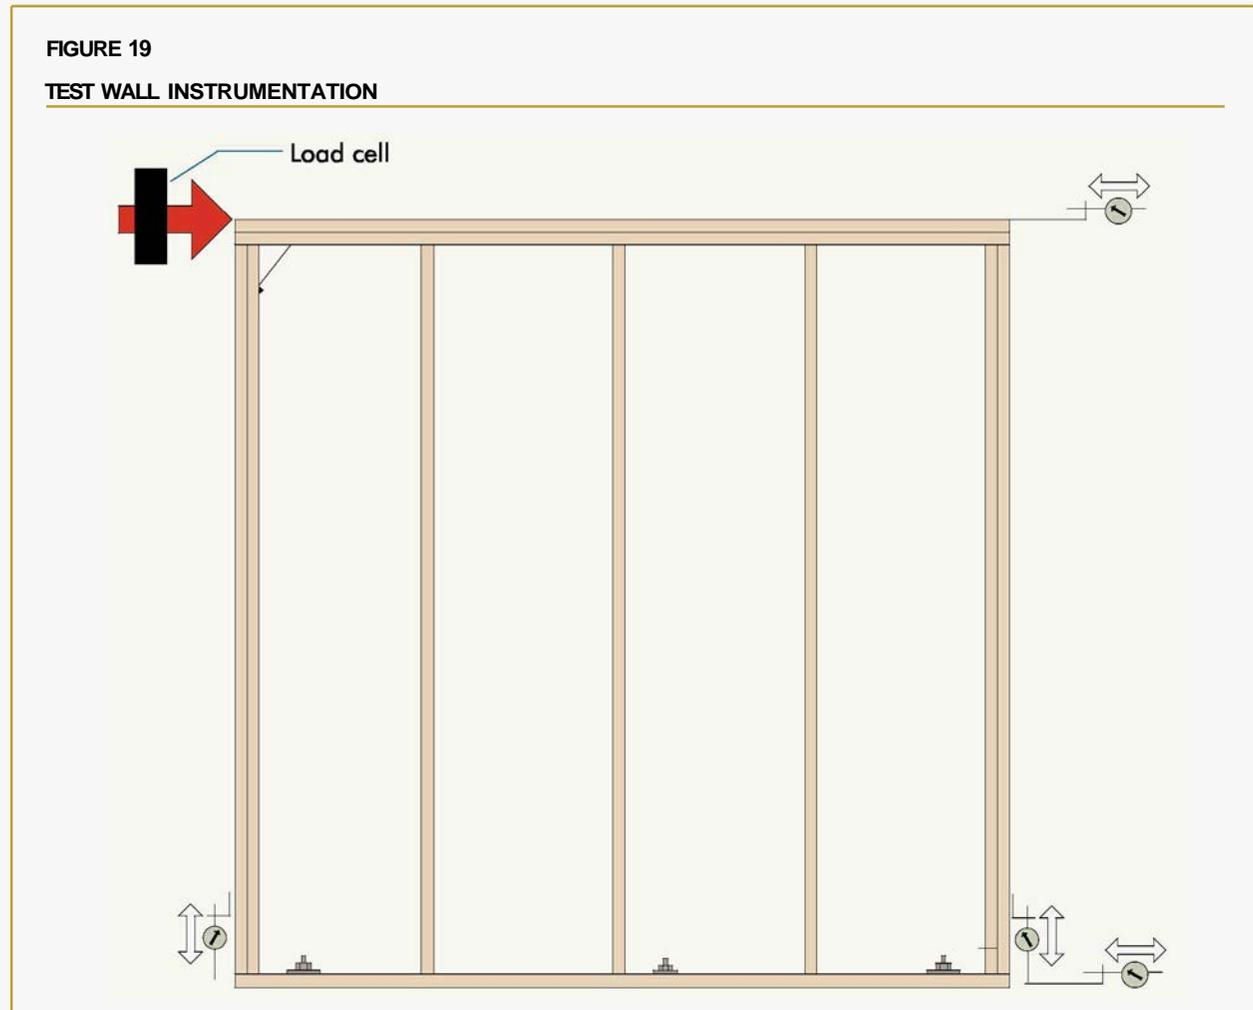
Instrumentation was provided, as shown in Figure 19. Linear potentiometer devices were attached to the wall assembly and test frame. The applied load was measured with a load cell located between the hydraulic actuator and the load head.

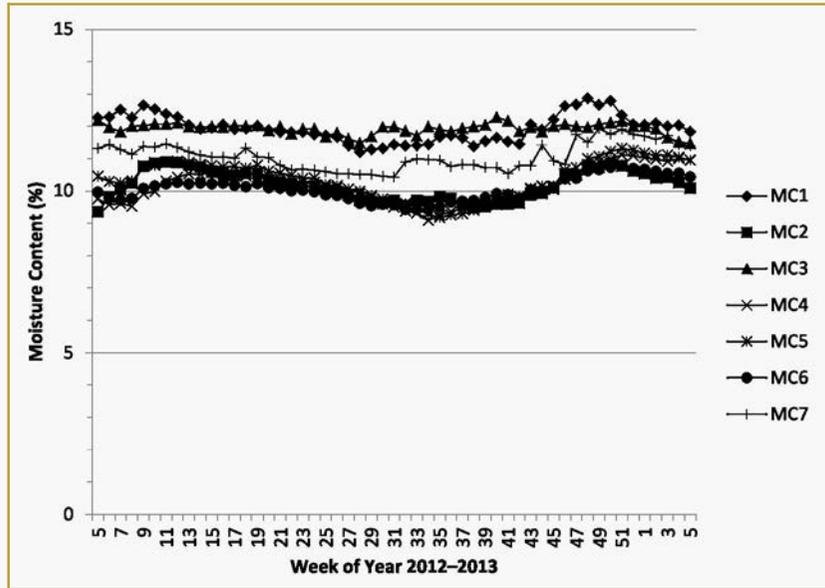
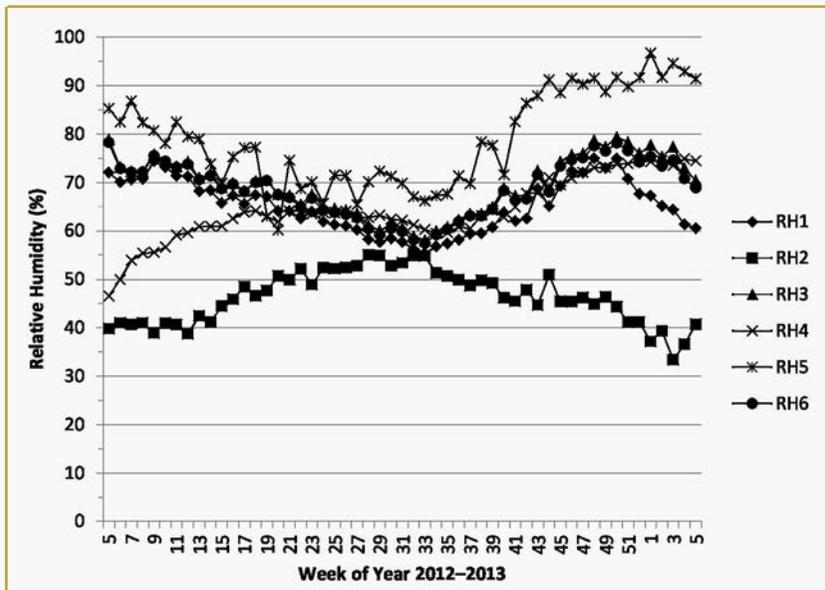
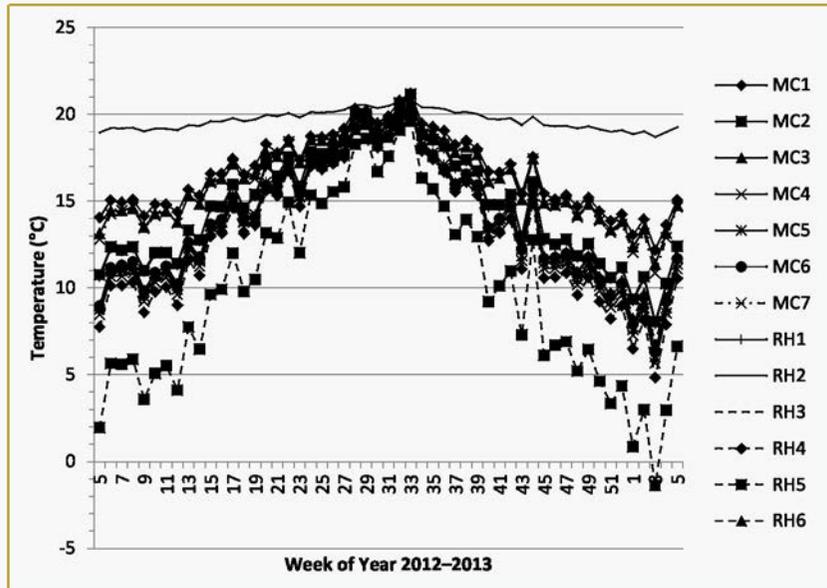
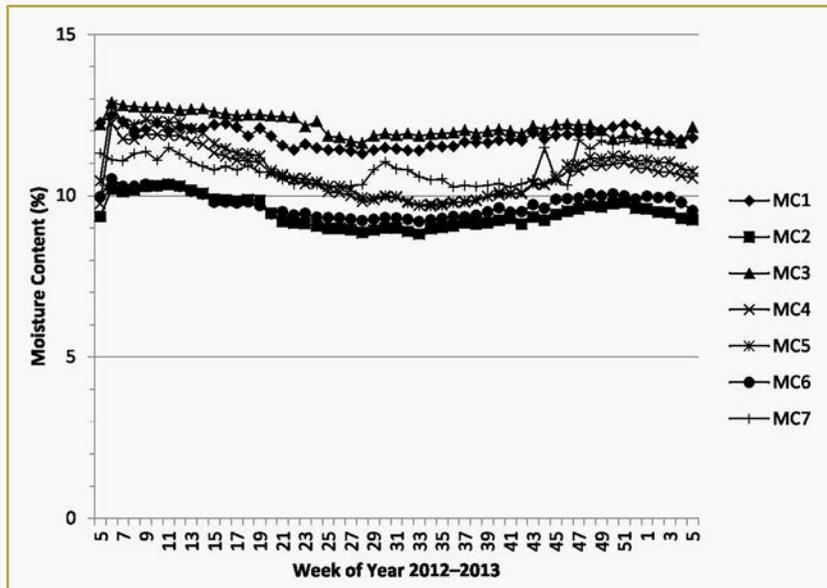
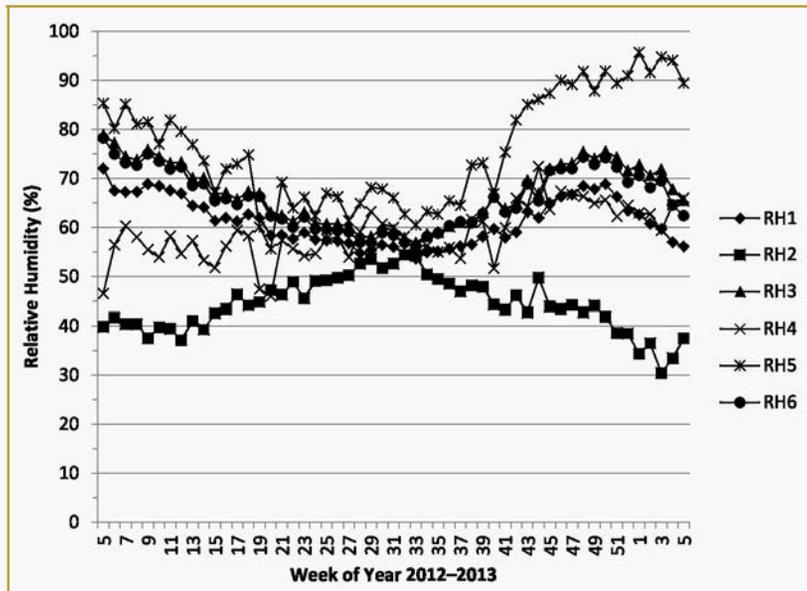
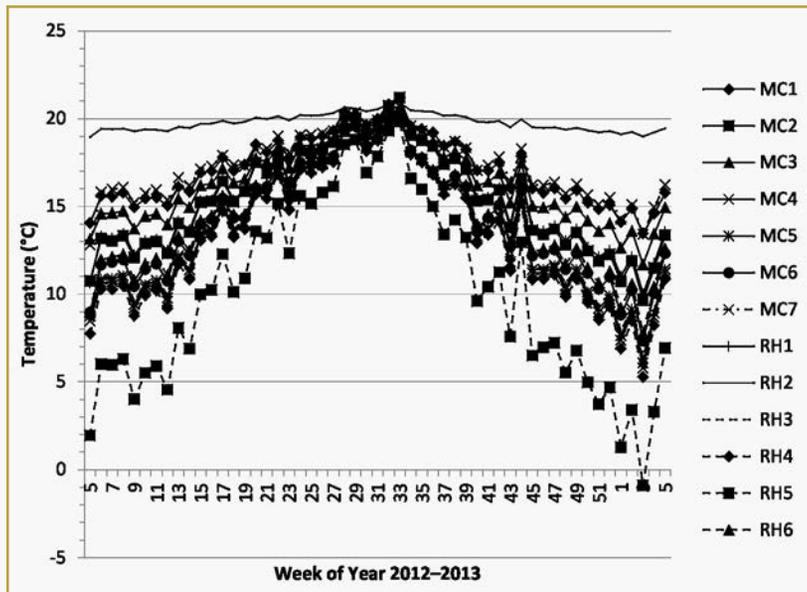
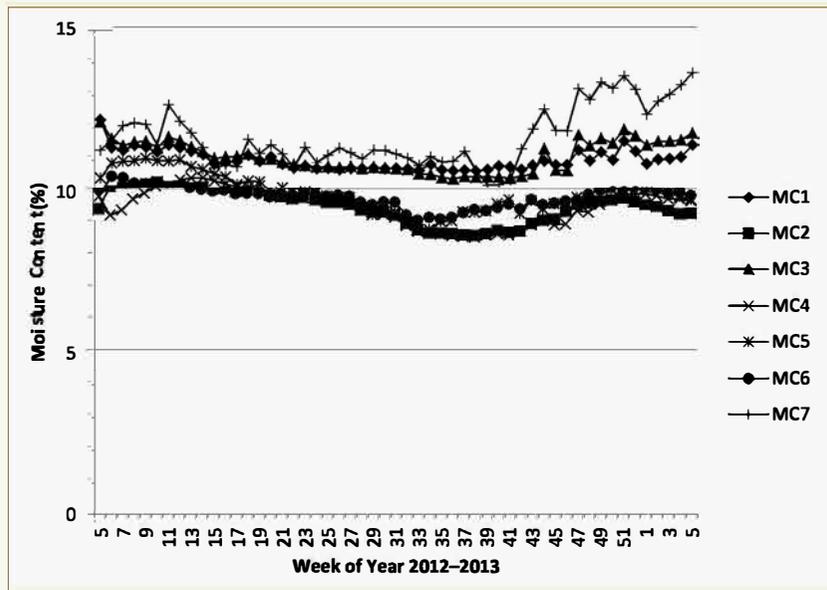
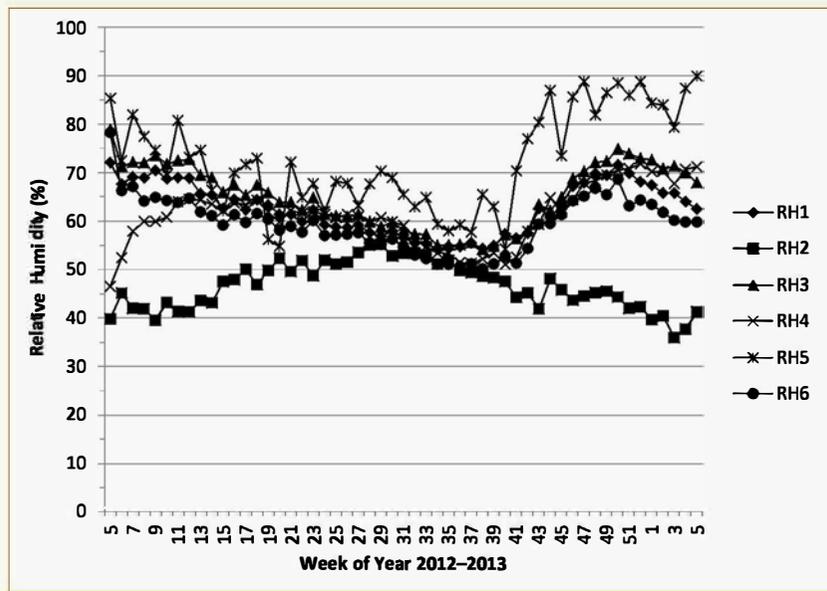
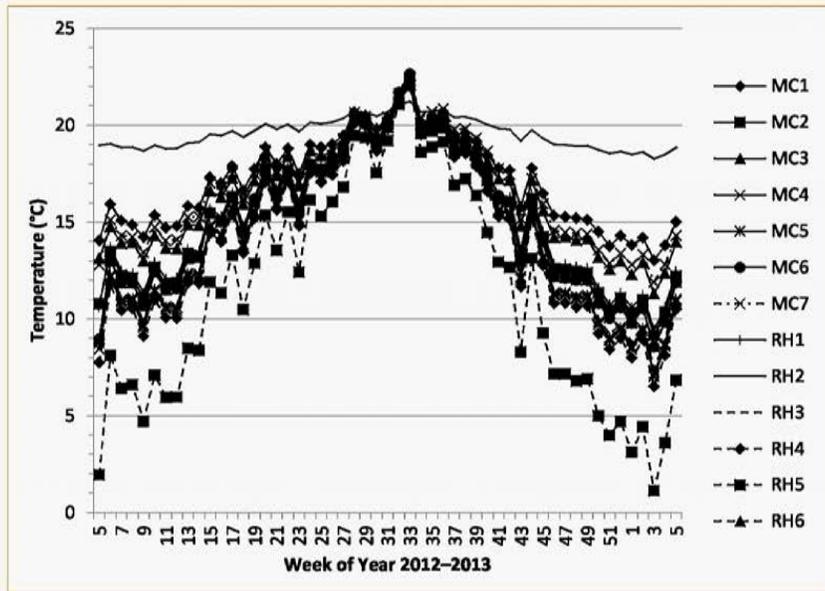
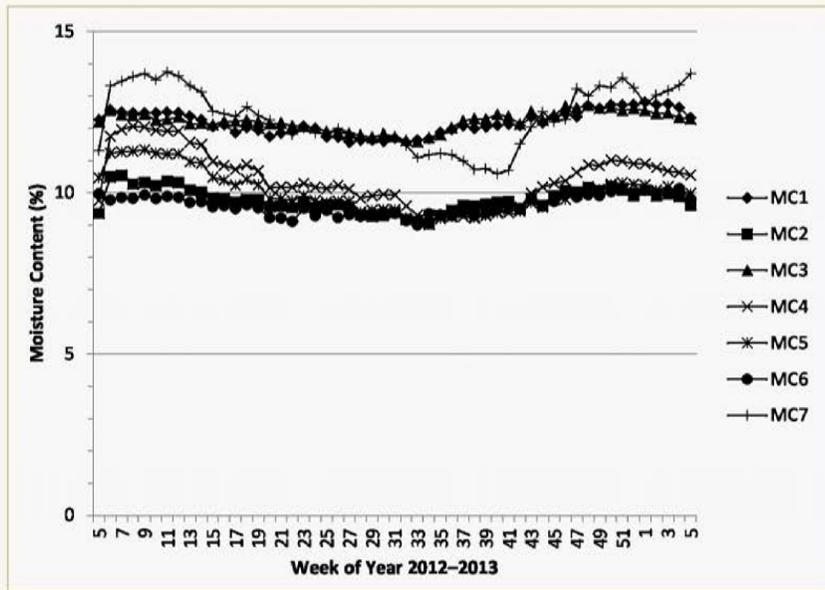
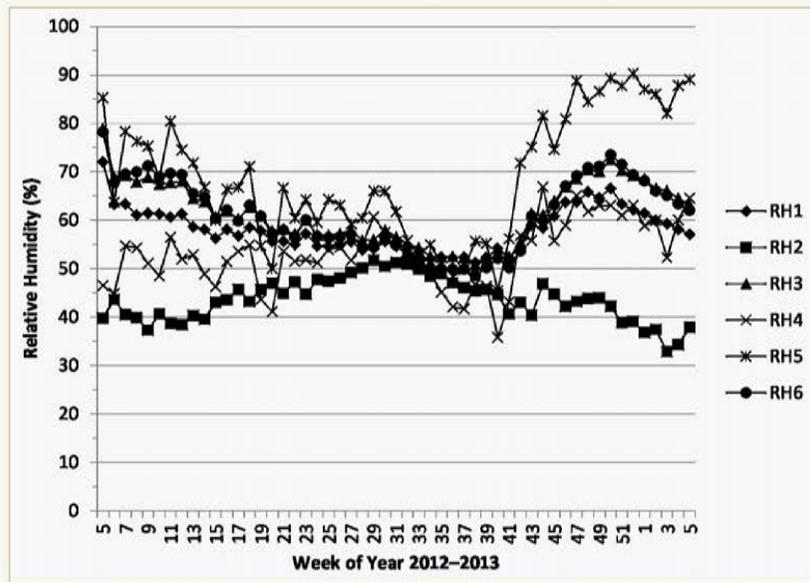
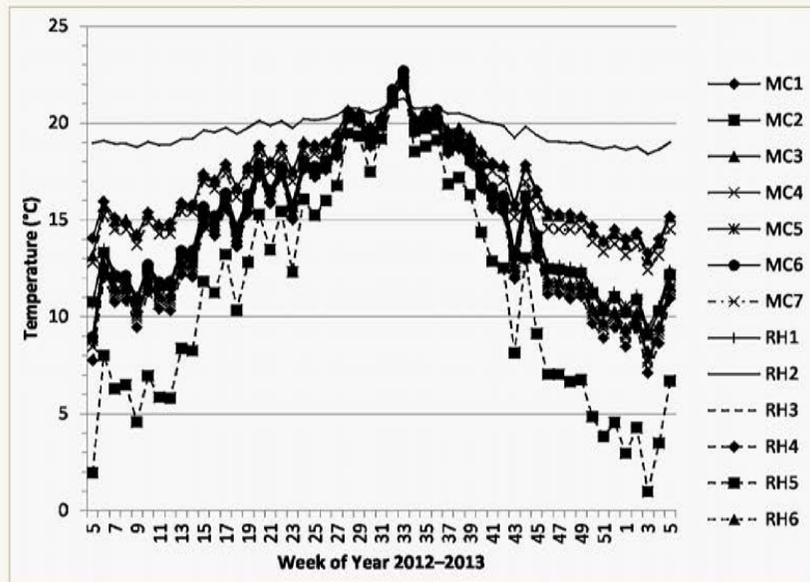
WALL N7—WOOD MOISTURE CONTENT

WALL N7—CAVITY RELATIVE HUMIDITY

WALL N7—TEMPERATURE

WALL N8—WOOD MOISTURE CONTENT

WALL N8—CAVITY RELATIVE HUMIDITY

WALL N8—TEMPERATURE

WALL S11—WOOD MOISTURE CONTENT

WALL S11—CAVITY RELATIVE HUMIDITY

WALL S11—TEMPERATURE

WALL S12—WOOD MOISTURE CONTENT

WALL S12—CAVITY RELATIVE HUMIDITY

WALL S12—TEMPERATURE

- 1) Recorded moisture content levels are below 14 percent for the investigated time period.
- 2) The seasonal fluctuation in moisture content is minor (the moisture content in summer and winter differs typically by less than 2 percent).
- 3) Differences between north- and south-facing walls appear to be insignificant.
- 4) Differences between wall assemblies constructed with MWI and XPS exterior rigid insulation appear to be insignificant.
