# Wood Structural Panel & Foam Insulation Systems:

Hygrothermal Behavior & Lateral Load  
Resistance — Experimental Studies

**JOINT RESEARCH REPORT**

**September 30, 2014**

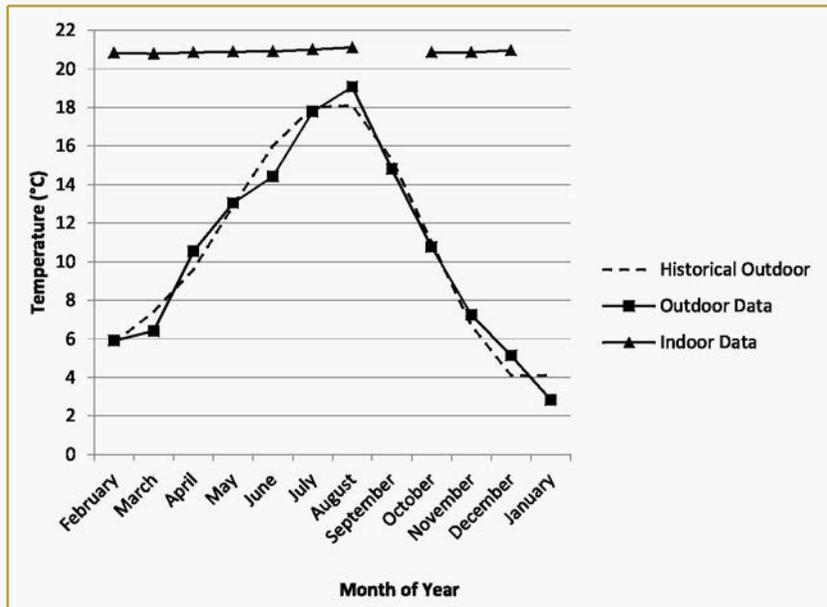
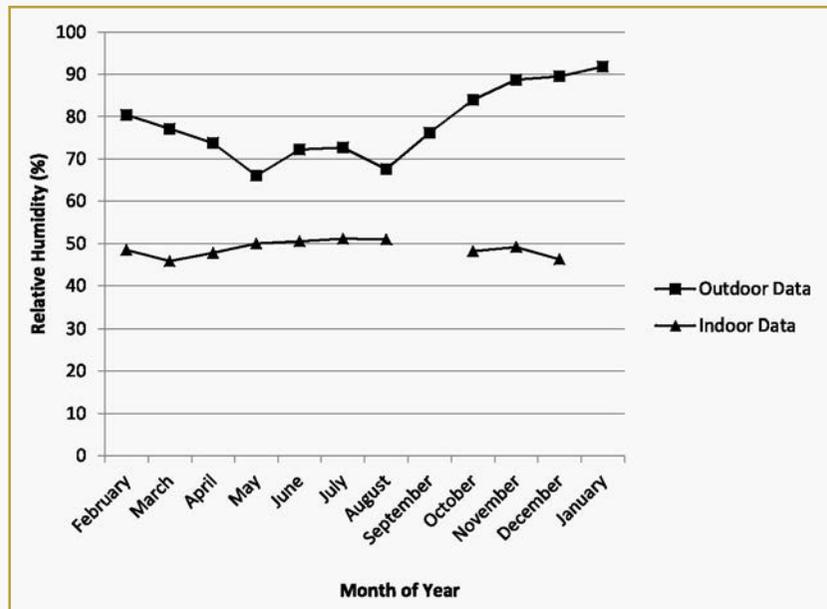
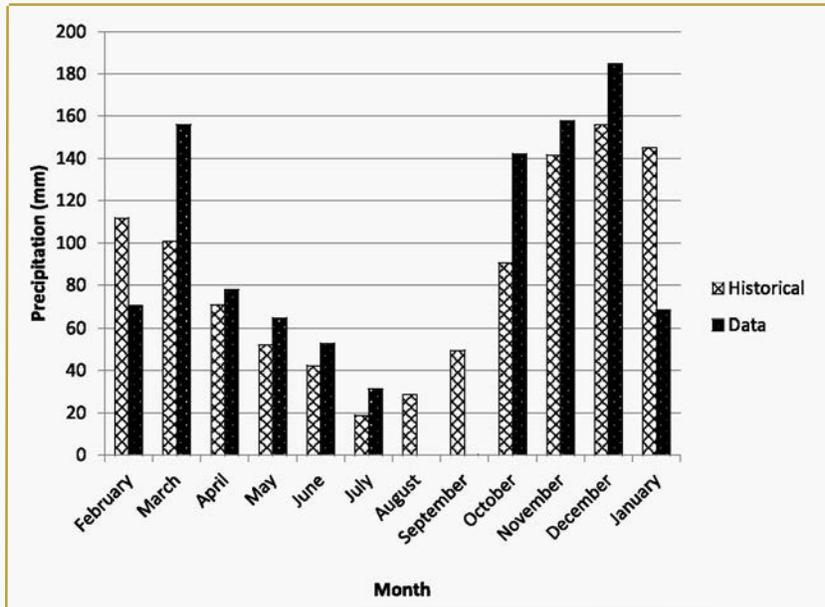
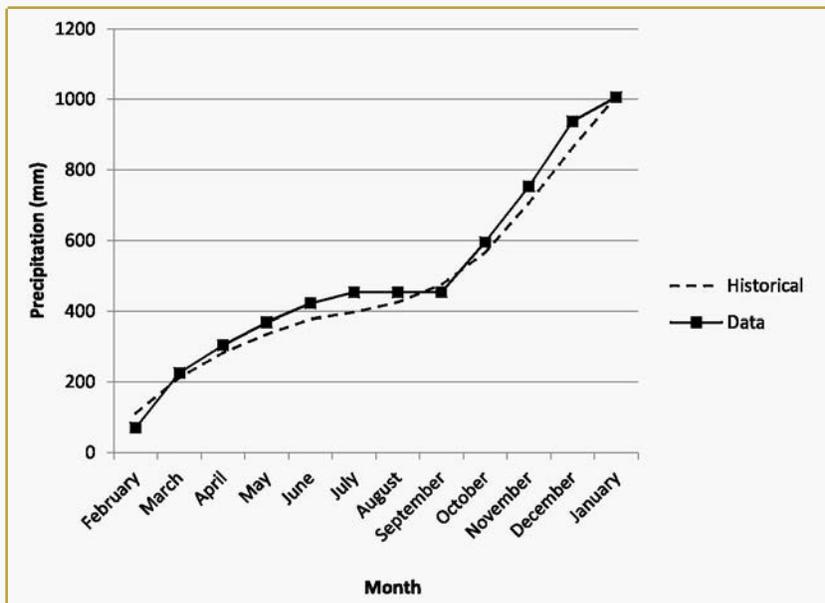
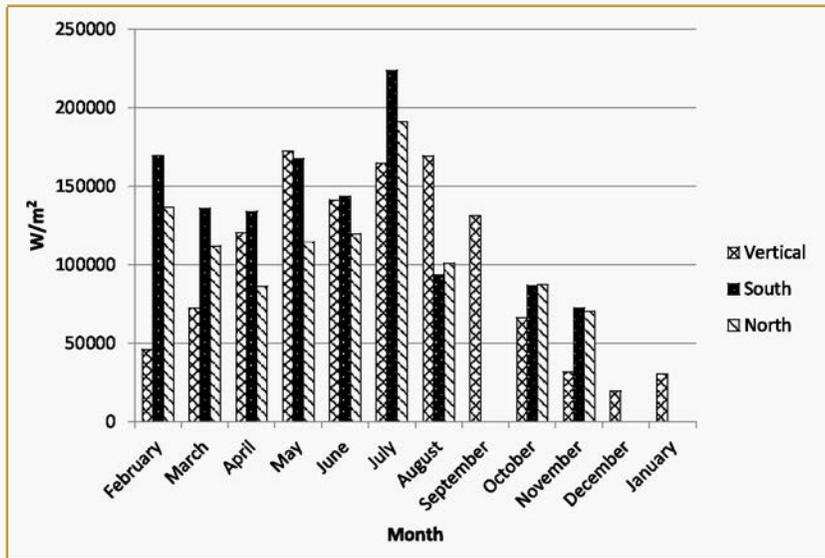
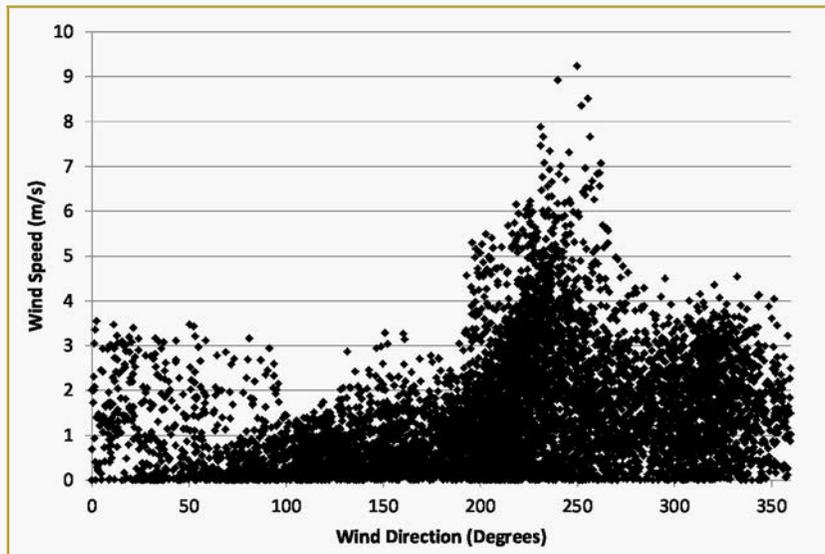
**OUTDOOR AND INDOOR TEMPERATURE**

**OUTDOOR AND INDOOR RELATIVE HUMIDITY**

SUM OF PRECIPITATION

CUMULATIVE PRECIPITATION

**SUM OF VERTICAL AND HORIZONTAL SOLAR RADIATION**

**WIND SPEED BY WIND DIRECTION**

For any given year, the outdoor environmental conditions vary from one season to another. Weekly averaged weather data are presented in **Appendix B**. It should be noted that the cumulative precipitation during this study period was virtually the same as the historical norm.

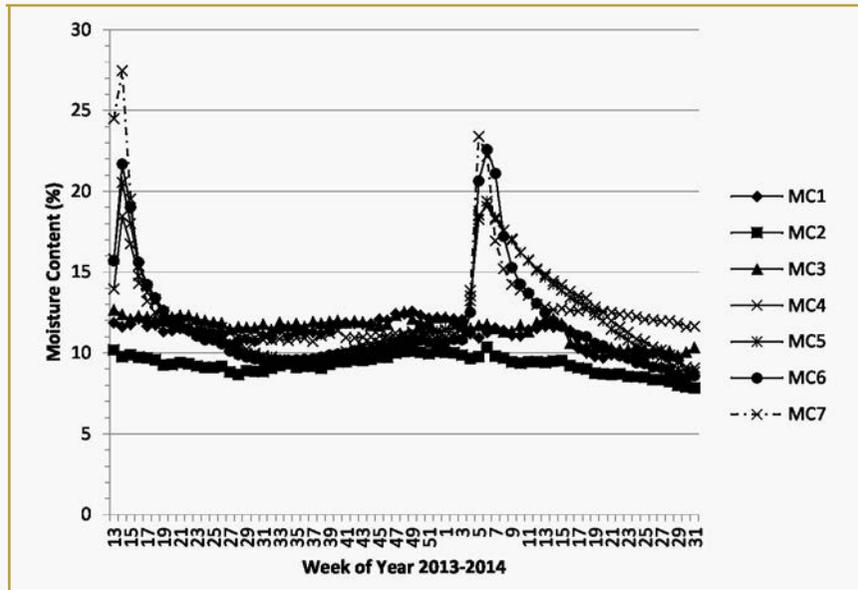
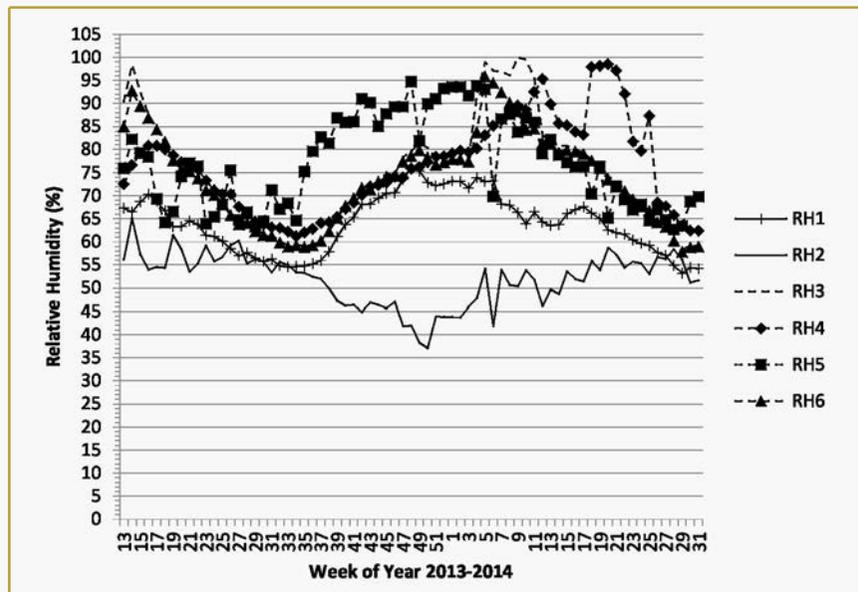
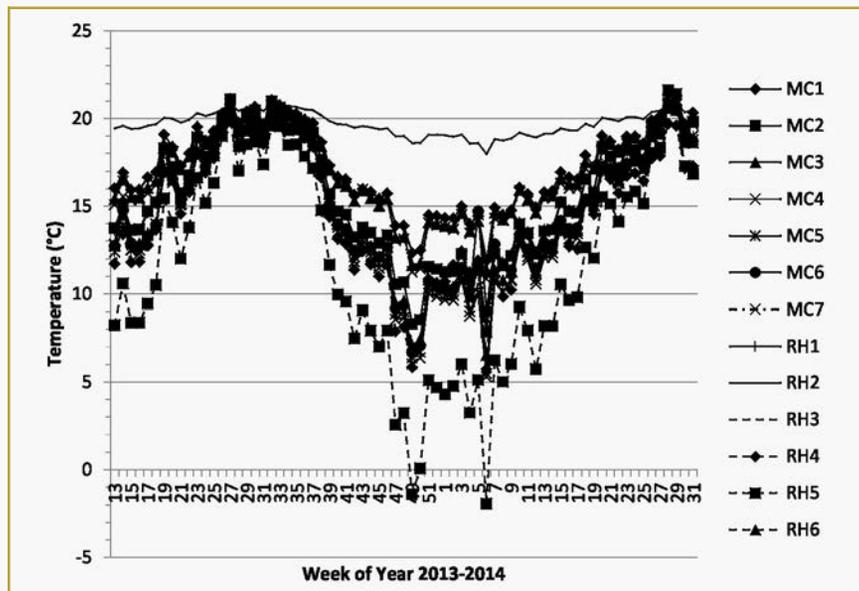
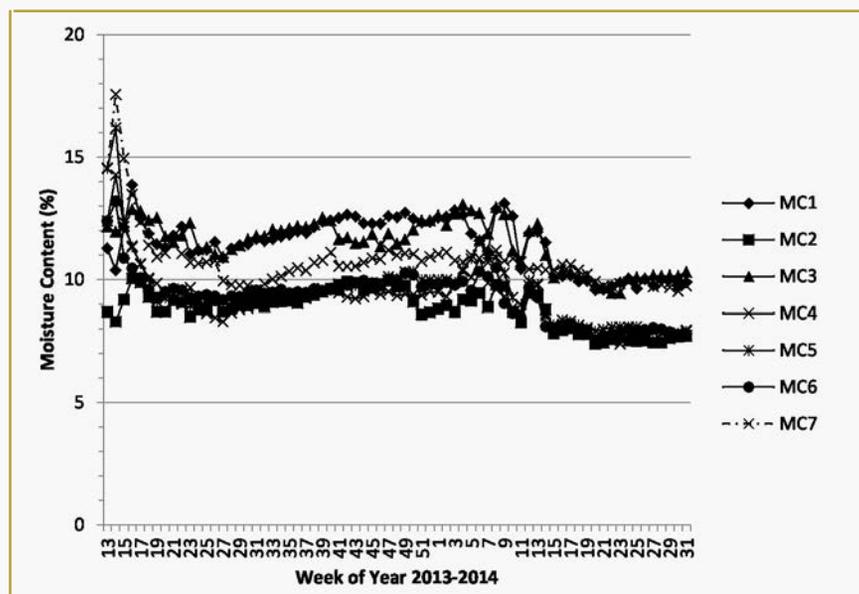
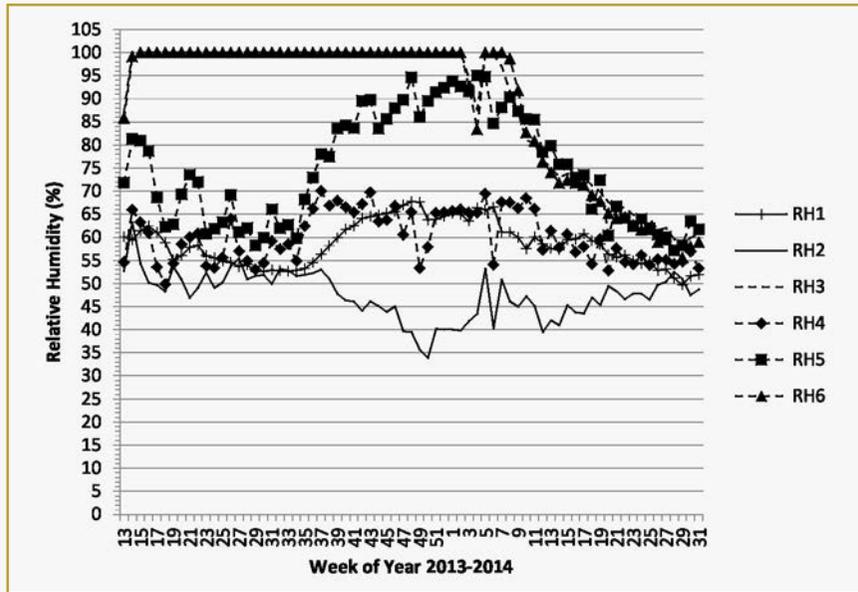
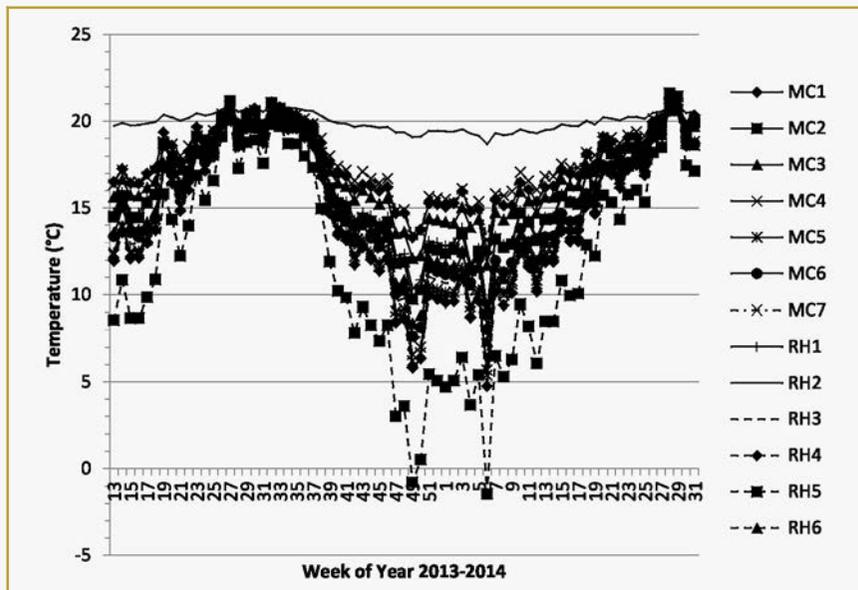
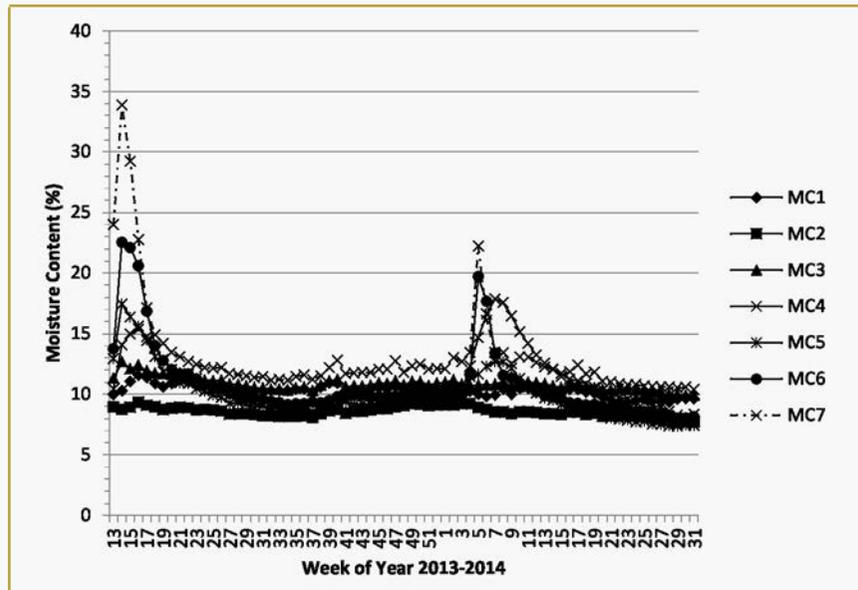
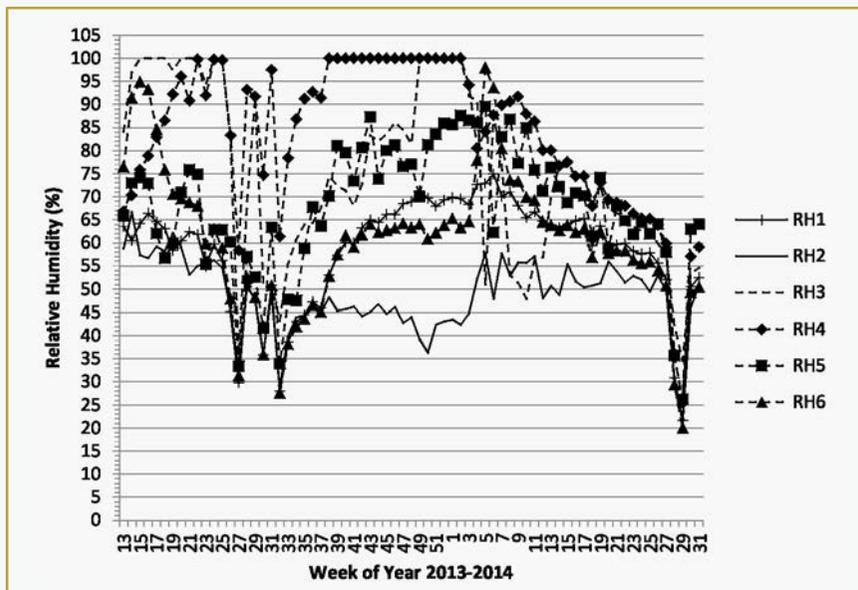
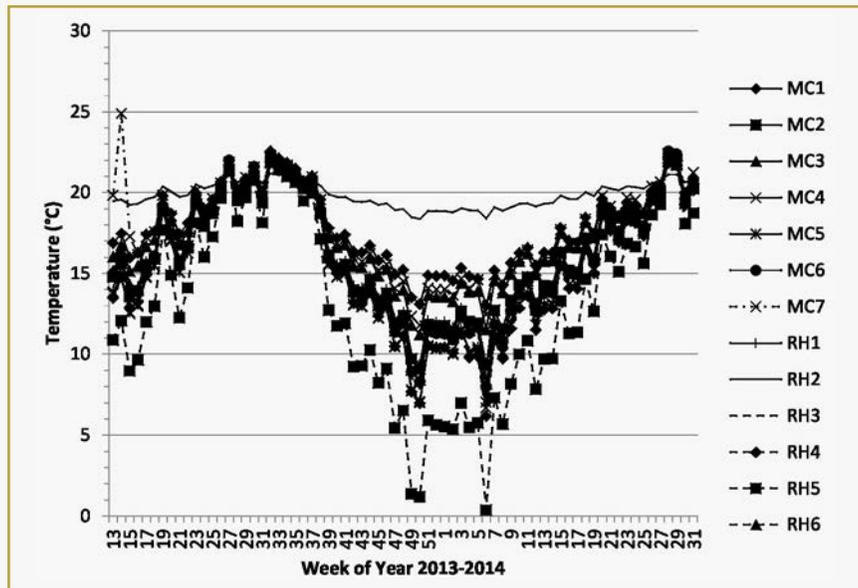
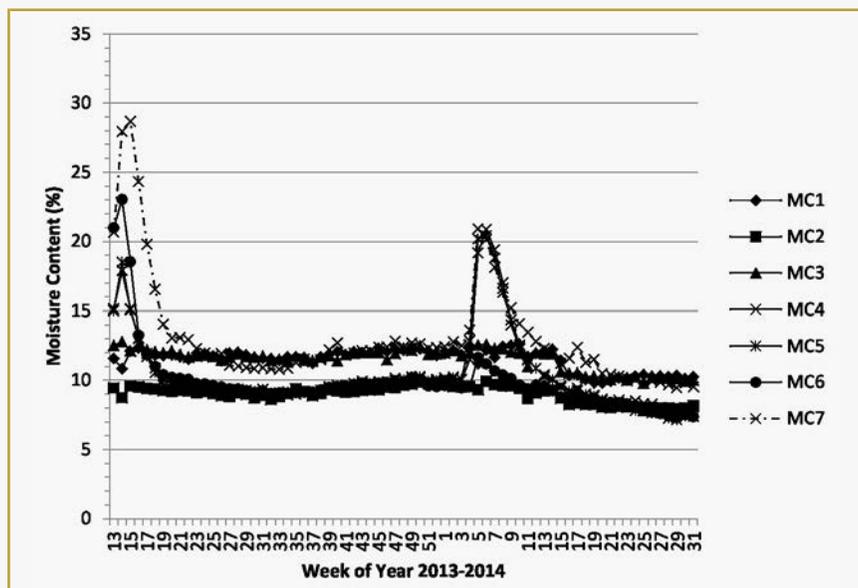
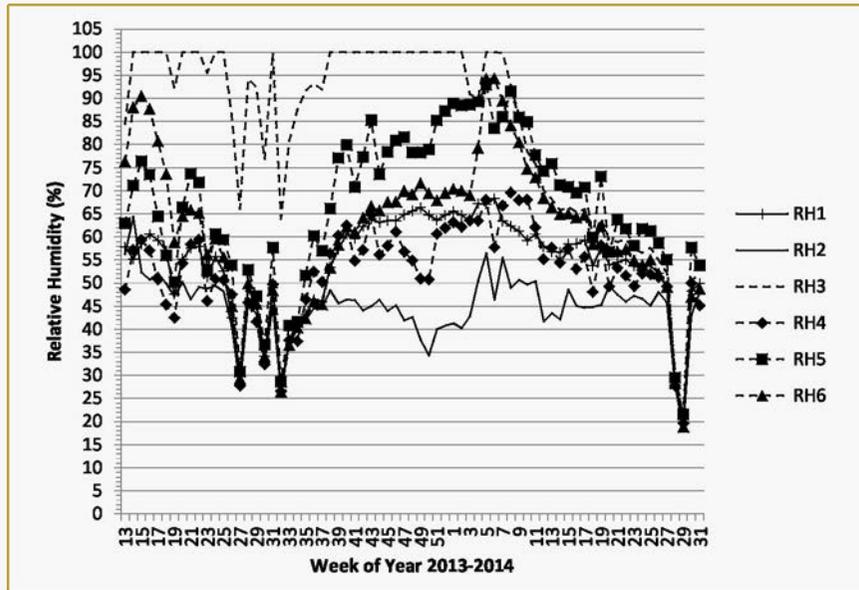
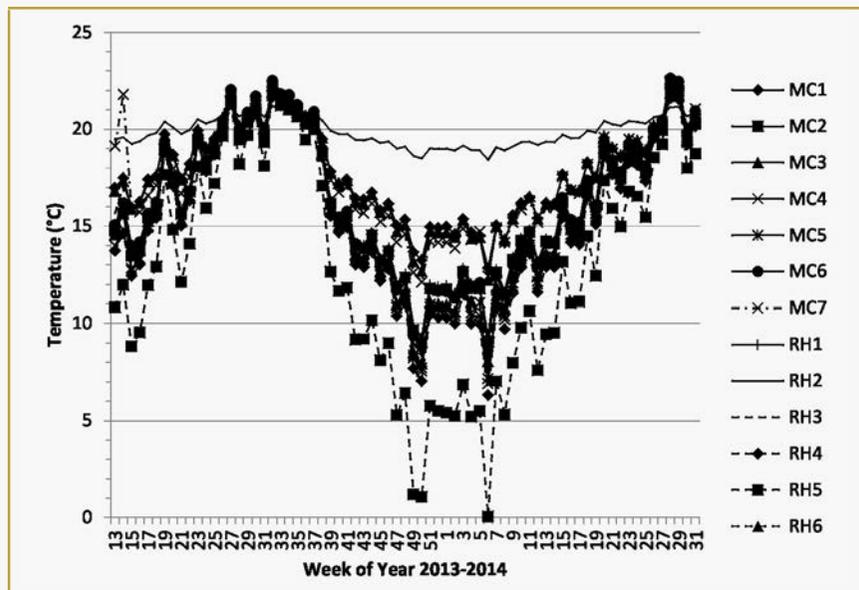
WALL N7—WOOD MOISTURE CONTENT

WALL N7—CAVITY RELATIVE HUMIDITY

WALL N7—TEMPERATURE

WALL N8—WOOD MOISTURE CONTENT

WALL N8—CAVITY RELATIVE HUMIDITY

WALL N8—TEMPERATURE

WALL S11—WOOD MOISTURE CONTENT

WALL S11—CAVITY RELATIVE HUMIDITY

WALL S11—TEMPERATURE

WALL S12—WOOD MOISTURE CONTENT

WALL S12—CAVITY RELATIVE HUMIDITY

WALL S12—TEMPERATURE

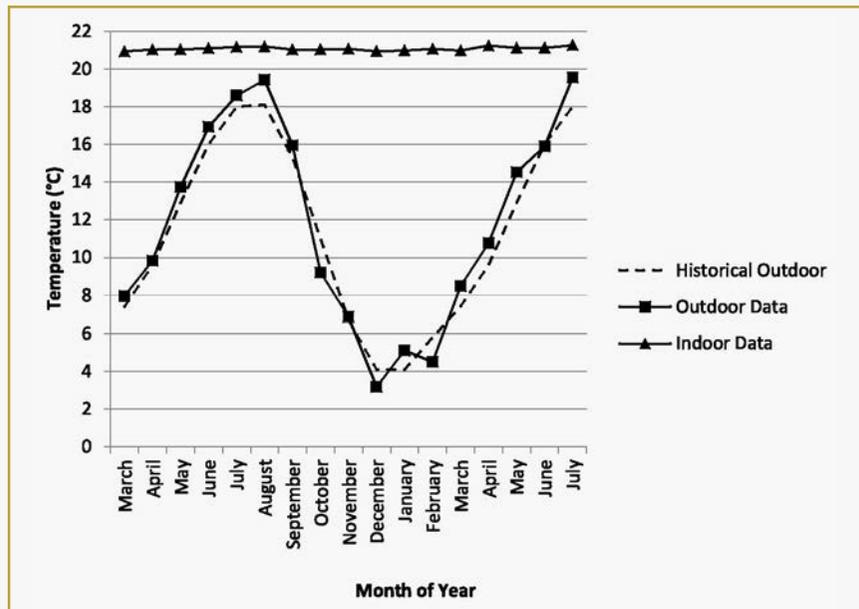
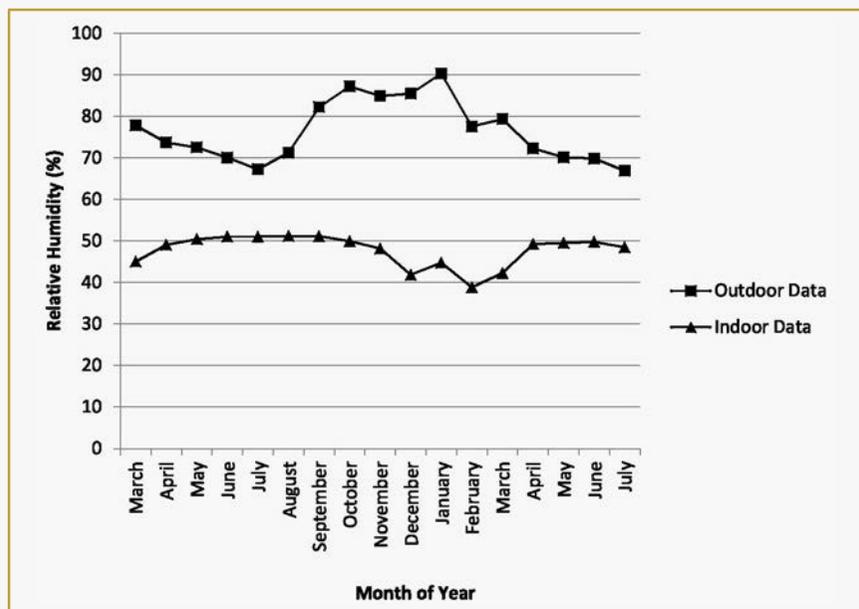
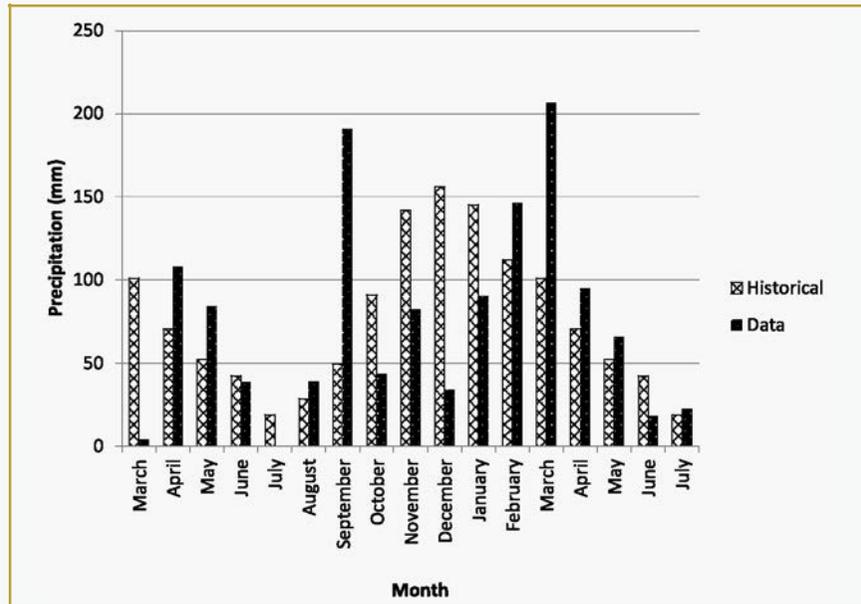
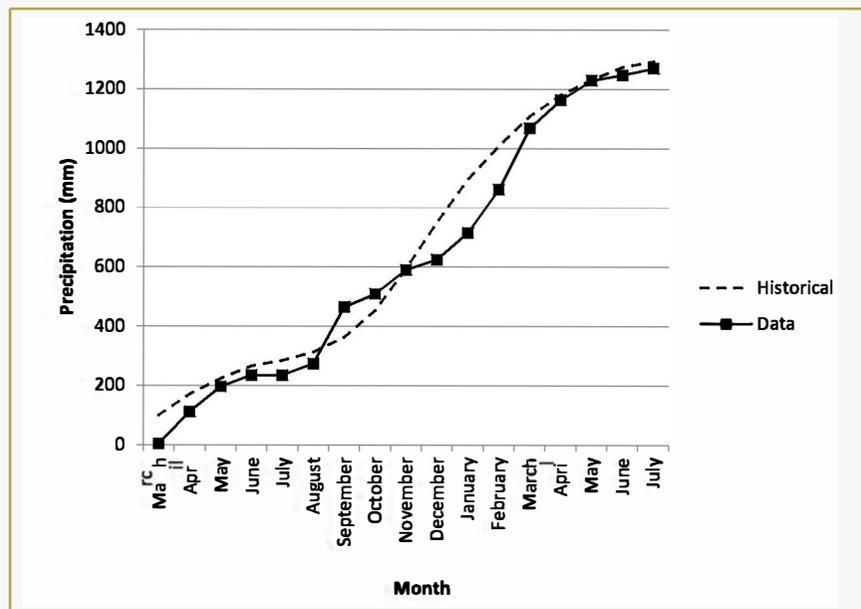
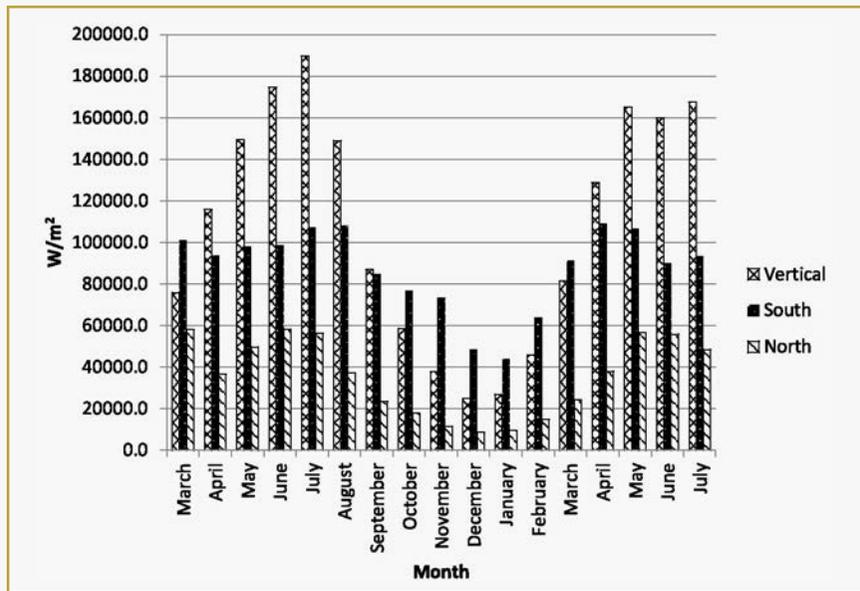
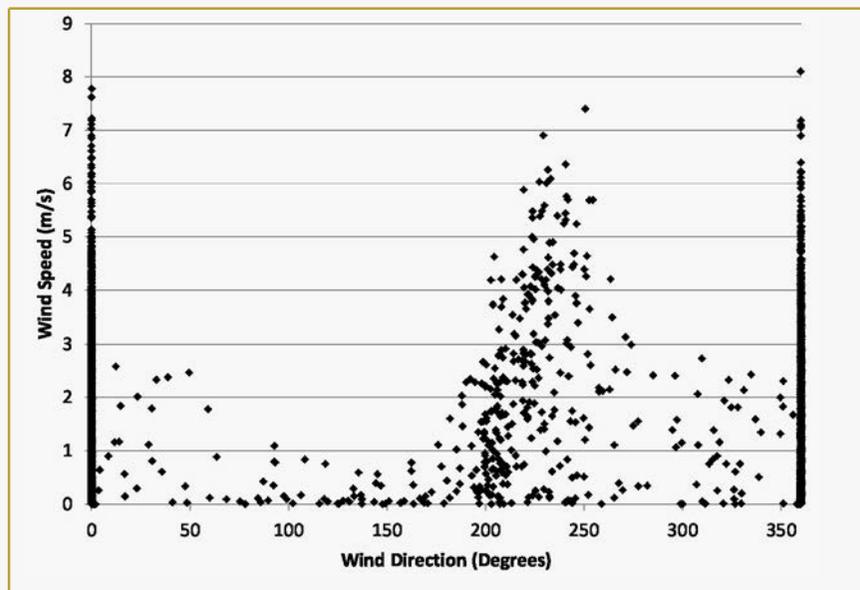
OUTDOOR AND INDOOR TEMPERATURE

OUTDOOR AND INDOOR RELATIVE HUMIDITY

**FIGURE D3**  
**SUM OF PRECIPITATION**

**FIGURE D4**  
**CUMULATIVE PRECIPITATION**

SUM OF VERTICAL AND HORIZONTAL SOLAR RADIATION (W/m<sup>2</sup>).

WIND SPEED BY WIND DIRECTION

The weekly averaged outdoor environmental data are presented in **Appendix D**. It should be noted that the cumulative precipitation was about 2 percent lower than the historical norm during this study period.
