Laboratory and environmental decay of wood–plastic composite boards: flexural properties

Rebecca Ibach^a, Marek Gnatowski^b, Grace Sun^b, Jessie Glaeser^c, Mathew Leung^b and John Haight^c

^aForest Products Laboratory, USDA Forest Service, Madison, WI, USA; ^bPolymer Engineering Company Ltd, Burnaby, BC, Canada; ^cCenter for Forest Mycology Research, USDA Forest Service, Madison, WI, USA

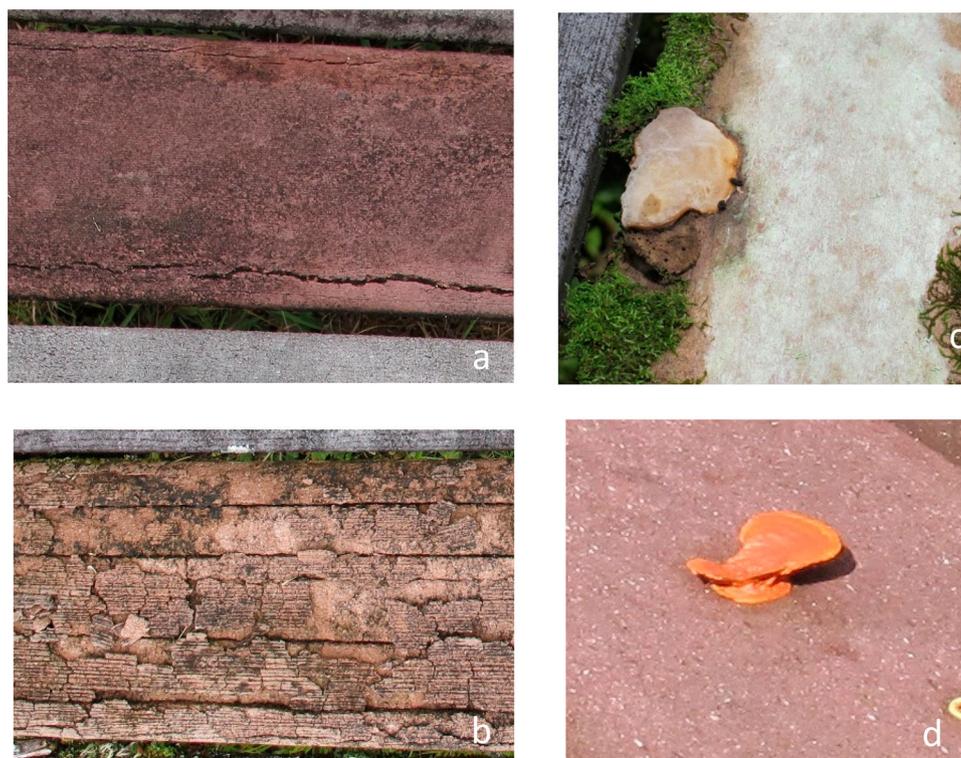
Figure 1. Examples of features developed during weathering of WPC boards near Hilo, Hawaii, for 9.5 years. (a,b) show cracks, and (c,d) show decay fungi (*Perenniporia tephropora* and *Pycnoporus sanguineus*, respectively).

on many of the exposed boards and was not altered by cleaning during this study. Biological growth, including fungal fruiting bodies, moss and lichens, was particularly distinct in the Shadow exposure. Figure 1(a–d) shows an example of some fruiting bodies of decay fungi and cracked boards that were found during this inspection.

Based on fruiting body morphology, these decay fungi were tentatively identified as including the white rot fungi *Perenniporia tephropora* and *Pycnoporus sanguineus*, as well as the brown rot fungus *Dacryopinax spathularia*. Several other fruiting bodies were sterile and could not be identified using morphological techniques. In addition, cultures grown from fruiting body tissue and wood particles were identified by DNA analysis (Table 2) and indicated that the same decay fungi were found on multiple boards in the exposure site and that fungi found on the surface, represented by fruiting bodies, were also colonizing the interiors of the boards.

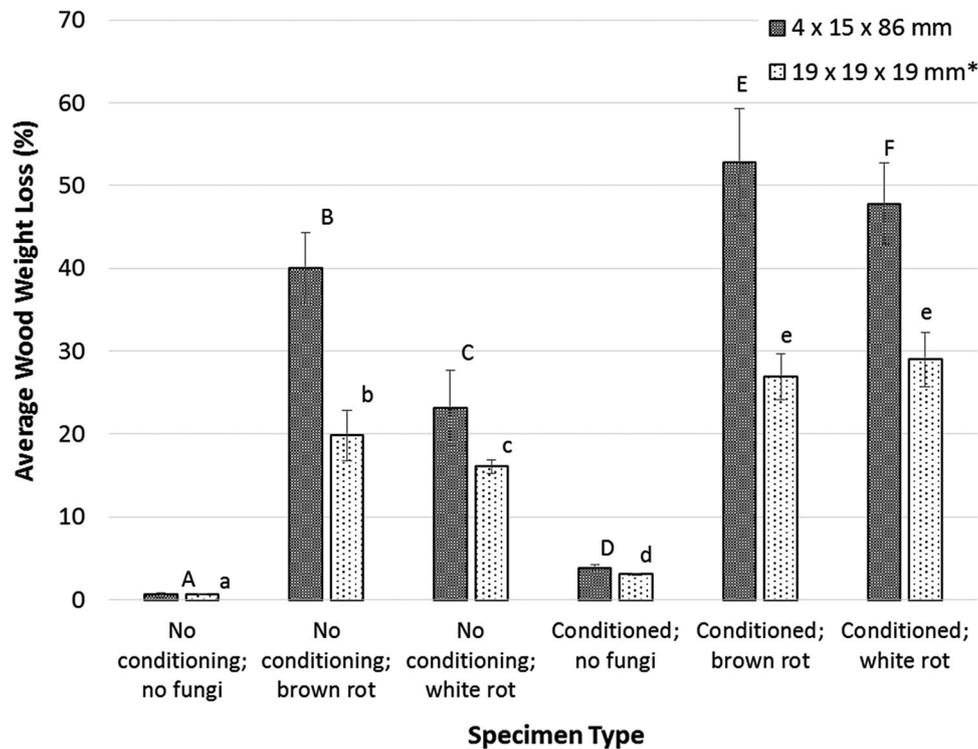
Figure 2. Wood weight loss – effect of conditioning, fungi species, specimen size and geometry; bars with the same letters (case-sensitive) are statistically similar based on a *t*-test at 95% confidence. *All data for $19 \times 19 \times 19 \text{ mm}^3$ specimens are from previously published research (Sun *et al.* 2015).

Specimens with different geometry cut from the same WPC reference board material and tested with and without conditioning showed different weight losses after 12 weeks of fungal exposure (Figure 2). The relative weight loss of the specimen and its related wood weight loss were significantly larger for flexural test bars (4 × 15 × 86 mm³) in comparison to earlier tested specimens that were cut to the standard size of 19 × 19 × 19 mm³ (Sun *et al.* 2015) as required by the AWPA E10 standard (2013). Comparison of wood weight loss

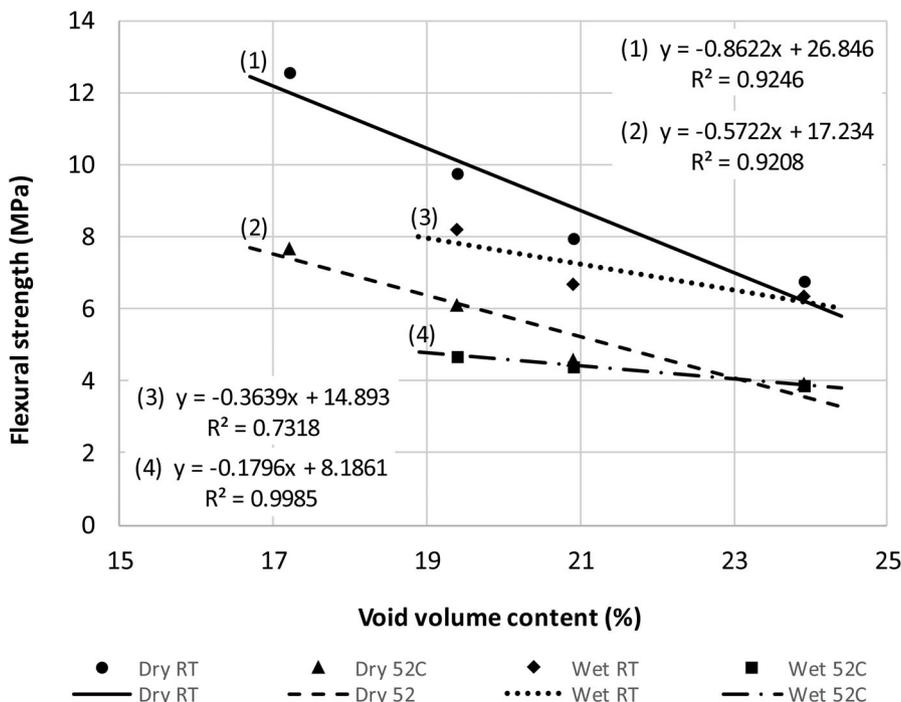
Figure 3. The relationship between flexural strength and void volume content for unconditioned and conditioned laboratory samples with and without insertion into soil block bottles, tested at four different conditions. No decay fungi were present in the tests.

Linear regression analysis was used to study the relationship between flexural strength and void volume change in the WPC samples when subject to different exposure conditions without the presence of fungi. In Figure 3, four linear regression lines applied to data are distinct on the graph; each line is associated with a particular flexural testing condition. For three of these lines, R^2 values were in the range of .92–.99. For the regression line representing Wet samples tested at RT (23°C), the R^2 was lower at .73, due to slightly larger data distribution. Regression lines (1) and (2) represent test points for samples tested dry at different temperatures and these lines are relatively parallel. Similarly, the two other regression lines (3) and (4) both representing samples tested wet at RT and 52°C also appear to be parallel. Another interesting observation is that lines (1) and (3) and lines (2) and (4), with each pair representing different testing temperatures, meet together at a similar void volume content of about 24%. It may be possible that 24% is the highest void volume content that can be reached for tested WPCs subject to the applied exposure conditions without decay fungi activity, and a wet/dry cycle does not introduce a significant amount of new microcracks during the experiment.

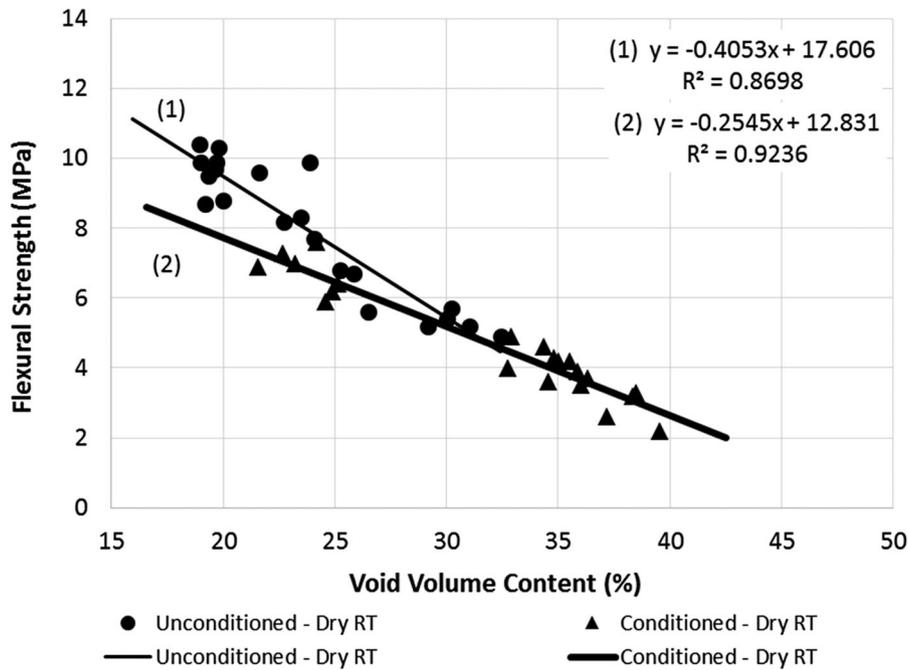
Figure 4. Laboratory samples conditioned and unconditioned and exposed to decay fungi – flexural strength versus void volume content – linear regression analysis with experimental data.

To determine if a single linear regression is sufficient to model the behavior for conditioned or unconditioned WPC samples, regardless of exposure to either fungal species or no fungi, linear regression analysis was performed on the data relating flexural properties to void volume content. Previous research determined that WPC exposed to different fungal species would develop different void volumes and sizes (Sun *et al.* 2014, 2015). All of the applicable 42 individual test data belonging to the six test groups with unconditioned and conditioned samples exposed to white- and brown-rot under Dry conditions at RT were used to construct the graph in Figure 4. The individual test results for each group are averaged and presented in Table 8. There were two regression lines constructed with R^2 values of .87 (line No. 1) for unconditioned specimens and $R^2 = .92$ (line No. 2) for conditioned specimens to fit these data. These regression lines seem to be characteristic for the composite tested.

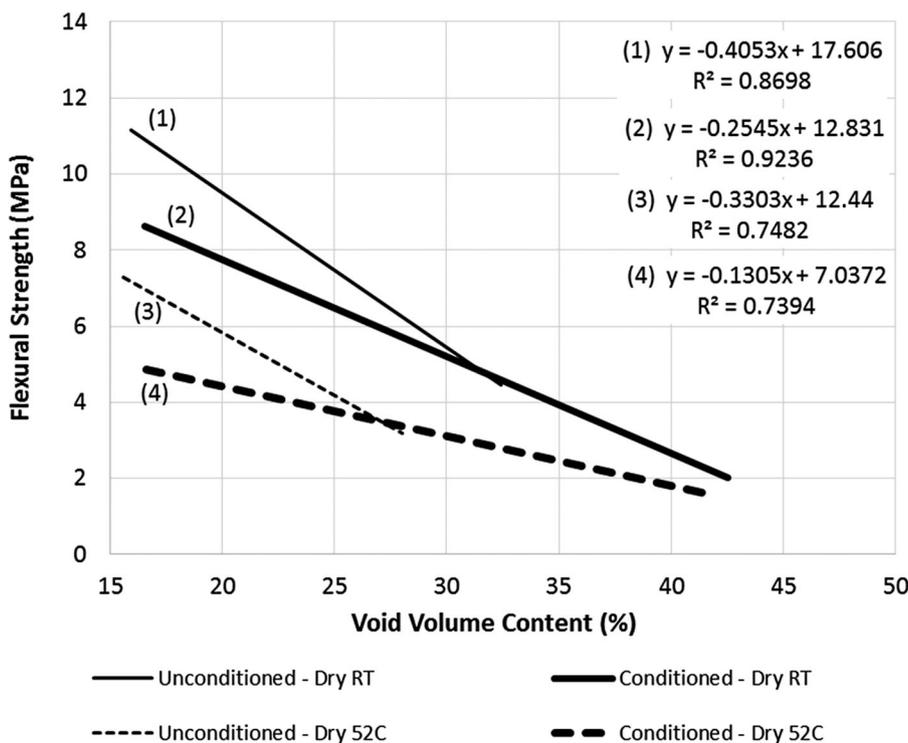
Figure 5. Laboratory samples conditioned and unconditioned and exposed to decay fungi – linear regression analysis for flexural strength versus void volume content – samples tested dry at RT and 52°C.

To confirm the proposed approach to data analysis, the other tested sets of samples were analyzed with respect to the dependence of flexural strength on void volume. Figure 5 contains corresponding regression lines of WPC samples that were conditioned and unconditioned and tested Dry at RT and 52°C. For clarity, individual data points were not shown in the graphs. The fit of the points is represented by the coefficients of determination for the regression lines that are shown together with line equations on the graph.

In Figure 5, the regression lines for unconditioned samples showed larger slopes and usually ended in contact with lines constructed based on data for conditioned specimens. Also, it appears that if regression lines for conditioned samples were to be extended to intersect the x-axis, it would occur at a point where the void volume is about 50%, which happens when the wood content is 0% (data not shown). If the observed relationship between flexural strength and void volume is still valid in the region of 50% void volume, then mechanical disintegration of the composite before testing may be expected when all wood becomes completely digested by fungi.

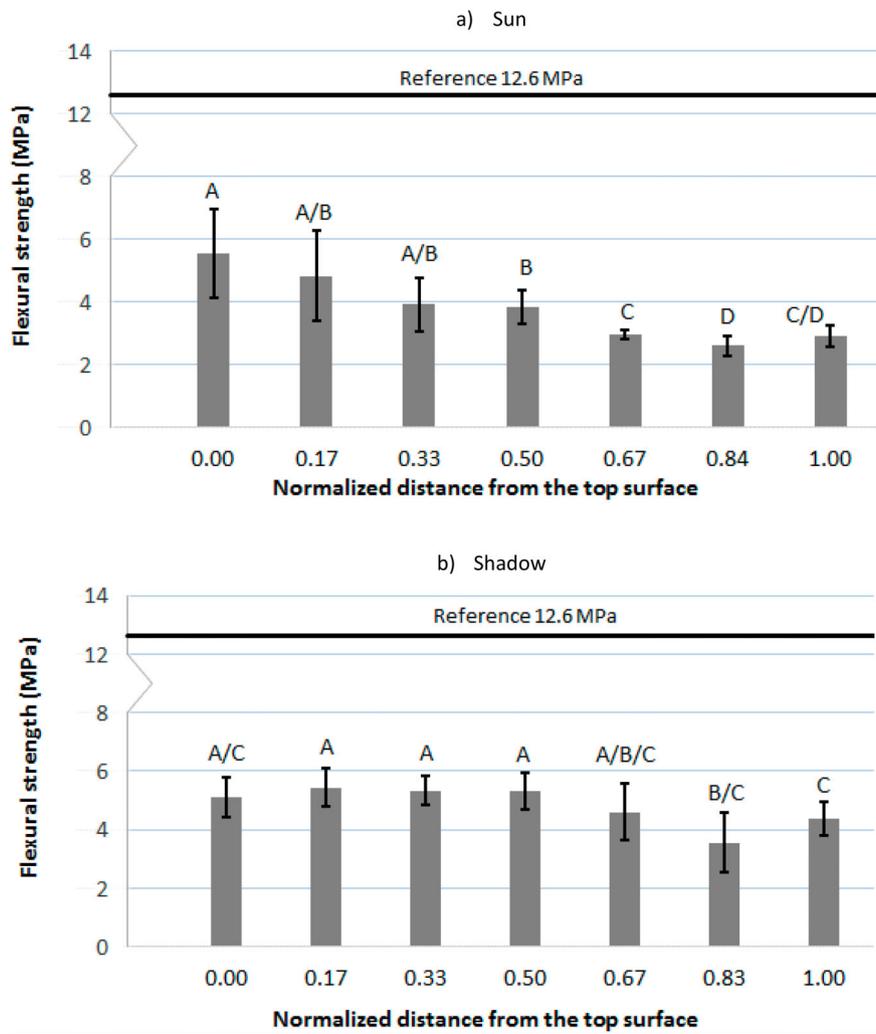
Figure 6. Sun and shadow samples tested dry at RT – flexural strength versus normalized distance from the top surface; bars with the same letters are statistically similar based on a *t*-test at 95% confidence.

Flexural strength and modulus for field-exposed samples are shown in Tables 9 and 10 and in Figures 6(a,b) and 7. A comparison of flexural properties of unexposed (Reference) WPC board and decayed boards exposed in sun and shadow both showed a decrease compared to the Reference. The average MOR and MOE for the unexposed board tested dry at RT was 12.6 and 854 MPa (Table 8) vs. 3.5 and 170 MPa, respectively, for the sun-exposed board and 4.8 MPa and 255 MPa for the Shadow-exposed boards. The reductions in the performance of the exposed boards could be explained by the average of about 60% wood loss due to decay for the core samples that were exposed in the sun location and about 50% for those exposed in Shadow. Testing temperature, as would be expected, influenced the flexural properties of WPC decayed. For sun exposure, flexural strength decreased from about 3.5 MPa to 2.4 MPa and flexural modulus from 170 to 138 MPa with temperature increase to 52°C. The presence of moisture during testing did not affect

maximum strength near the upper surface and minimum flexural strength and modulus on the opposite side. For example, the sun-exposed set of specimens cut from the board upper surface (#1 group) showed an average MOR 5.5 MPa (tested Dry at RT) vs. only about 2.8 MPa for #5, #6 and #7 groups of specimens from the opposite side of the board (Figure 6 (a)). A similar trend was also observed for the shadow-

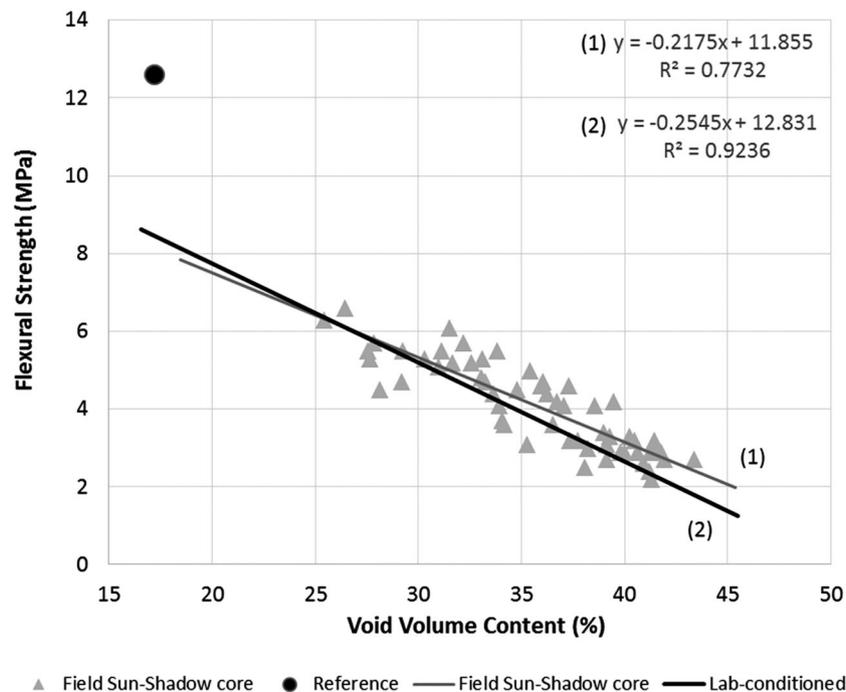
Figure 7. Field samples (core) tested dry at RT – flexural strength versus void volume content, shown with regression line for conditioned laboratory samples (black) and test points with regression line for sun and shadow field samples (gray). The flexural strength for the reference unconditioned sample is also shown.

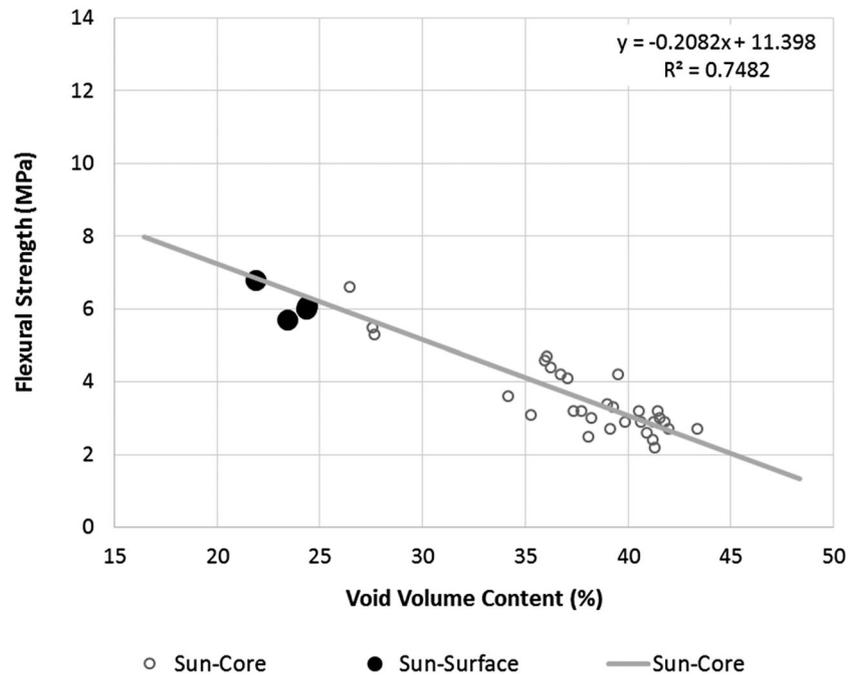
Figure 8. Sun samples tested dry at RT – flexural strength versus void volume, comparison of surface and core specimens.

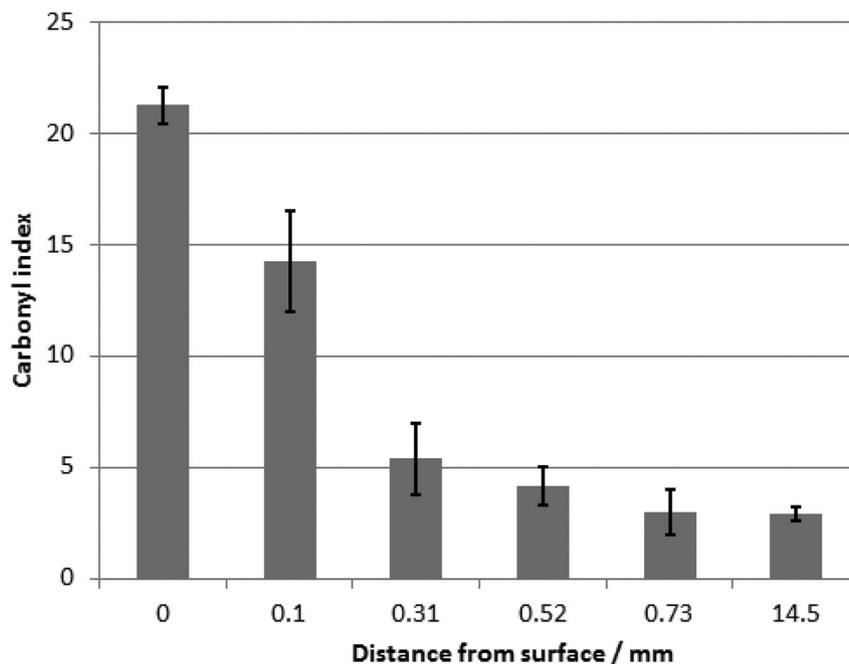
Figure 9. Carbonyl index versus distance from the sun board surface.

distance from the board surface are shown in [Figure 9](#). At the surface, the carbonyl index measured 21.2. At a distance of 0.10 mm from the surface, it was reduced by almost half to 14.2 and at a distance of 0.73 mm, it was only 3.0. This was close to the threshold of the carbonyl index, which was measured as 2.9 in the center of the board. A statistical evaluation of the carbonyl index data indicated that photo-oxidation in WPC was similar for samples taken at 0.73 mm below the board surface and deeper. As can be seen, the carbonyl index decreased quickly with the increasing distance

from the surface, regardless of almost 10 years exposure of the tested samples in tropical conditions. Similar results, with very shallow UV induced degradation, have been reported in the past where photo-oxidation in the board cross-section in the vicinity of the surface of the laboratory weathered WPC sample, made without UV absorbing pigments and stabilizers, was tested using Raman spectroscopy (Gnatowski *et al.* 2007). However, UV radiation from the sun may have a significant effect on the exposed surface appearance related to material discoloration (Ebe and Sekino 2015)
